Our File: 22-01049

Re: Engineering Report of Fire Damage to a Dwelling

Loss Location: 60 Fleury Street, Aurora, ON
Insured: Ryan & Michelle Panet

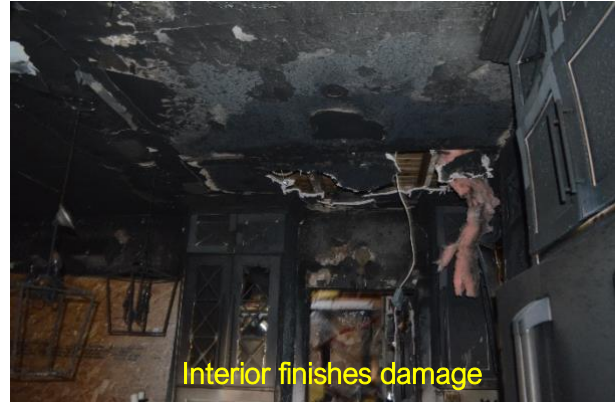
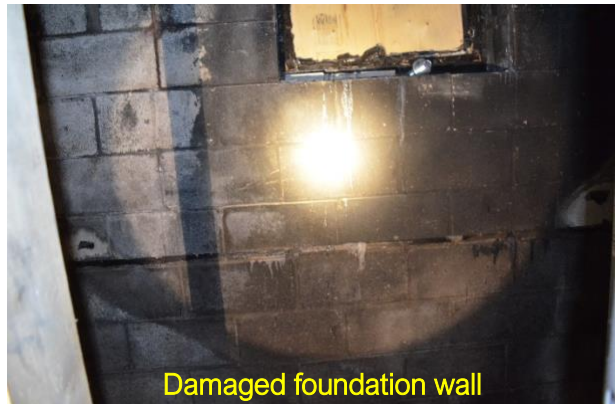
The building sustained damage as a result of a fire. The fire appeared to originate within the fireplace of the one-storey addition. A visual inspection of the existing condition of the floor frames and walls was completed.

The fire caused structural damage to the building's framing, particularly a portion of the foundation wall in the basement. The roof, walls, and flooring of the one storey addition, on the south side of the dwelling were fire damaged.

Interior finishes within the original dwelling sustained substantial damages as a result of the fire.

To restore the dwelling to pre loss performance, demolition and replacement of a portion of the addition foundation wall and full demolition and replacement of the one storey addition superstructure will be required. The building is to be reconstructed to match the existing footprint and height.
