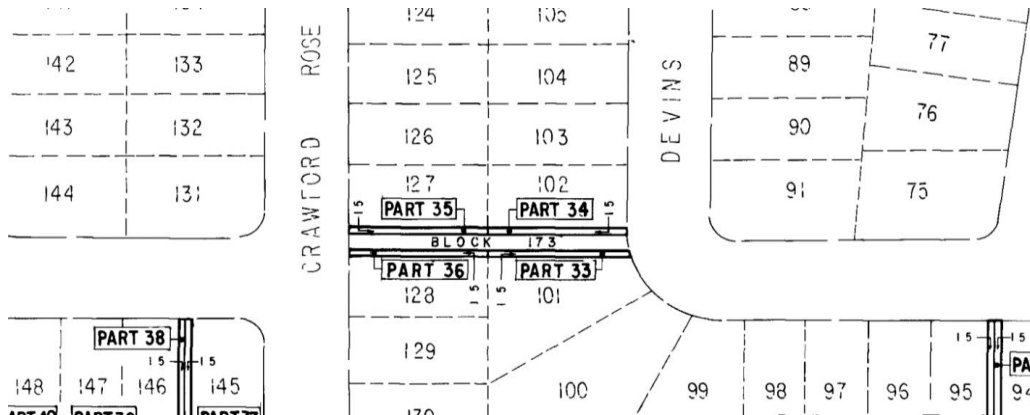
**Figure 1 – Image showing a 1.5-meter registered easement on the north and south side of this walkway:**

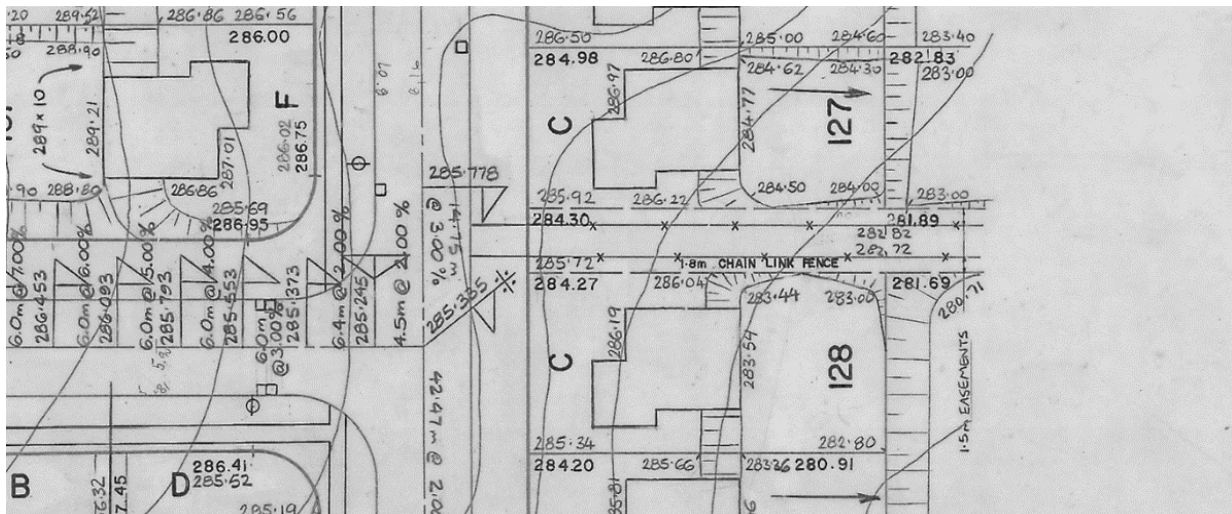
**Figure 2 – Approved plan showing 1.5 easement with no retaining wall at Lot 127-108 Crawford Rose:**

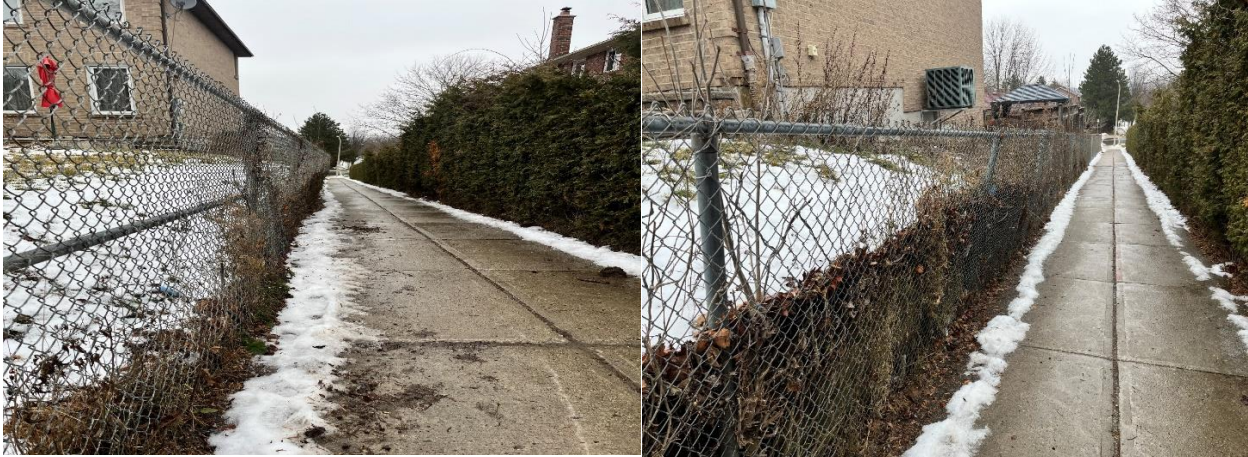
**Figure 3 – Images of the failing retaining wall with the chain-link fence leaning into the walkway:**

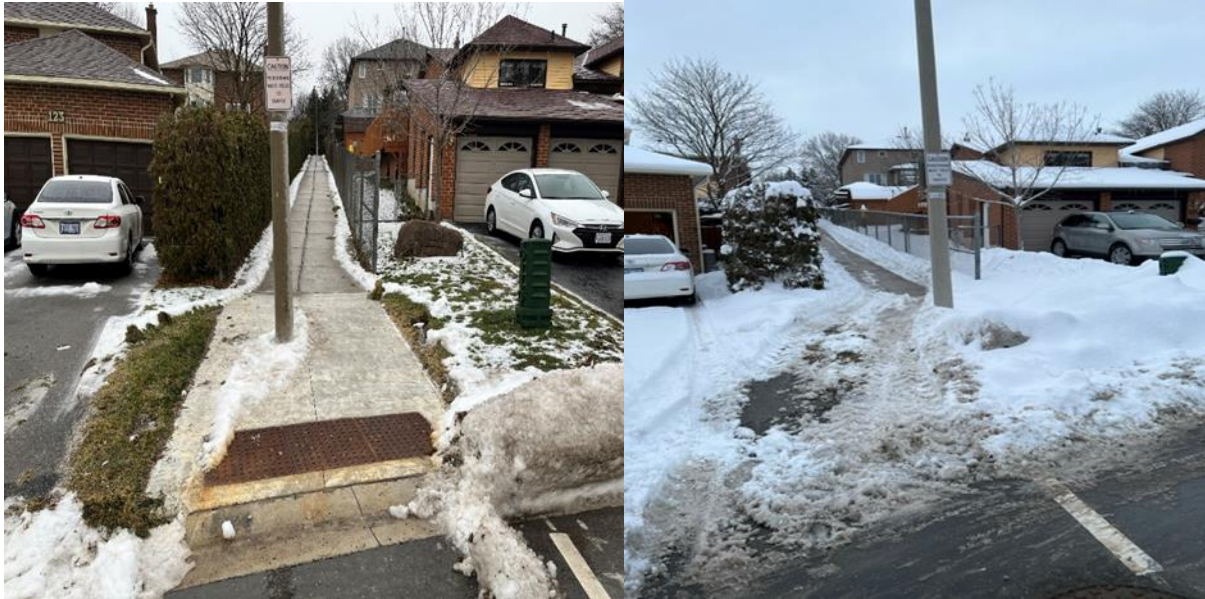
**Figure 4 – images of the challenges in plowing this walkway due to a streetlight being installed in the middle of this walkway at both ends:**

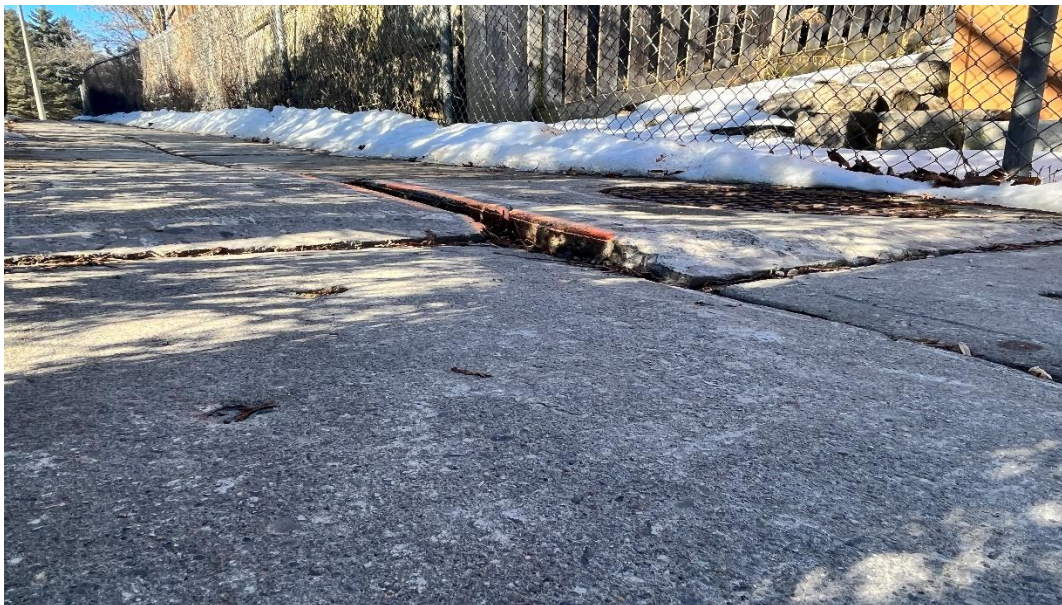
Operations also maintains a Sanitary sewer main and a Storm sewer main under this walkway. Storm water and sanitary manholes require adjustment due to heaving and failed adjustment units which are currently causing uneven walking surfaces.

**Figure 5 – Sidewalk panels heaved:**

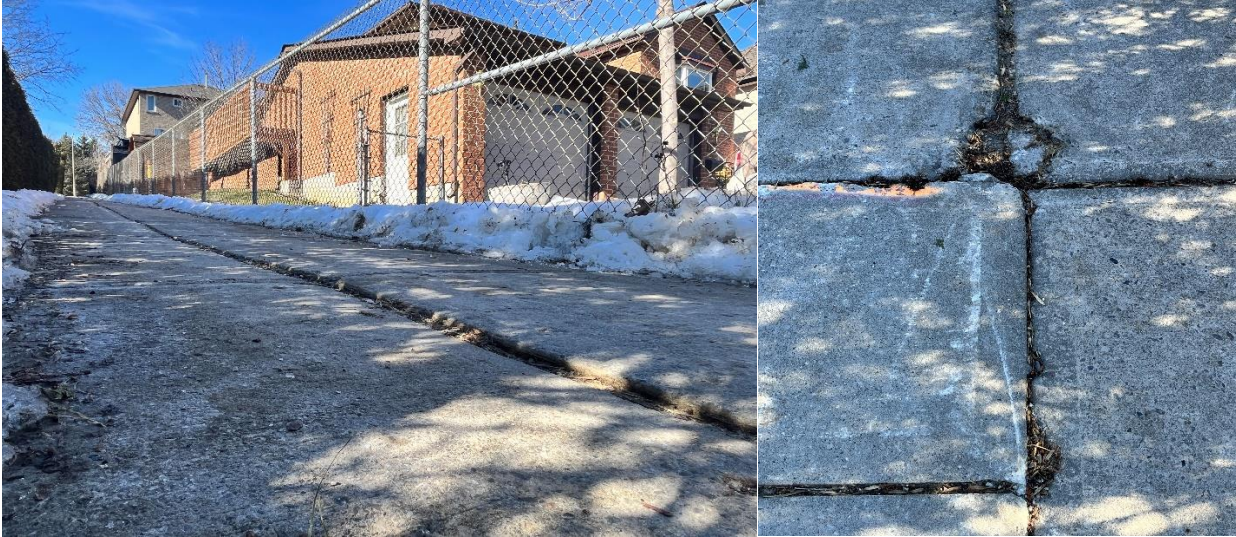
Other documented deficiencies include cracked panels, heaved sidewalk bays, separations creating large gaps pose a trip hazard to walkway users.

**Figure 6 – Longitudinal joint deflections and uneven walking surface:**
