Town of Aurora

Closed Session Council Report No. PDS20-046

Subject: Potential Property Acquisition – 250213 Holdings Ltd (15157, 15165, 15171 Yonge Street)

Property Condition Assessment Report Of an Improved Commercial Property

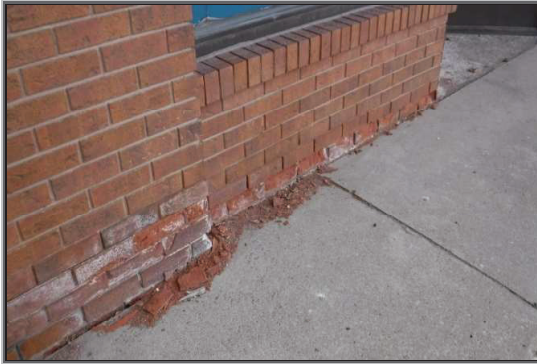
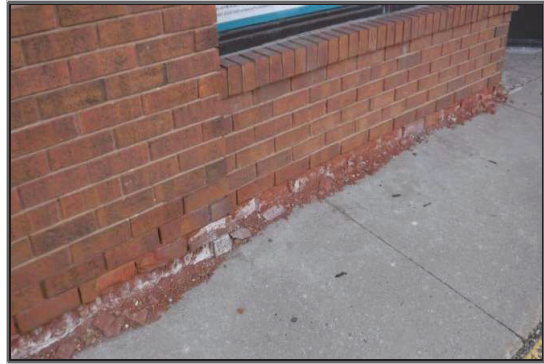
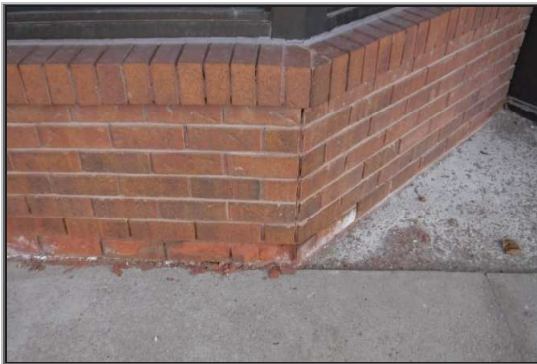
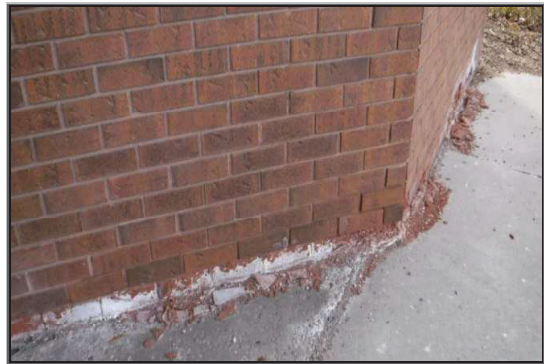
Always monitor the building envelope and exterior through inspection and observations. Further investigation is recommended by either a structural company or any professional expert to repair or replace the affected areas.

Recommendation	EUL	EFF AGE	RUL	Year	Cost
Brick Deterioration	40	20	20	Immediate	\$2,000
Total					\$2,000

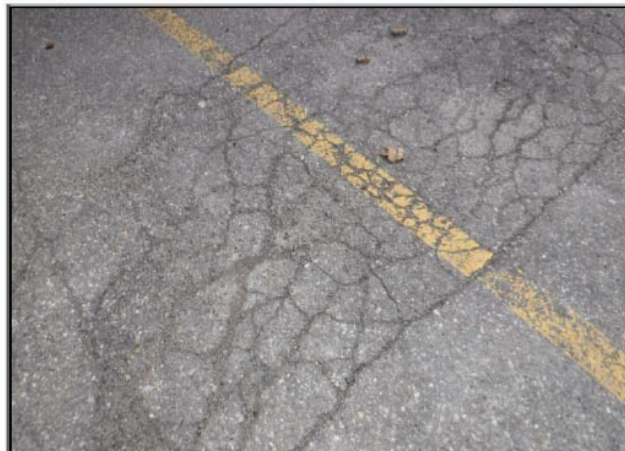
Marginal capital expenditures pertaining to the paving, curbing, parking and landscaping are anticipated over the next three (3) years, apart from ongoing routine maintenance and repairs. Cracks, and landscaping should always be monitored and mitigated as needed.

Recommendation	EUL	EFF AGE	RUL	Year	Cost
Asphalt crack sealing	30	25	5 Yrs	Immediate	\$1,000
Total					\$1,000

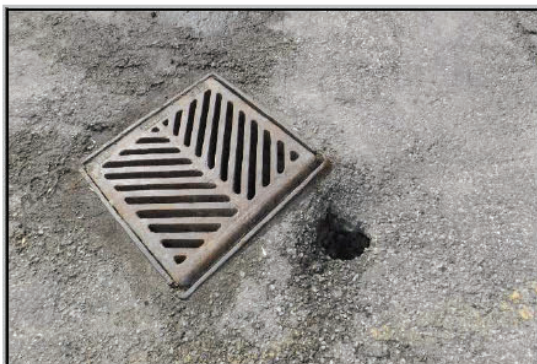
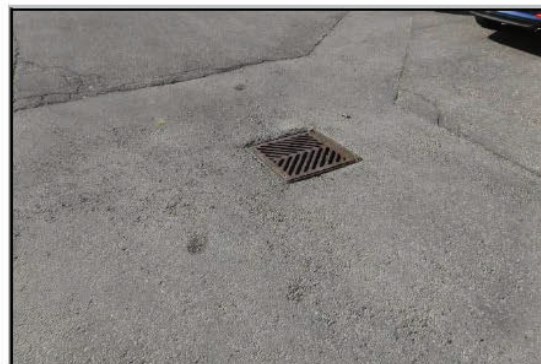
No significant capital expenditures pertaining to the site topography are anticipated over the next three (3) years, apart from ongoing routine maintenance and repairs. Cracks, loose pavement, concrete walks, proper drainage should always be monitored and mitigated.

Recommendation	EUL	EFF AGE	RUL	Year	Cost
Repair asphalt hole	40	30 yrs	10	Immediate	\$3000
Total					\$3,000
