VICTORIA HALL

Heritage Advisory Committee Meeting,
April 13, 2026

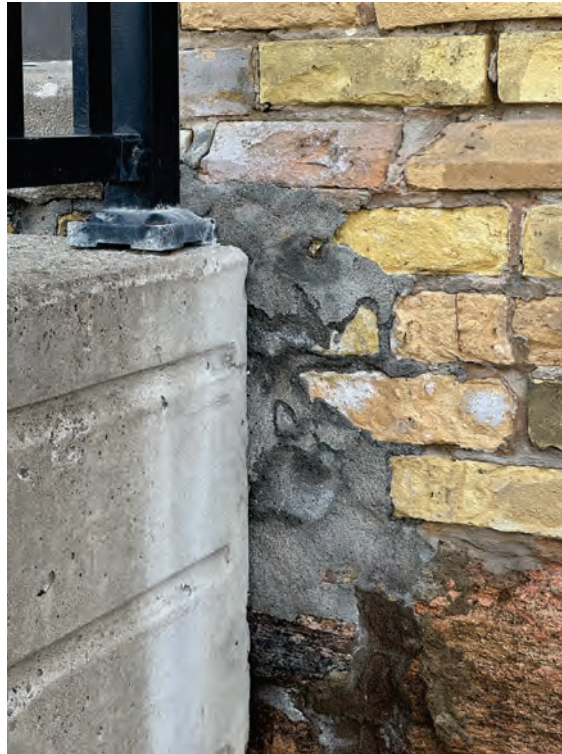
Cementitious repair and deterioration at junction with brick masonry

HERITAGE ATTRIBUTE	IMPACT
Yellow brick exterior	Direct adverse: N/A Indirect adverse: N/A Positive: The project supports masonry repair and conservation, including treatment of cracked units, parging, and incompatible mortar repairs.
Datestone	Direct adverse: N/A Indirect adverse: N/A Positive: N/A
Remnants of historic doorway	Direct adverse: N/A Indirect adverse: N/A Positive: As part of the restoration efforts, the existing covering at the transom can be removed to investigate whether original material remains beneath.
[Interior] Side trim and wainscoting	Direct adverse: Minor. Based on the current floor plan, the interventions at the north end of the building will obscure some of the interior side trim and wainscoting. Direct adverse: N/A Positive: N/A

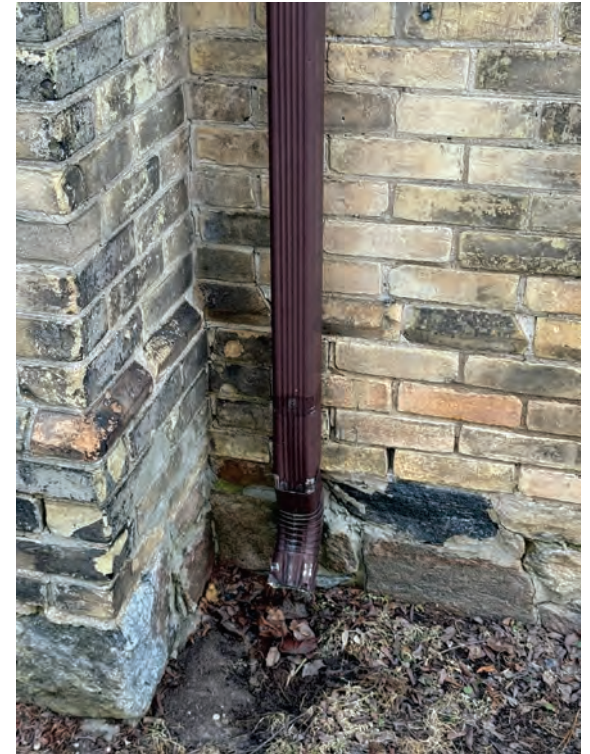
Downspout discharge at foundation with localized masonry deterioration

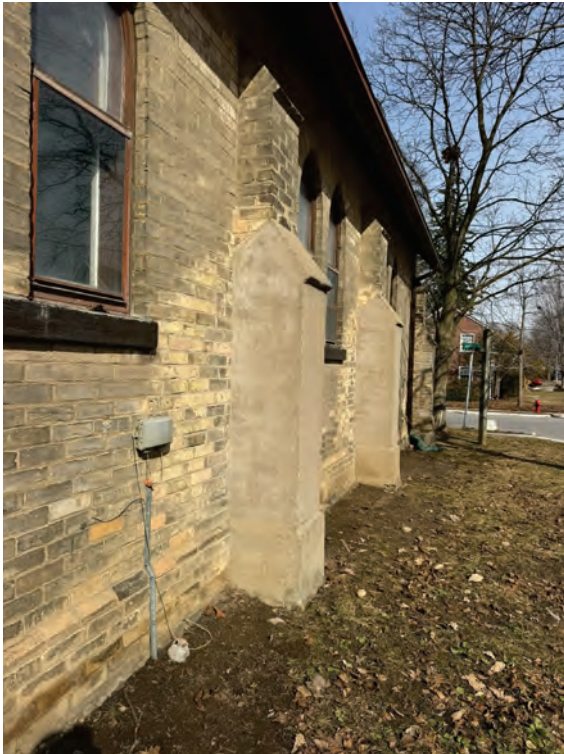
Parged buttresses

HERITAGE ATTRIBUTE	IMPACT
Front gable roof with steep Gothic pitch	Direct adverse: None anticipated based on the current proposal, as the overall building form and steep front gable roof are proposed to be retained. Indirect adverse: N/A Positive: The proposal retains the building in situ and supports its continued use, which helps conserve its overall form.
Gothic wood pointed sash windows on the side and front elevations	Direct adverse: None anticipated, as the current proposal does not indicate changes to the pointed sash windows or historic sills. Indirect adverse: N/A Positive: The proposal supports ongoing conservation of these elements, including repair and replacement of exterior storm units where required by a qualified heritage contractor.
Historic Sills	
Buttresses at the sides and front of Victoria hall	Direct adverse: N/A Indirect adverse: N/A Positive: The buttresses will be restored through removal of parging, replacement of masonry and repointing as required.

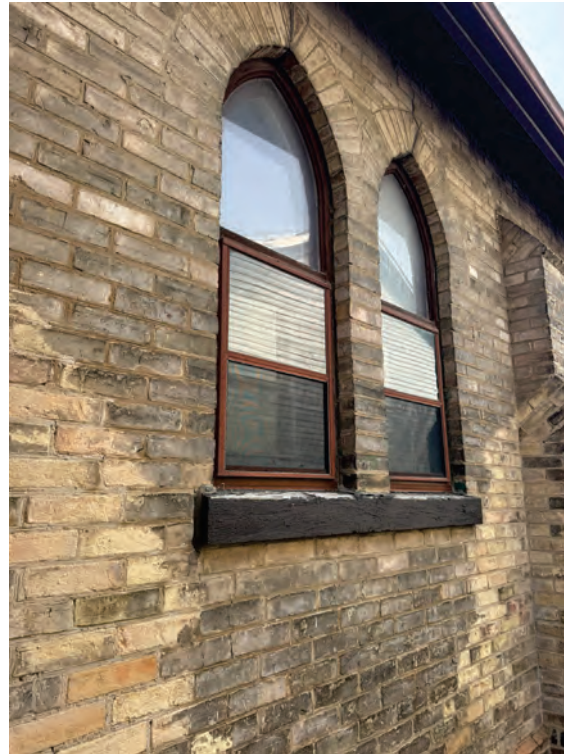
Masonry cracking at the pointed window arch

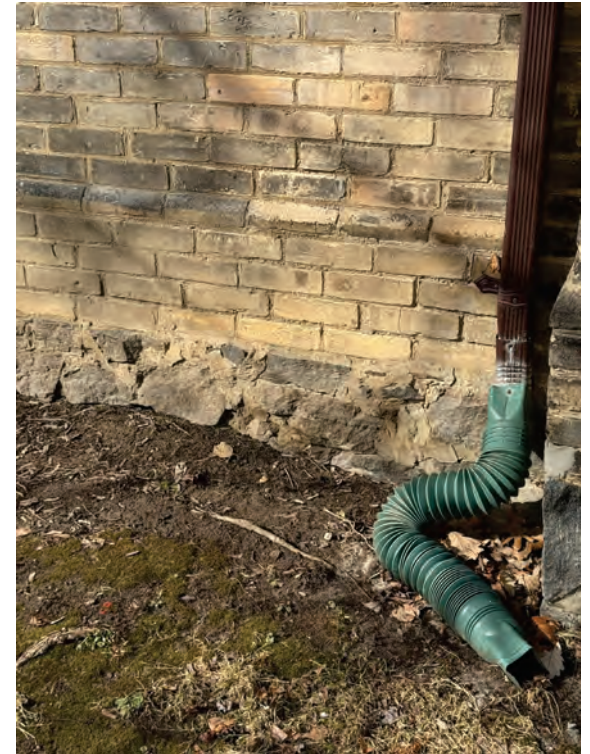
Condition of lower buff brick wall and downspout area

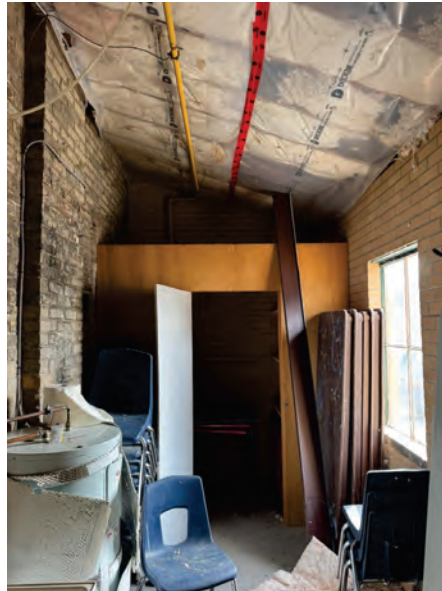
Ancillary space showing alterations, and exposed utilities (current south elevation addition)

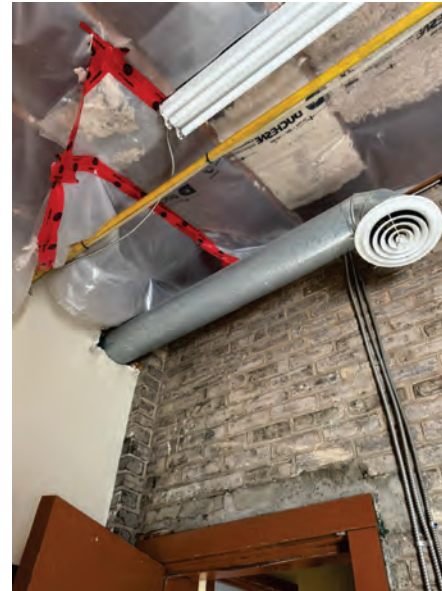
Exposed services, and insulated ceiling assembly against historic brick
