## HERITAGE IMPACT ASSESSMENT

### **Victoria Hall**

27 Mosley Street  
Aurora, ON L4G 1R2

Date: 2 April 2026

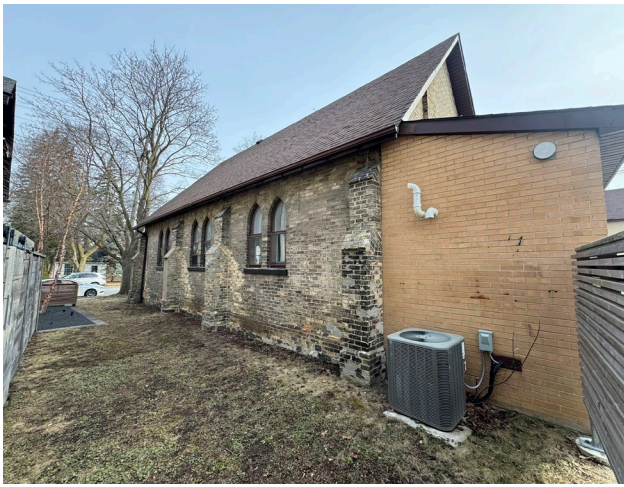
Fig. 5.1. West elevation showing overall wall condition

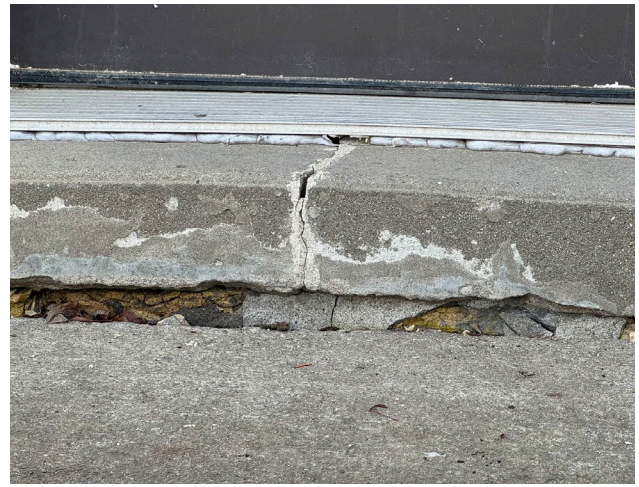
Fig. 5.4. Front entrance, cracking and deterioration at base of entrance

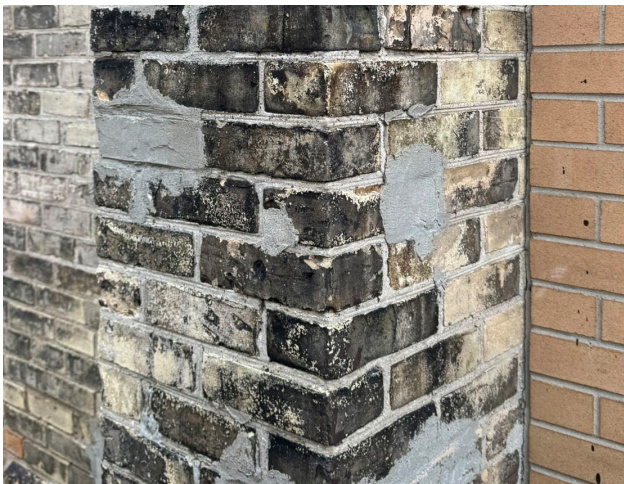
Fig. 5.2. West Elevation, butters with parging, staining, and localized deterioration

The buff brick masonry, buttresses, arches, and foundation should be repaired using methods and materials that are sympathetic to the historic masonry in material, profile, texture, and finish. Unsympathetic mortar repairs, parging, and localized cementitious repairs should be removed where appropriate and replaced with more compatible repair work. Selective brick replacement should be limited to units that are cracked, spalled, or deteriorated beyond reasonable repair. Particular attention should be given to the buttresses, cracks at the window arches, cracking at the main entrance arch, areas of mortar loss, localized brick spalling at the entrance base, and the rubblestone foundation.

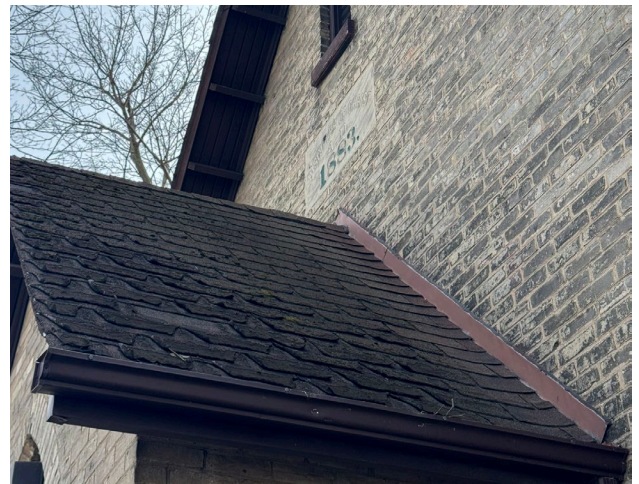
The roof is currently finished in asphalt shingles, which appears to be a later roofing material and may not reflect the original historic roof finish. The roof over the main portion of the building seems to be in fair condition, however, the roof at the principal elevation entrance is in poor condition with evidence of biological growth on asphalt shingles and lifting.

Fig. 5.5. Front entrance, asphalt shingle roof at the front entrance in poor condition and evidence of biological growth

The asphalt shingles at the front entrance porch is recommended to be replaced in kind. Eavestroughs and downspouts should also be replaced throughout the building as required using compatible profiles and detailing.

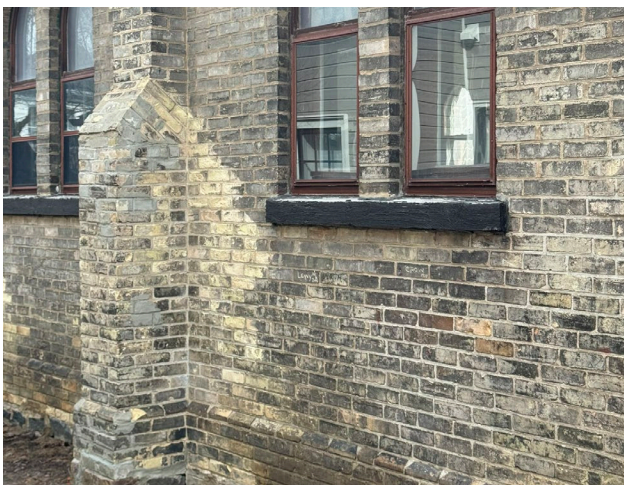
Fig. 5.3. West elevation, typical butters condition and localized masonry weathering

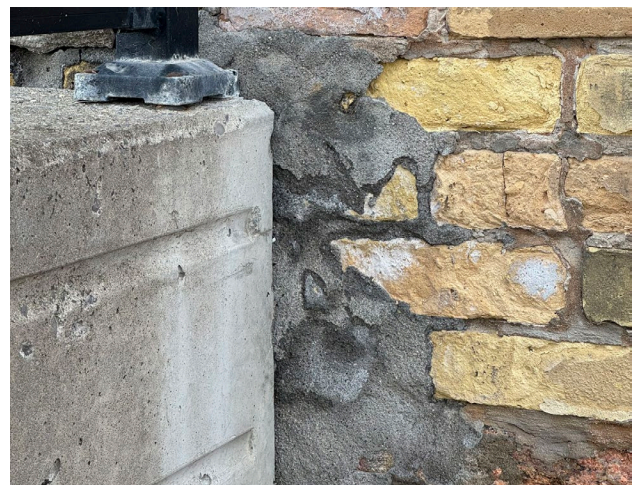
Fig. 5.6. Front entrance, parging and deterioration at junction with brick masonry

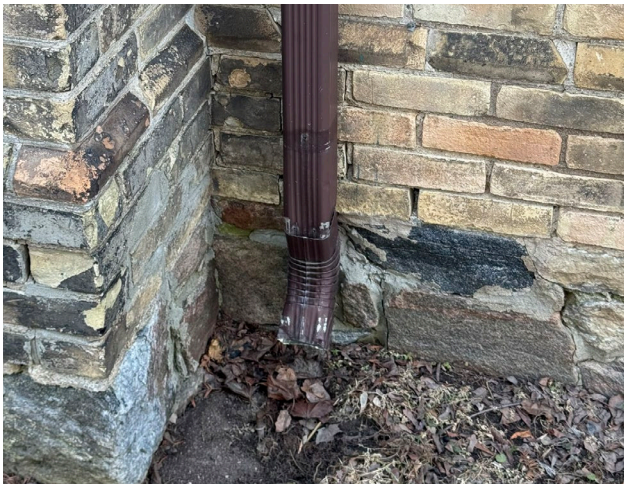
Fig. 5.7. Northwest corner, downspout discharge at foundation with localized masonry deterioration

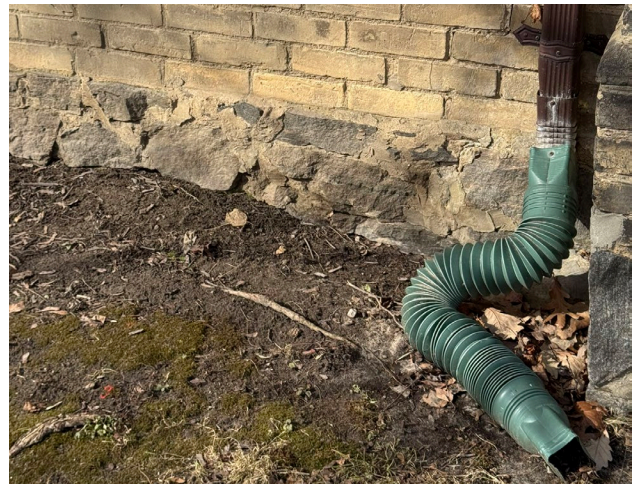
Fig. 5.9. Northeast corner, condition of lower buff brick wall and downspout area

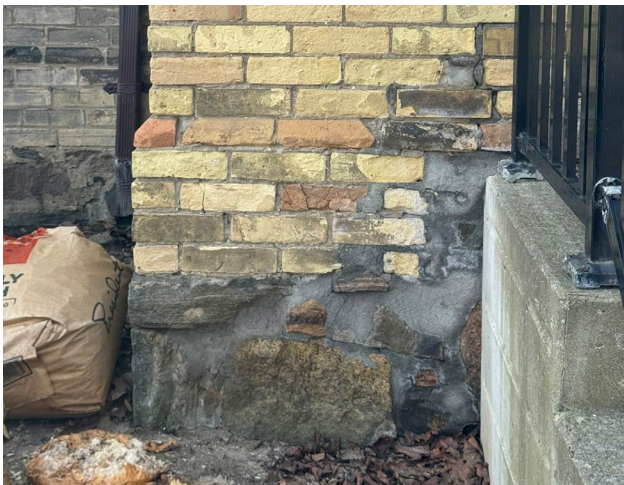
Fig. 5.8. Foundation and lower wall showing brick deterioration, and incompatible repair

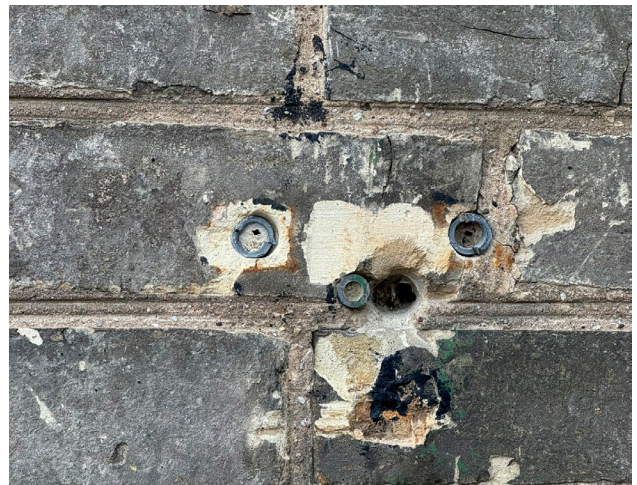
Fig. 5.10. Front entrance, penetrations in the wall

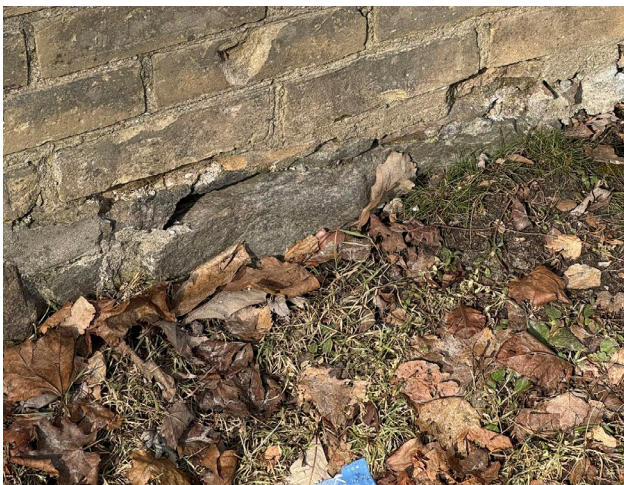
Fig. 5.11. Mortar loss and cracking at the foundation stone, brick weathering

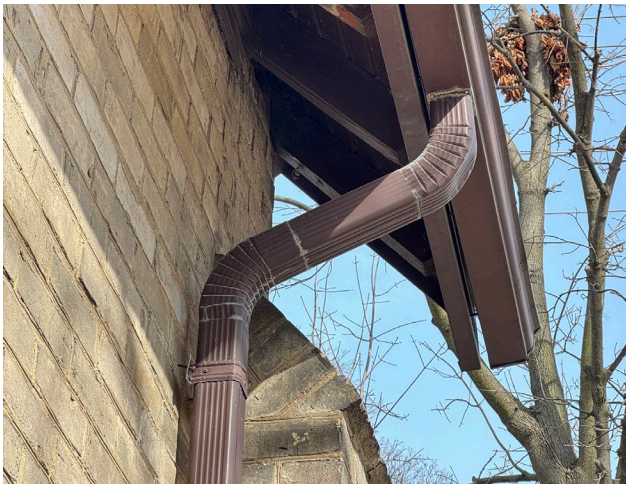
Painted rafter tails and eaves appear to be generally in good condition, with only select areas of weathering. The rear elevation soffit and fascia appear to have been replaced or covered with aluminum, which suggests earlier alteration and loss of original material in that area. Any surviving wood elements should be carefully inspected during detailed design so that repair can be prioritized over replacement where feasible.

Fig. 5.12. Eaves, soffit, and downspout showing existing rainwater management and roof edge

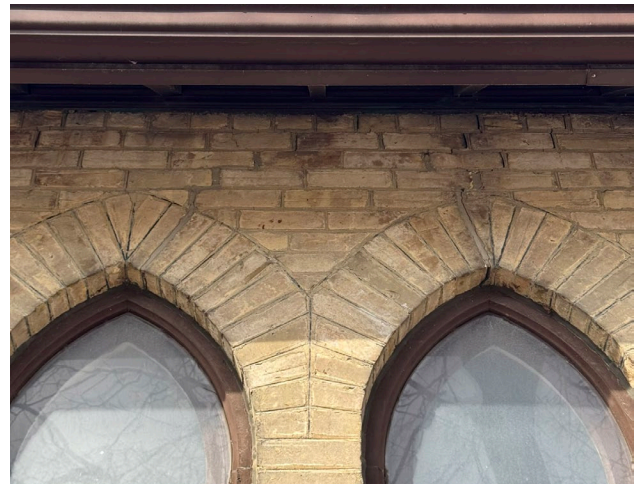
Fig. 5.15. Masonry cracking at the pointed window arch

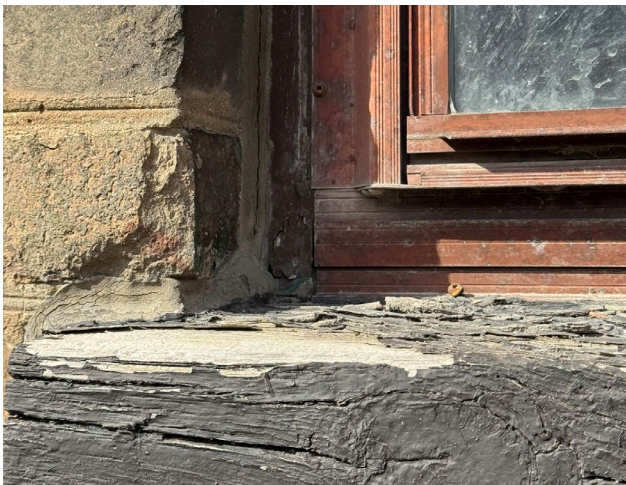
Fig. 5.13. Window sill and jamb showing weathering, and localized deterioration

Existing pointed sash windows, historic sills, rafter tails, and other surviving wood elements should be retained and repaired where feasible. Repair should be prioritized over replacement, and any replacement of exterior storm units or localized deteriorated wood elements should be limited to what is necessary and carried out in kind or with a physically and visually compatible material. Painted wood sills showing peeling, flaking, or weathering should be repaired and repainted as part of the conservation work.

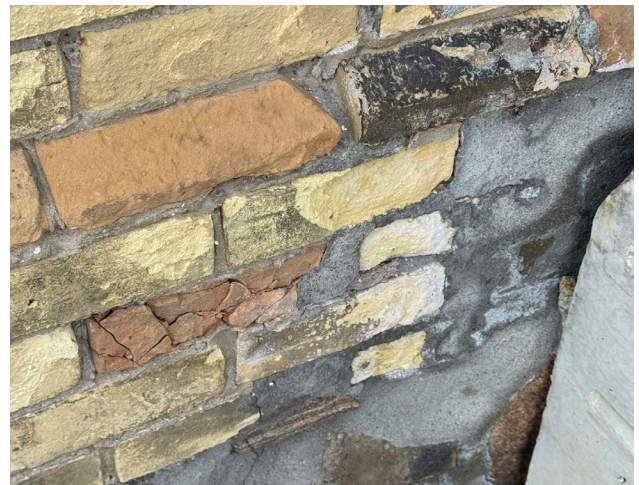
Fig. 5.16. Localized brick spalling and mortar deterioration at base

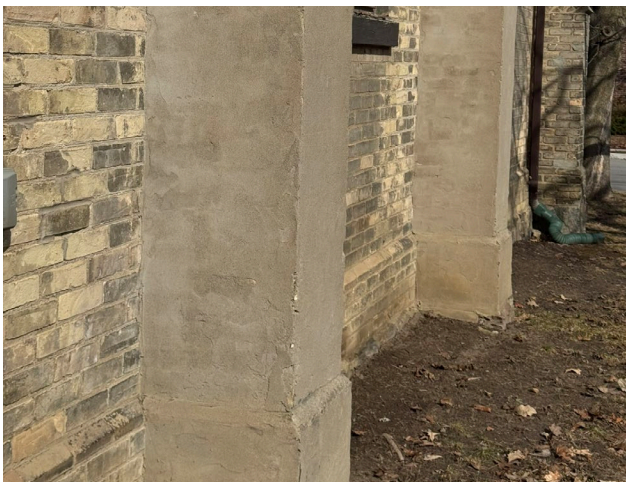
Fig. 5.14. East elevation, buttresses with parged finish

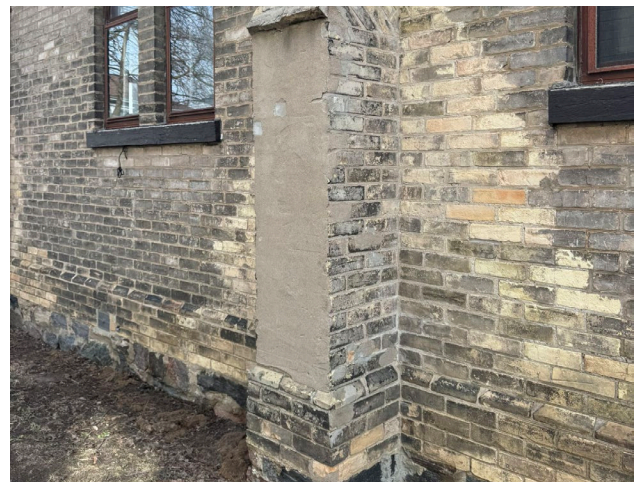
Fig. 5.17. West elevation, buttress with parging and localized deterioration at lower portion

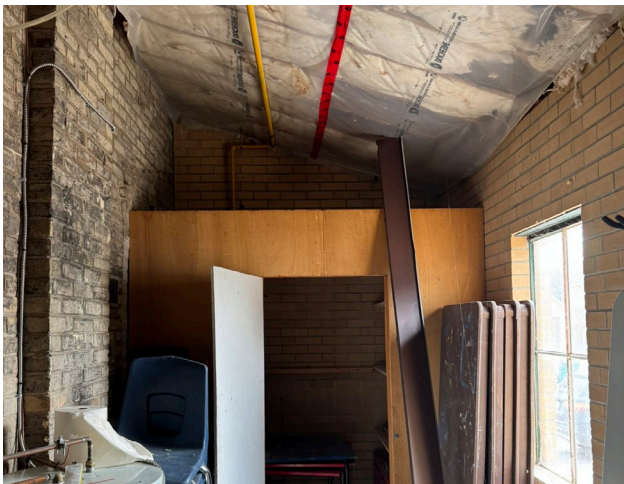
Fig. 5.19. Existing rear elevation addition, ancillary space showing alterations, and exposed utilities

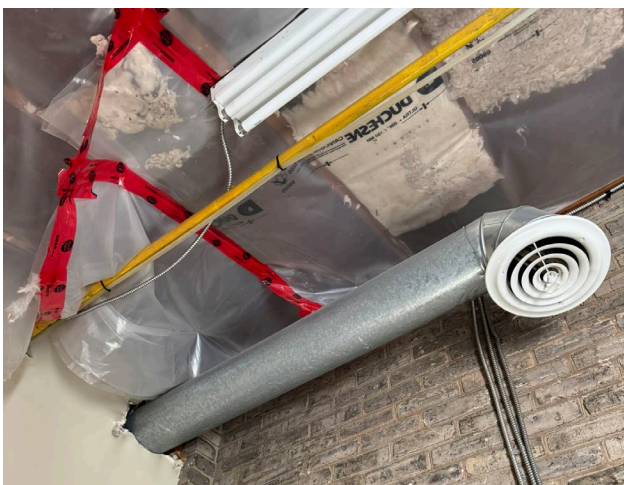
Fig. 5.20. Exposed services, and insulated ceiling assembly against historic brick wall

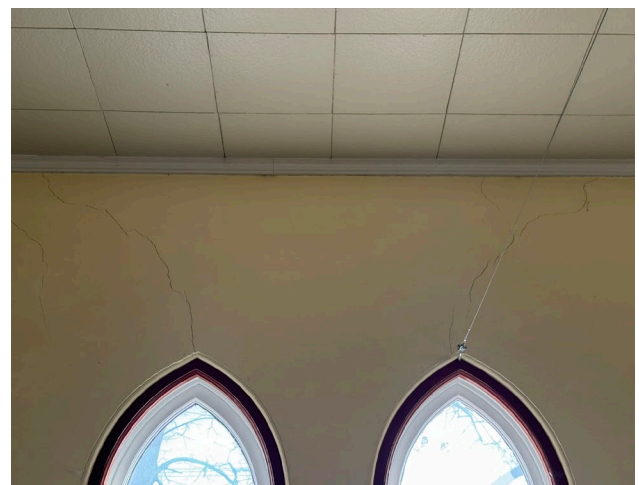
Fig. 5.22. Cracking at the pointed window arch visible at majority of the openings
