VICTORIA HALL

Committee of the Whole Meeting,
May 12, 2026

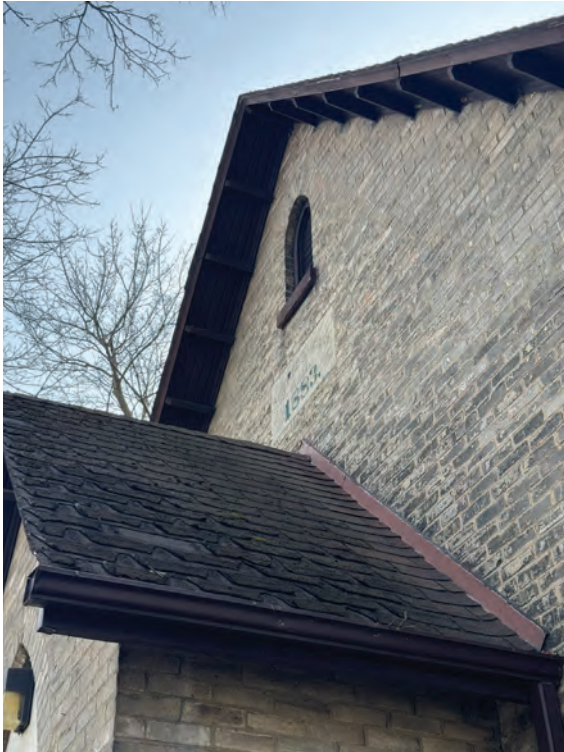
General view of gable end and roofline

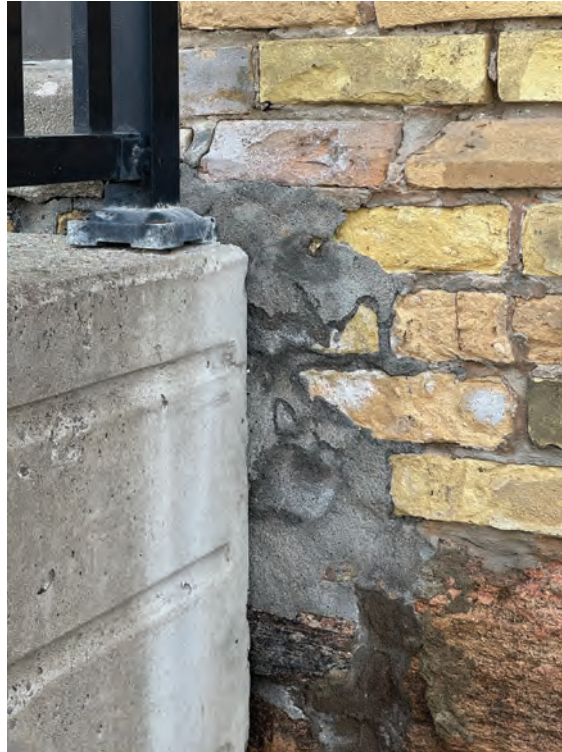
Cementitious repair and deterioration
at junction with brick masonry

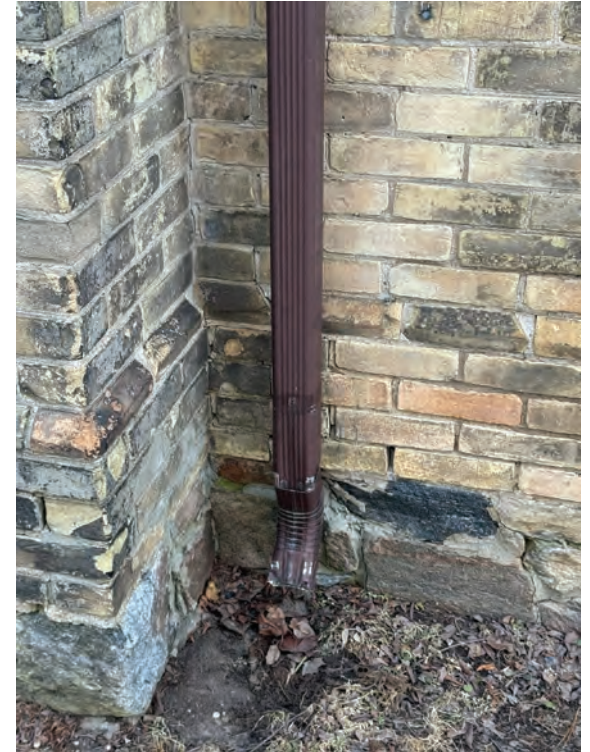
Downspout discharge at foundation
with localized masonry deterioration

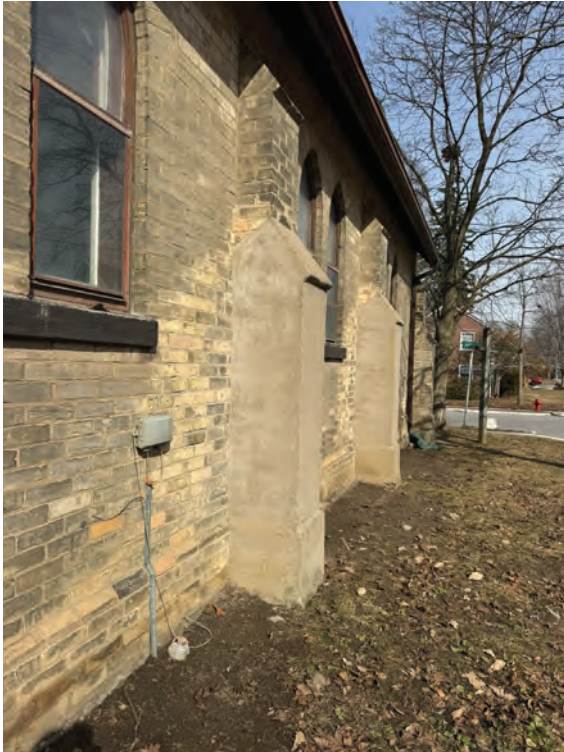
Parged buttresses

HERITAGE ATTRIBUTE	IMPACT (Direct adverse, Indirect adverse, or Positive)
Front gable roof with steep Gothic pitch	<p>Direct adverse: None. The overall building form and steep front gable roof are proposed to be retained.</p> <p>Indirect adverse: N/A</p> <p>Positive: The proposal retains the building in situ and supports its continued use, which helps conserve its overall form.</p>
Gothic wood pointed sash windows on the side and front elevations	<p>Direct adverse: None. The proposal does not indicate changes to the pointed sash windows or historic sills.</p> <p>Indirect adverse: N/A</p> <p>Positive: The proposal supports ongoing conservation of these elements, including repair and replacement of exterior storm units where required by a qualified heritage contractor.</p>
Historic Sills	
Buttresses at the sides and front of Victoria hall	<p>Direct adverse: N/A</p> <p>Indirect adverse: N/A</p> <p>Positive: The buttresses will be restored through removal of parging, replacement of masonry and repointing as required.</p>

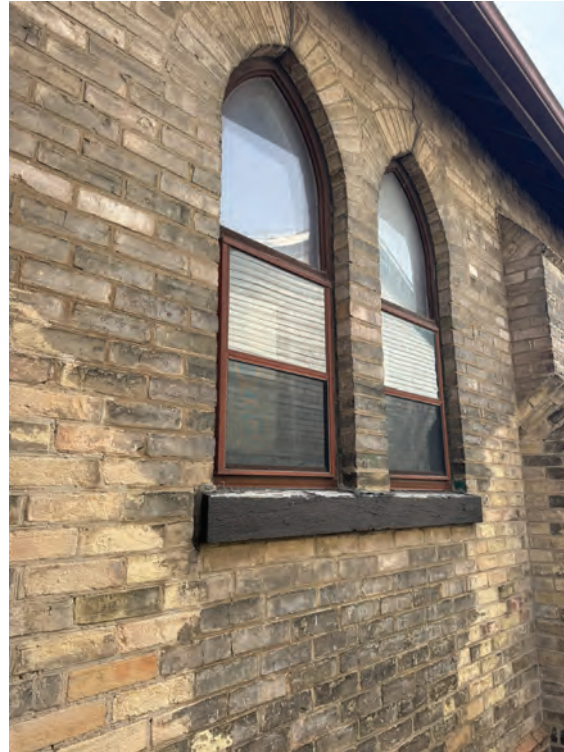
Masonry cracking at the pointed window arch

HERITAGE ATTRIBUTE	IMPACT (Direct adverse, Indirect adverse, or Positive)
Yellow brick exterior	<p>Direct adverse: N/A Indirect adverse: N/A</p> <p>Positive: The project supports masonry repair and conservation, including treatment of cracked units, parging, and incompatible mortar repairs.</p>
Datestone	<p>Direct adverse: N/A Indirect adverse: N/A</p> <p>Positive: N/A</p>
Remnants of historic doorway	<p>Direct adverse: N/A Indirect adverse: N/A</p> <p>Positive: As part of the restoration efforts, the existing covering at the transom can be removed to investigate whether original material remains beneath.</p>
[Interior] Side trim and wainscoting	<p>Direct adverse: Minor. Based on the current floor plan, the interventions at the north end of the building will obscure some of the interior side trim and wainscoting.</p> <p>Direct adverse: N/A Positive: N/A</p>

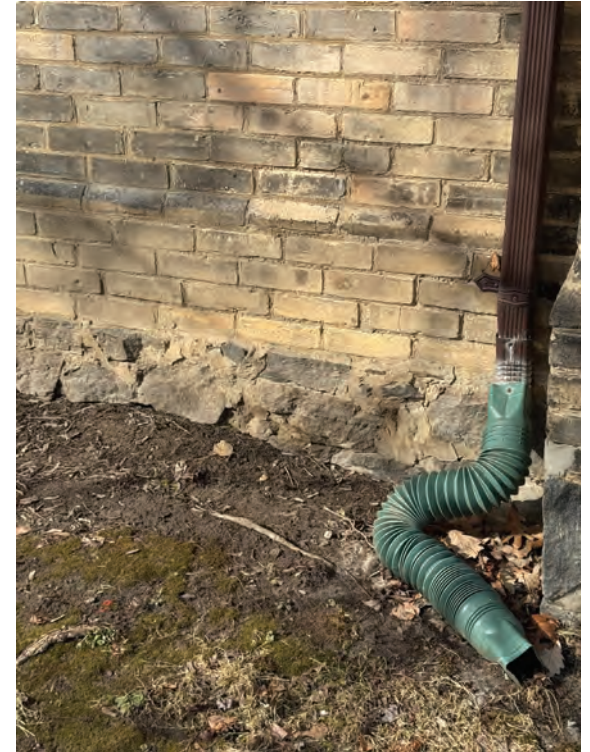
Condition of lower buff brick wall and downspout area

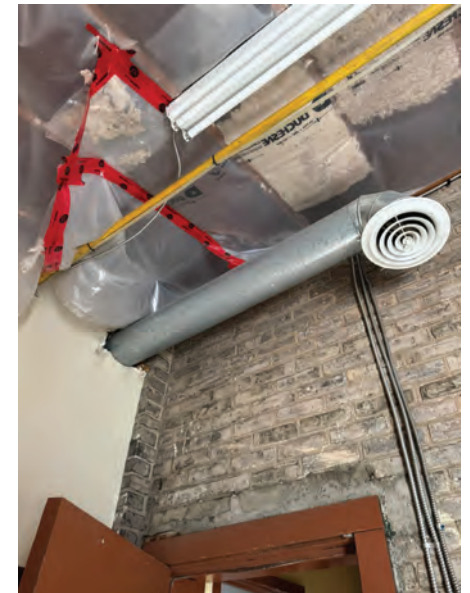
Exposed services, and insulated ceiling assembly against historic brick
