LOCATION: 15032 Yonge Street

FILE: HPA-2019-17

ATTACHMENT 1

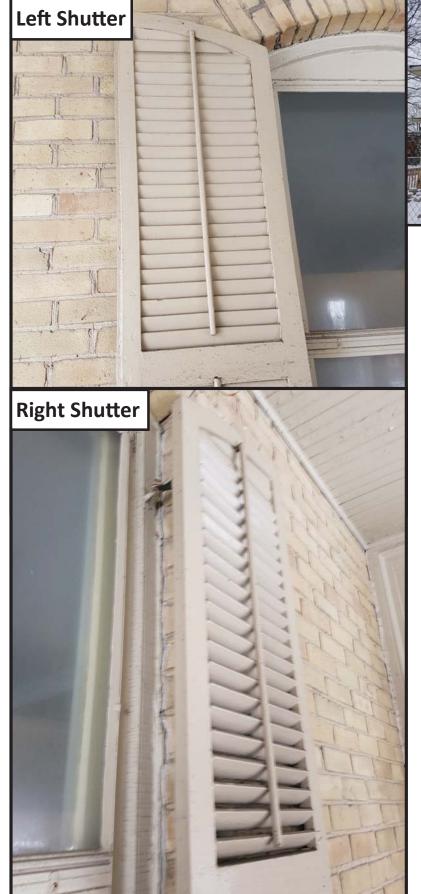
Location: Side window behind the glass display on the east elevation facing Yonge Street.

Condition: Both shutters are generally in good condition with minimal damages on the stile and mid rail.

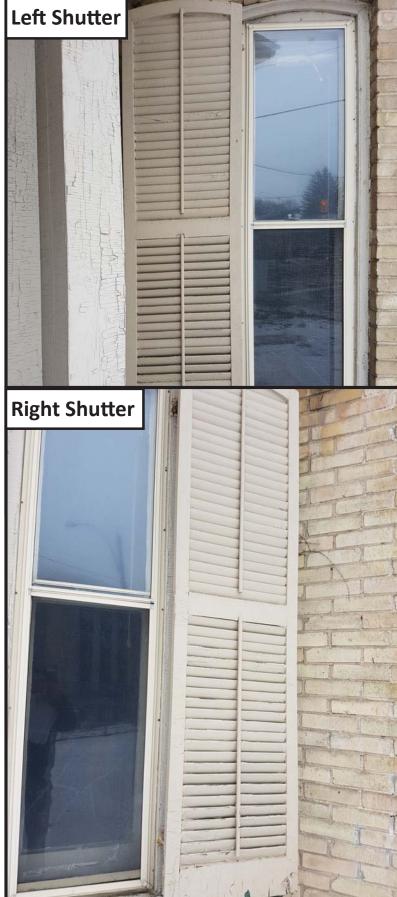
Location: Bay window on the east elevation facing Yonge Street.

Condition: The left shutter is in good condition with minor peeled paint on several slats.

The right shutter is in good condition with minor damages mainly on the bottom rail.

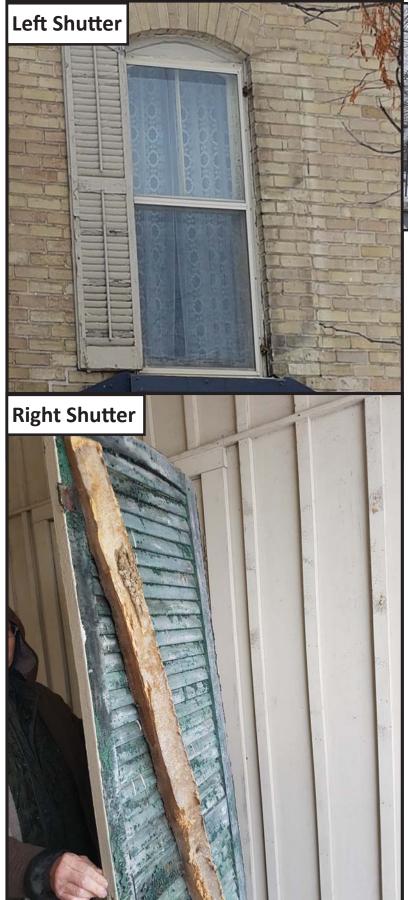
Location: Window above the bay window on the east elevation facing Yonge Street

Condition: The left shutter has severe damages on the stiles and a number of slates.

The right shutter has fallen off the building due to broken hinges. It has moderate damages on most of the slates.

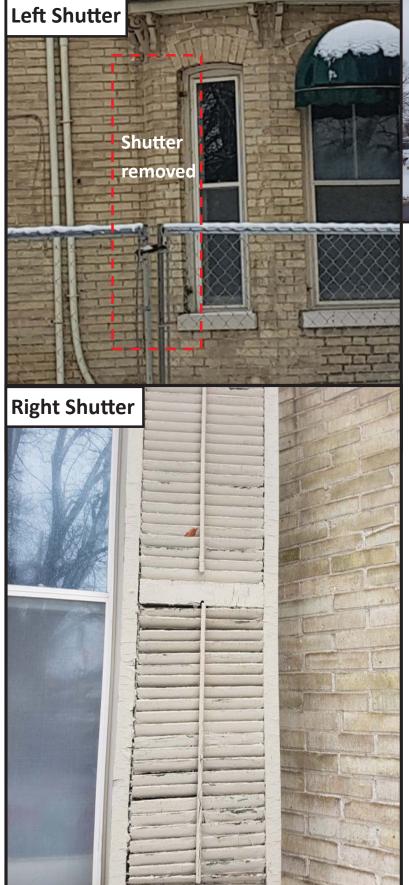
Location: Bay window on the south elevation facing Kennedy Street.

Condition: The applicant indicates the left shutter was removed in August 2019 due to severe deterioration.

The right shutter has moderate damages on the left stile, push rod and many of the lower slates.

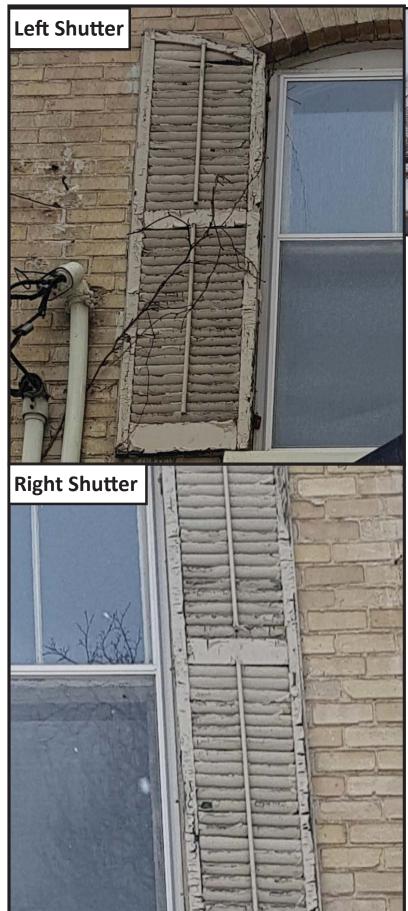
Location: Top left window above the bay window on the south elevation facing Kennedy Street.

Condition: Both shutters are in poor condition with severe rotting wood and broken parts.

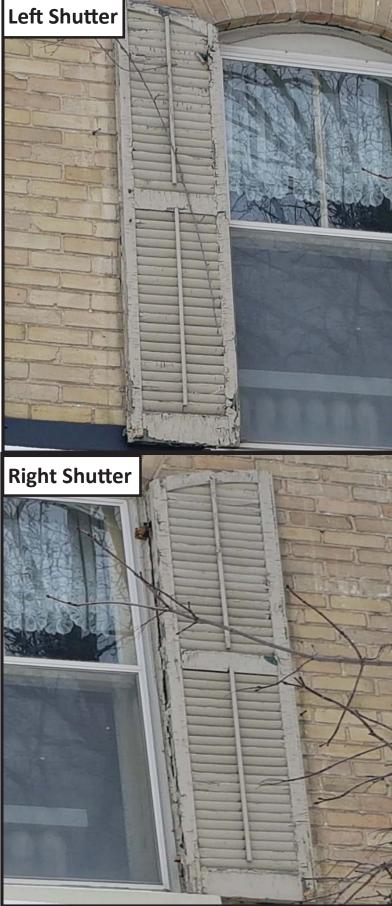
Location: Top right window above the bay window on the south elevation facing Kennedy Street.

Condition: Both shutters have moderate to severe damages on the rail and stile.
