CONSERVATION PLAN

Preliminary

KNOWLES / READMAN HOUSE 15356 YONGE STREET TOWN OF AURORA, ONTARIO

March 2022

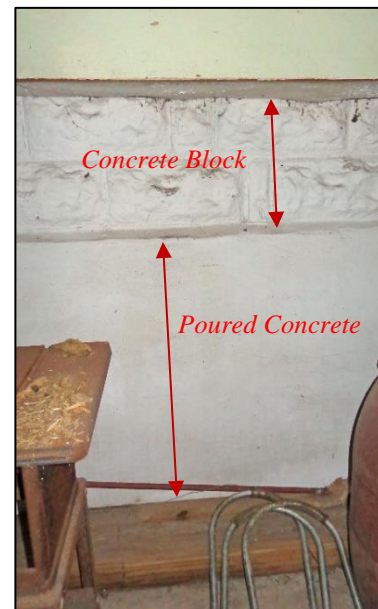
Figure 4.2
Foundation, Rear Wall.

The brick part of the House rests on a poured concrete and concrete block foundation with the poured concrete below grade and the rock-faced blocks above grade (Figure 4.2). The tail wing

1. There are two sections to the foundation – the poured concrete base and the concrete block upper part as shown in as shown in Figure 4.2. 1
2. *Poured Concrete Portion:* While most of this section of the foundation remains sound, some deterioration to the south wall has occurred due to pour drainage (photos 4 and 15, Basement, **Appendix G**, 2017 Heritage Impact Assessment).

- a. excavating the exterior area adjacent to the south wall;
- b. removing all spauling concrete on both the exterior and interior;
- c. parging the concrete foundation on both the exterior and interior;
- d. installing weeping tiles to the base of the foundation;
- e. installing a waterproof membrane to the exterior of the poured concrete; and
- f. regrading to ensuring drainage is away from the House.

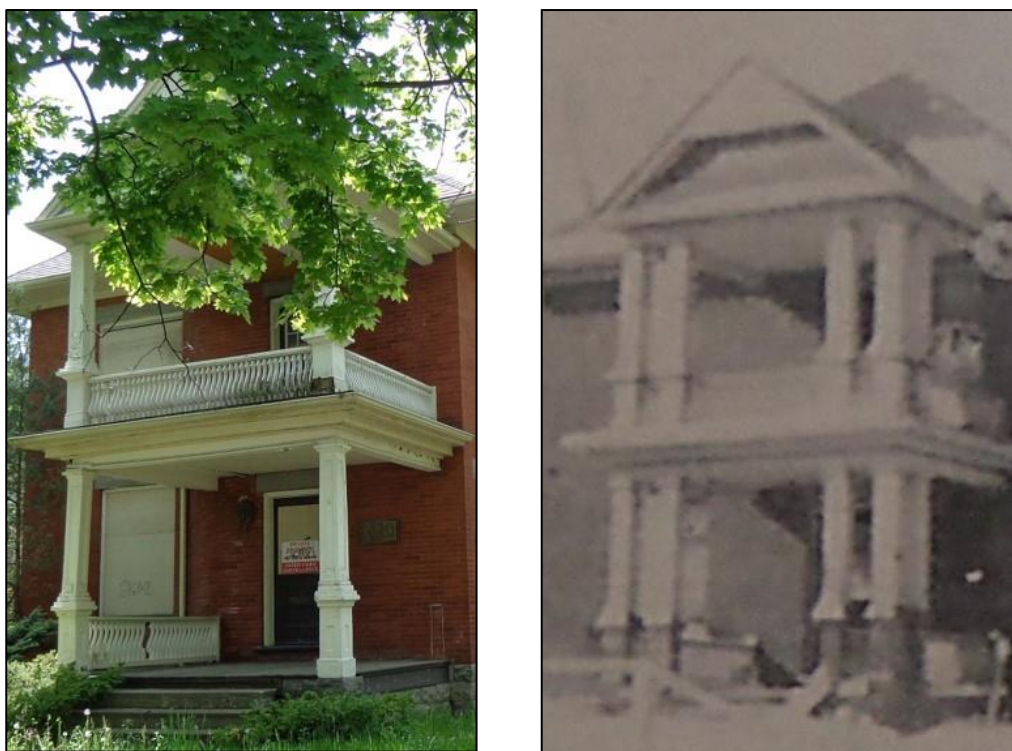
Figure 4.6
Front Porch – East Elevation. 2016 (left), 1920 (right)

The prominent feature of this elevation is the two storey porch capped by a gable roof. The porch is supported by tapered, square, paneled posts resting on square, paneled concrete piers. On the upper floor the posts are supported by wood piers. Originally there was a triple set of posts and piers on the outer corners of both levels of the porch (Figure 4.6). The balustrade has carved balusters. On the upper floor, the balustrade encloses the porch, while on the lower floor, it is limited to the north and south sides. The rock-faced concrete block porch foundation is identical to the House foundation.

- *Loss of porch balustrades and post.* Some of the balustrade from the front and side porches is missing as is the corner post of the side porch. Based on historic photos, four corner posts are missing from the ground and upper levels of the front porch.

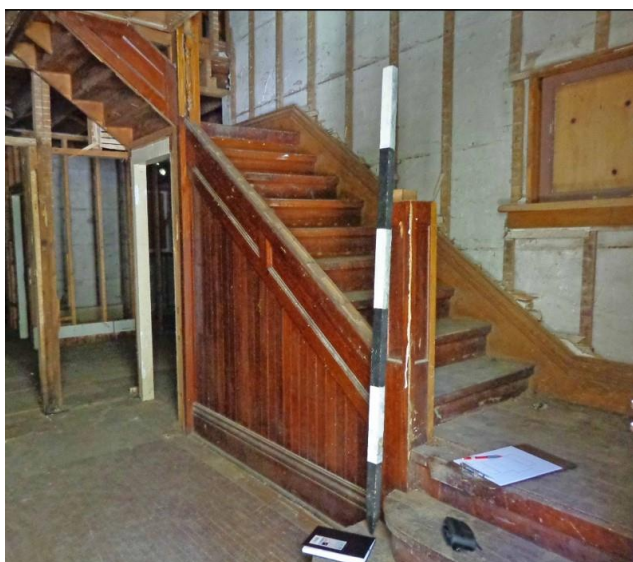
Figure 4.7
Staircase – Room 1. 2016

Originally this floor consisted of four rooms of similar size (the ‘Four Square’ plan) plus the tail wing. Room 1 contains the hall and staircase. Much of the staircase remains although part of the newel post, railing and all spindles, except one, have been removed (Figure 4.7).

1. Remnants of the staircase are shown in this Plan in Figure 4.7 and in the Heritage Impact Assessment, **Appendix G** – Ground Floor Photographs 1 to 4 and Upper Floor Photographs 1 to 3.
2. The intent of this Plan is to retain the existing parts of the staircase in situ and recreate the missing parts based on existing elements (e. g., newel post, spindles, profile of the hand rail as shown in Figure 5.19). Where existing elements are insufficient to complete the staircase, the design of features of interior staircases typical of the era may be used.
3. The same type of wood must be used in reconstruction missing elements
4. Drawings detailing the reconstructed staircase are contained in **Appendix D**.

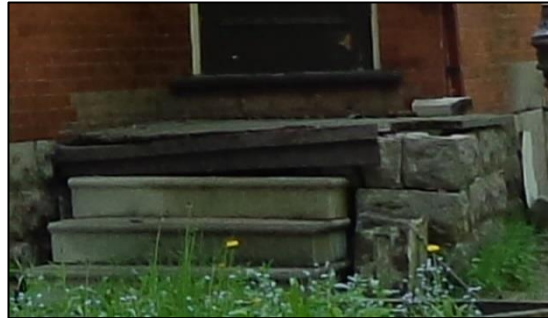
Figure No. 5.6
North porch base –
foundation deterioration

- *Mortar failure of the side porch concrete blocks:* There is a loss of mortar between concrete blocks of the side porch foundation. As a result of this deterioration, some of the blocks have shifted.

3. *Concrete Block Portion:* Most of the concrete block portion remains sound. However, some mortar joints have deteriorated as have some blocks especially on the porches (Figure 5.6).

Address this by:

- a. Matching, to the extent possible, the original foundation mortar mix in terms of strength, granularity and colour based on a chemical and visual analysis of original mortar.
- b. applying mortar to defective joints raked out by hand, not by machines.
- c. duplicating the profile and width of original mortar joints.
- d. Rebuilding sections of the north and possibly the south porch foundation where block have become dislocated.
- e. Confirm the footing for the porches remain sound; rebuild if necessary.

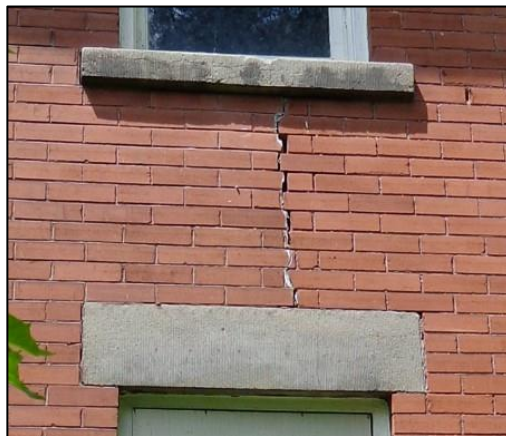
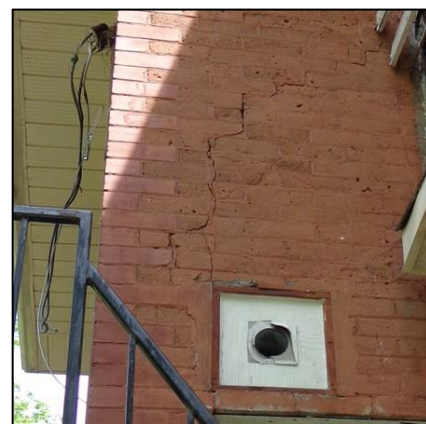
Figure No. 5.7
Masonry cracks – south wall (left and west wall (right

- *Heaving of part of the basement floor:* Parts of the concrete basement floor have cracked and heaved in Room 13 (HIA, **Appendix G** - photo 1).
- *Cracks in the brick walls:* A crack in the brick work of the south wall extends from the basement window to the upper floor window. The crack may be stable or may be related to the on-going water damage discussed above. There is also a crack on the west brick wall above the fire escape.

1. While most of the masonry walls remain sound, there are several notable cracks – one on the south wall extending from the basement window to the upper floor and on west wall above the fire escape (Figure 5.7).

2. Repointing will be addressed by:
 - a. Matching, to the extent possible, the original brick work mortar mix in terms of strength, granularity and colour based on a chemical and visual analysis of original mortar. Areas of pure white mortar joints are **not** acceptable.

- b. applying mortar to defective joints raked out by hand, not by machines.
 - c. duplicating the profile and width of original mortar joints.
3. Where replacement bricks are required, they will match, to the extent possible, the original bricks in terms of dimensions and colour. Such bricks will be laid in a bond that duplicates the original.

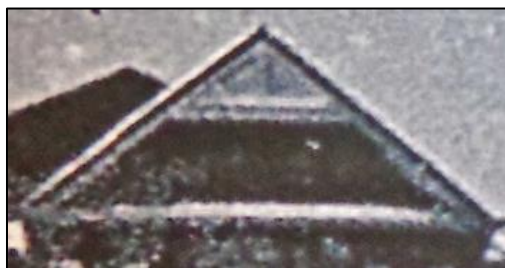
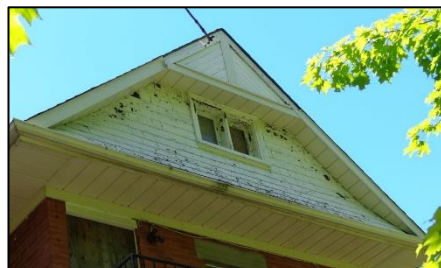
Figure No. 5.14
East Gable c1920 (left), North Gable (2016)

1. The gables on the east and north elevation, and, to a lesser extent, in the dormer window on the south elevation are prominent features of this House. The original and current condition of two of the gables is shown in Figure 5.14.

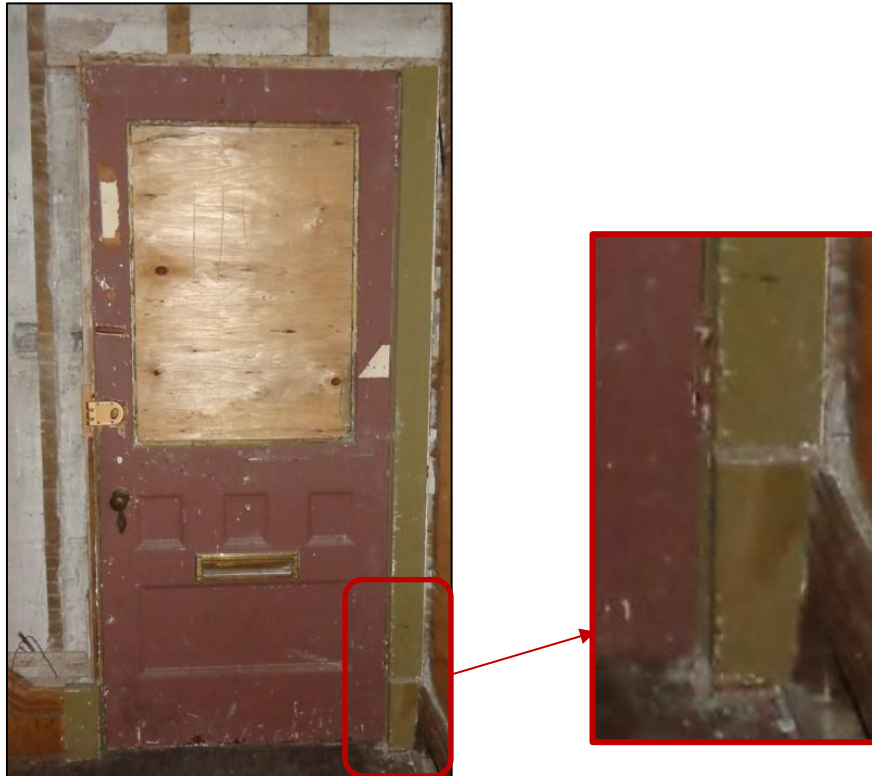
Figure No. 5.20
Front door, interior view showing remnant casing

5. Part of the door casing with base corner blocks remains on the front door as shown in Figure 5.20. Based on this evidence, the original was close to the design of that shown in Figure 5.4 of the Heritage Impact Assessment, although with the addition of plain corner blocks. This design should be used as a basis for recreating interior ground floor door casings.
