APPLICANT: Three Small Rooms Restaurant, Bar & Grill, Fine Dining Inc.

LOCATION: 15032 Yonge Street

FILE: HPA-2019-17

ATTACHMENT 1

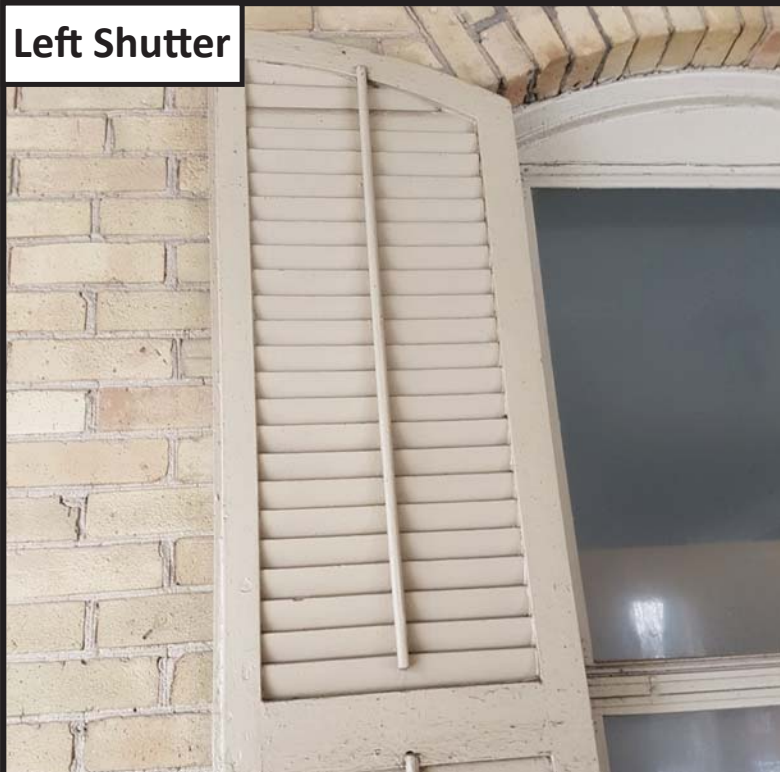
Left Shutter

**Condition:** Both shutters are generally in good condition with minimal damages on the stile and mid rail.

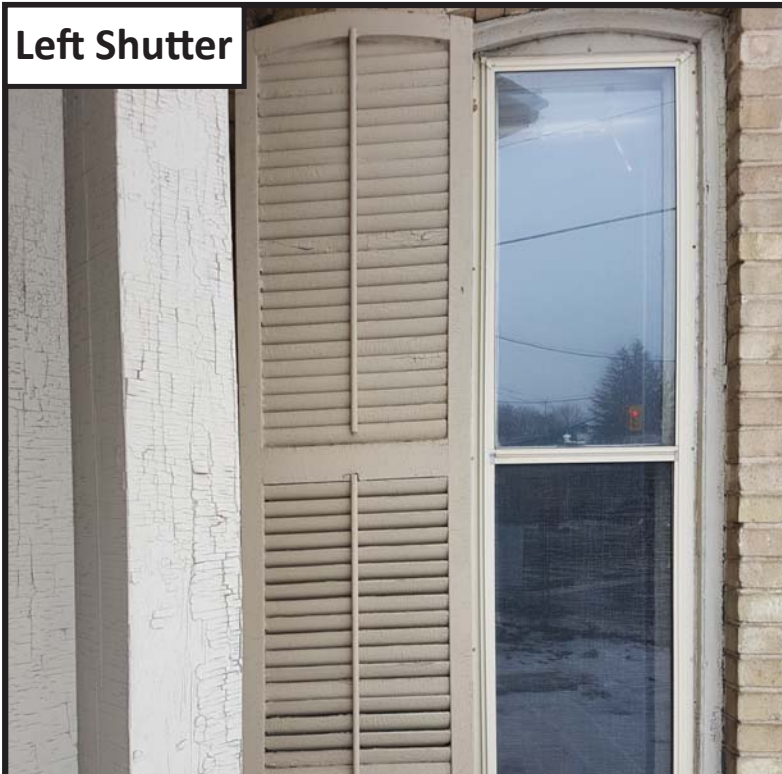
**Left Shutter**

**Condition:** The left shutter is in good condition with minor peeled paint on several slats.

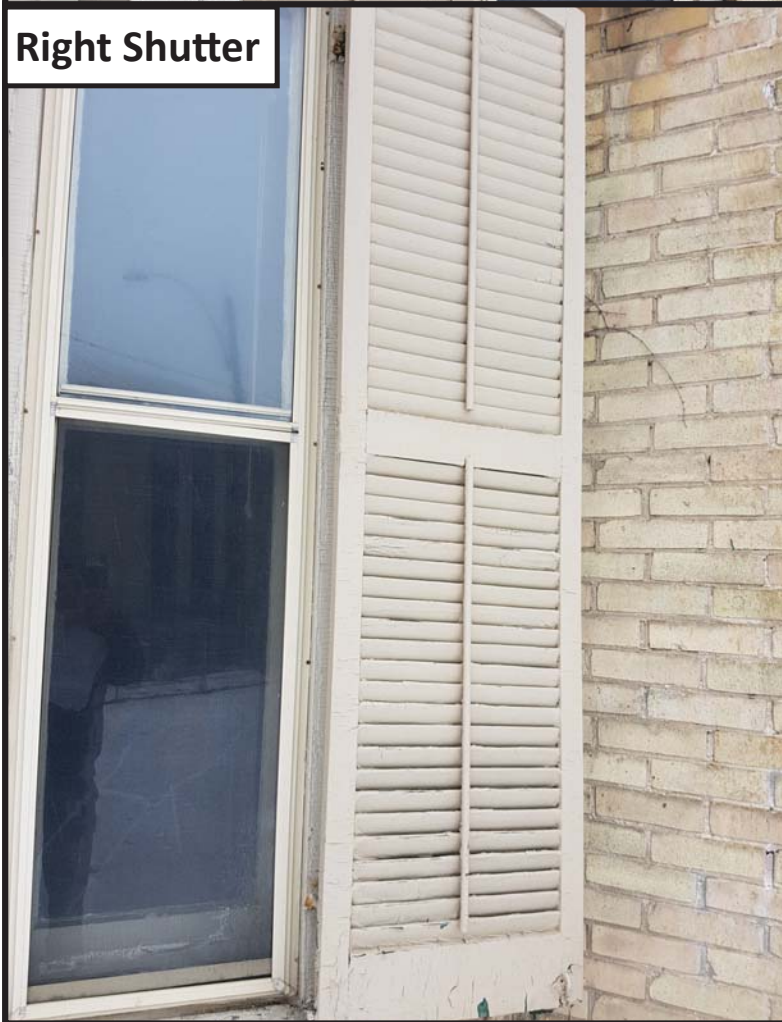
**Right Shutter**

The right shutter is in good condition with minor damages mainly on the bottom rail.

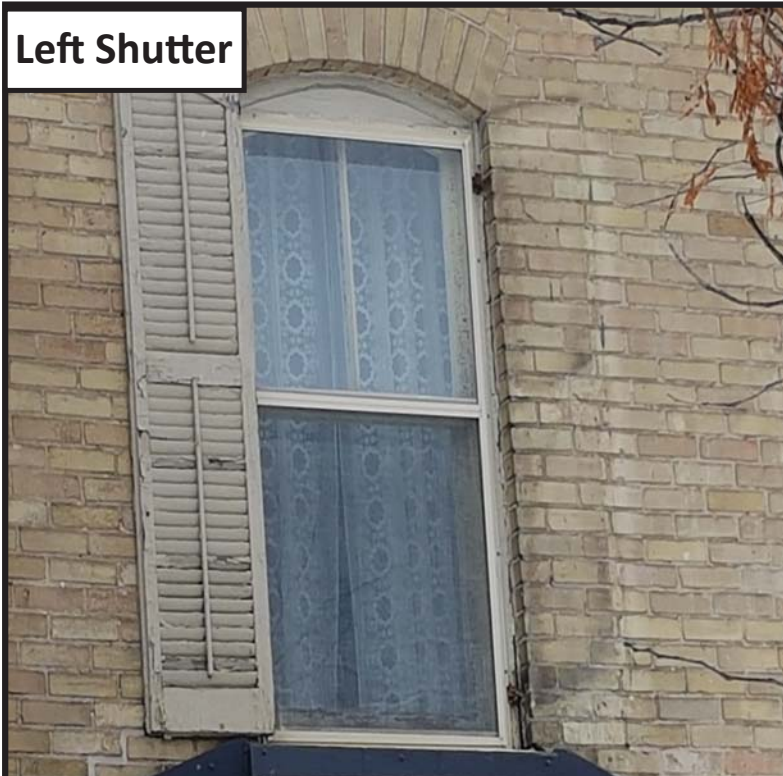
**Left Shutter**

**Condition:** The left shutter has severe damages on the stiles and a number of slates.

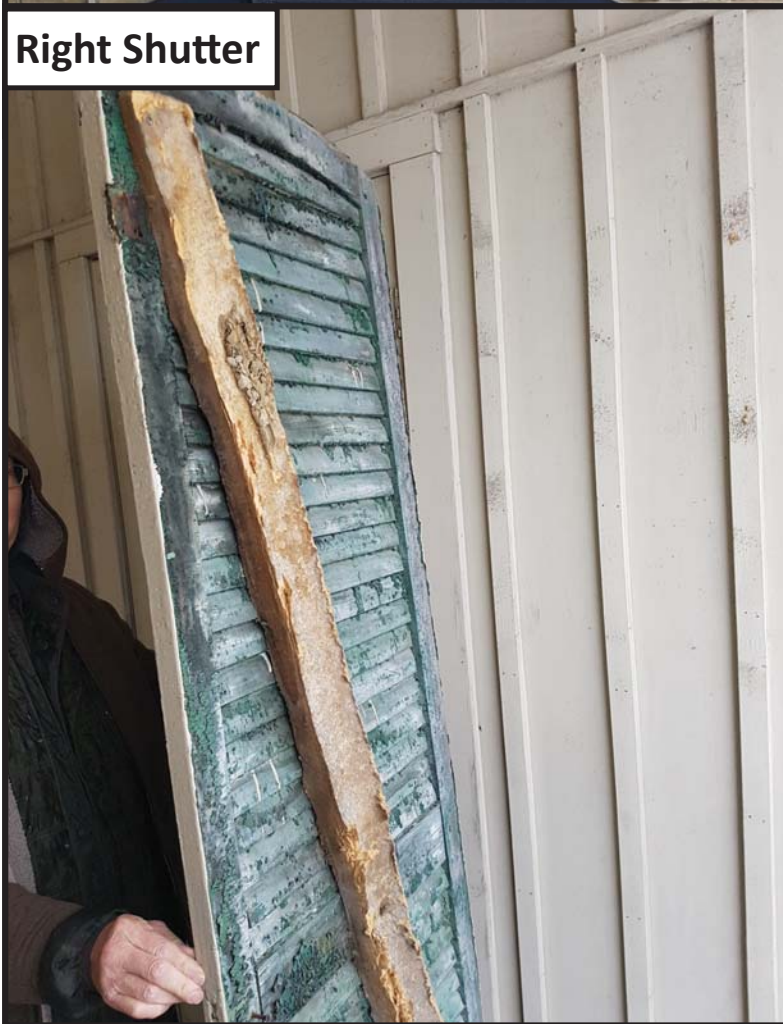
**Right Shutter**

The right shutter has fallen off the building due to broken hinges. It has moderate damages on most of the slates.

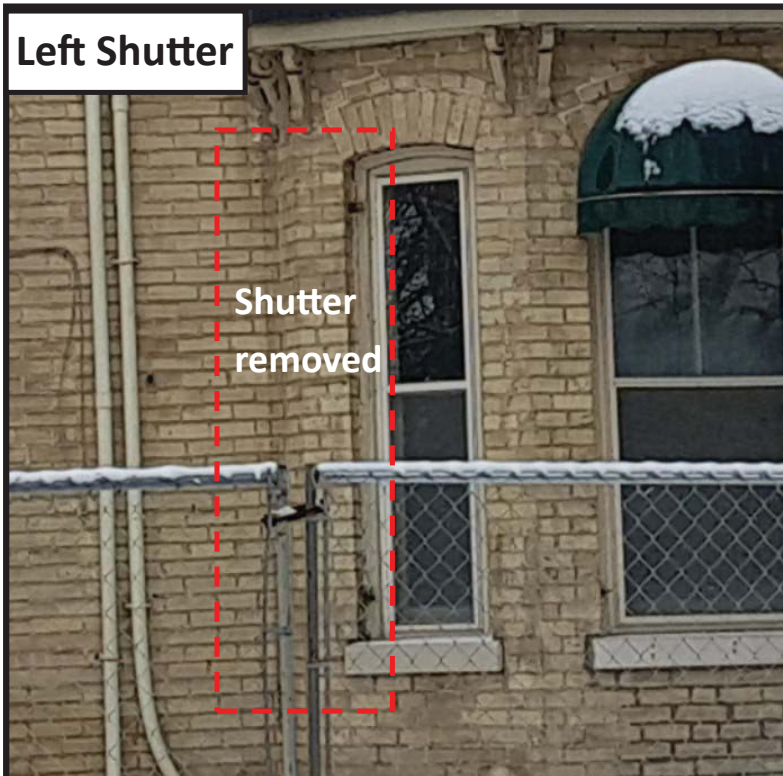
**Left Shutter**

**Condition:** The applicant indicates the left shutter was removed in August 2019 due to severe deterioration.

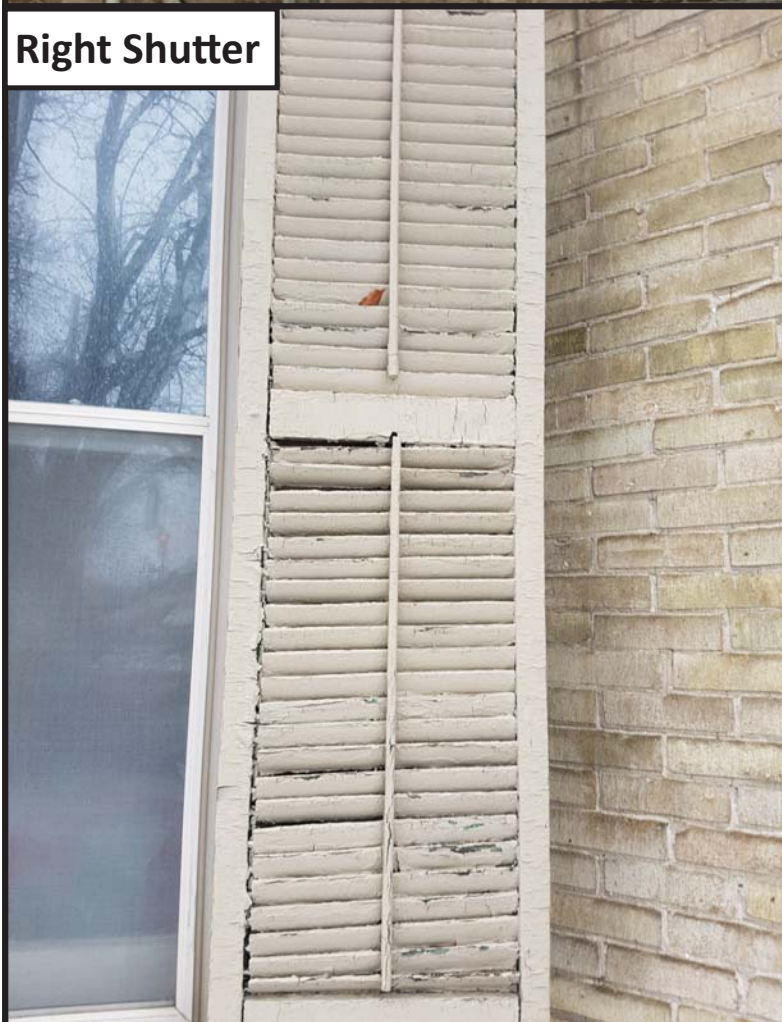
**Right Shutter**

The right shutter has moderate damages on the left stile, push rod and many of the lower slates.

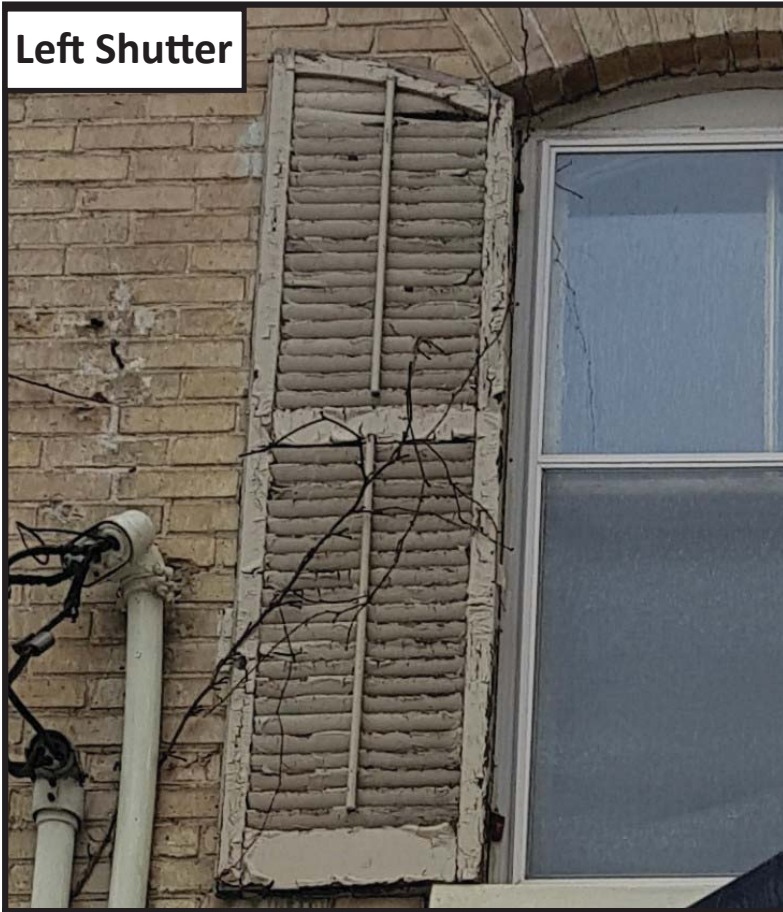
**Left Shutter**

**Condition:** Both shutters are in poor condition with severe rotting wood and broken parts.

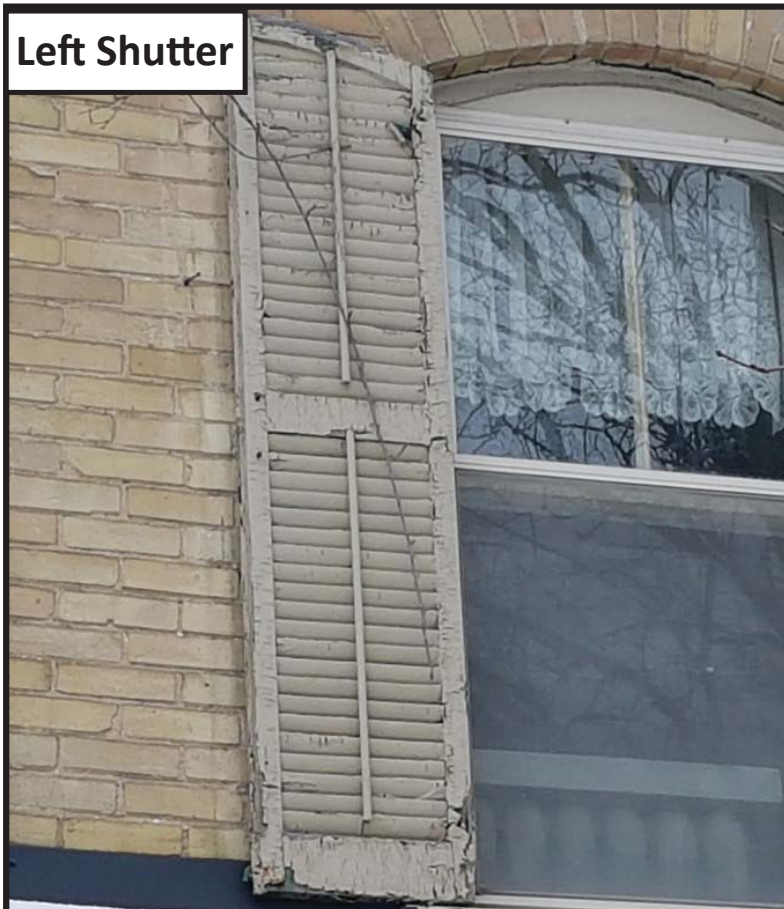
**Left Shutter**

**Condition:** Both shutters have moderate to severe damages on the rail and stile.
