## HERITAGE IMPACT ASSESSMENT

### **Victoria Hall**

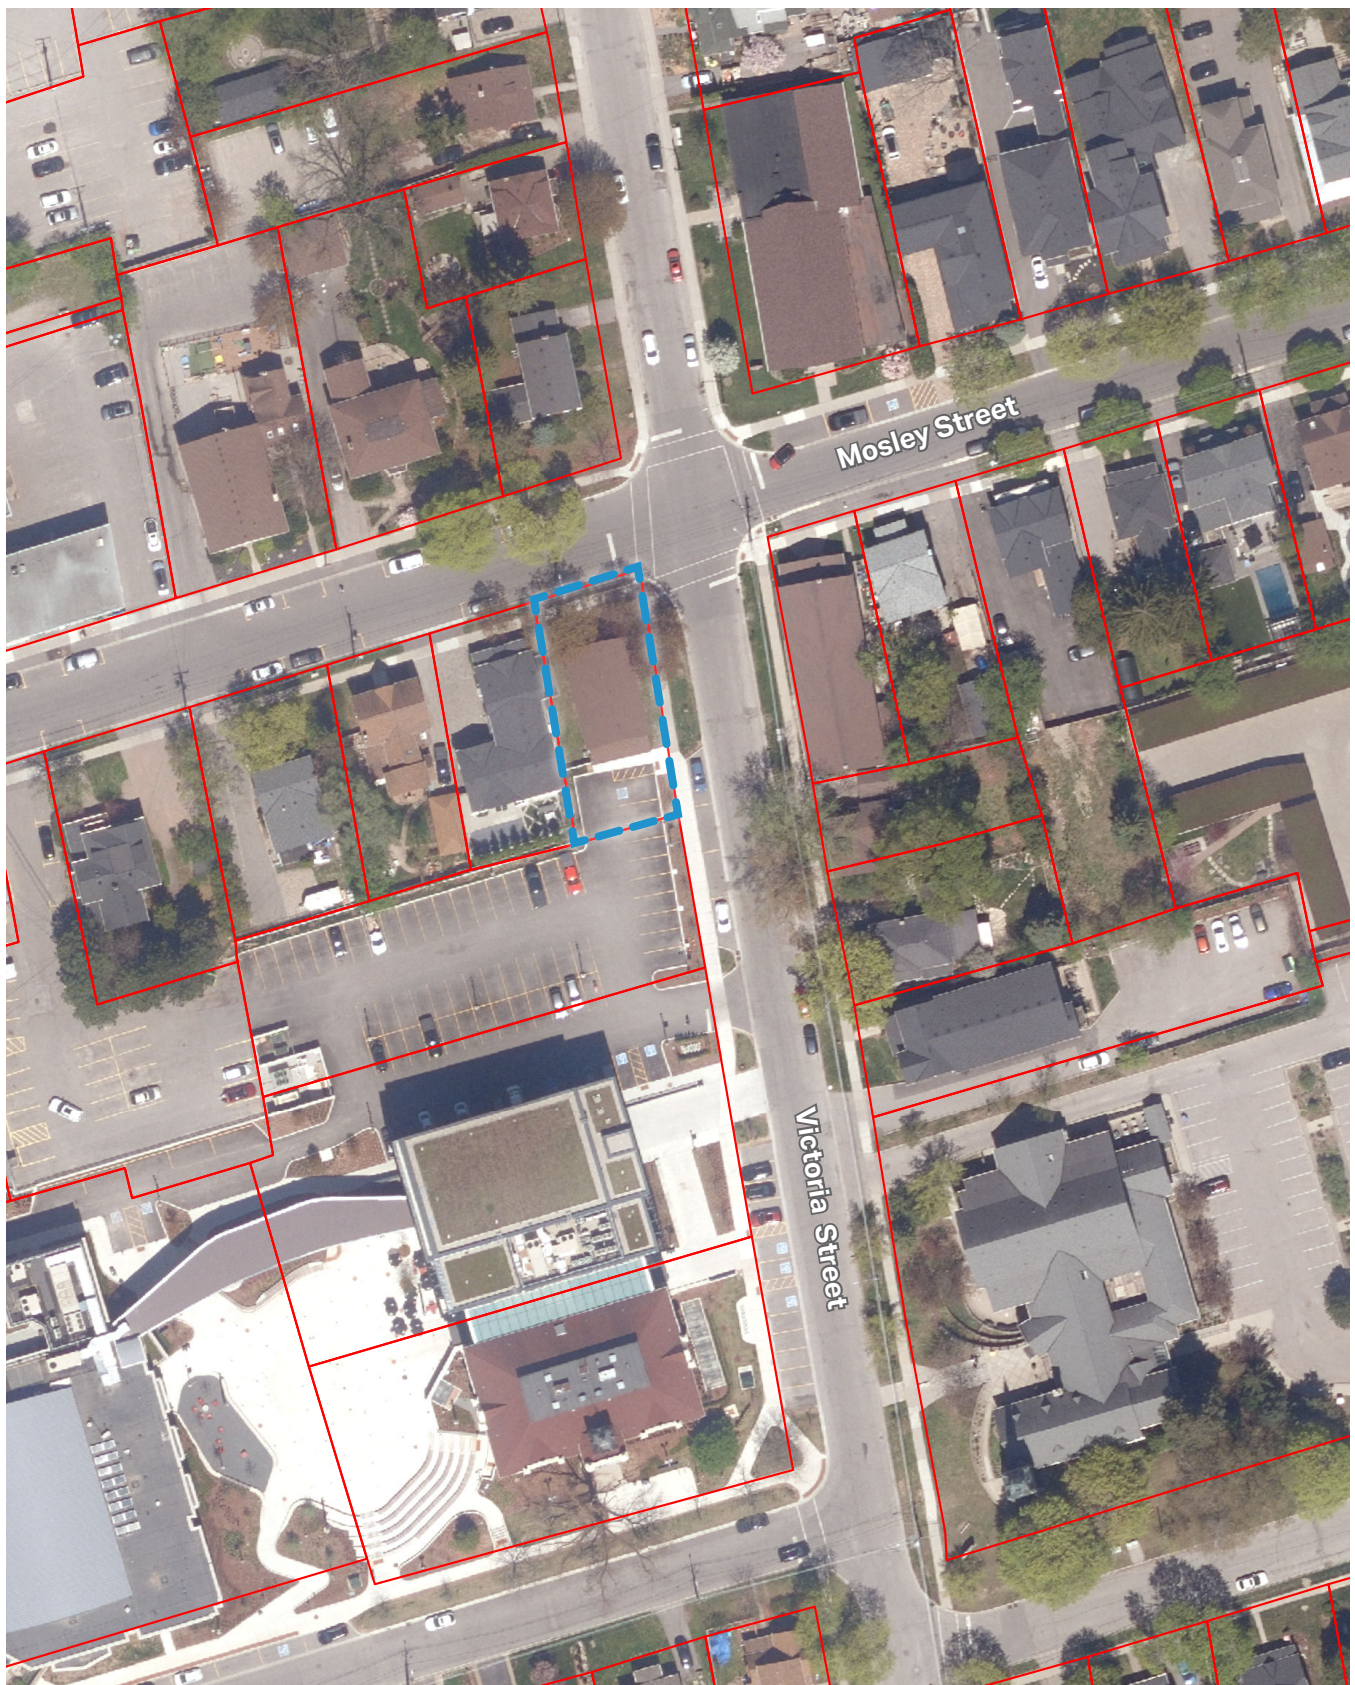
Fig. 1.1. Aerial view showing the subject property within the context in dashed lines.

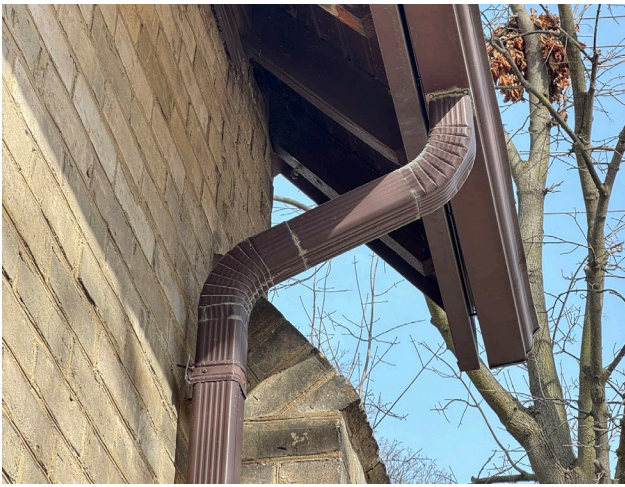
Fig. 5.12. Eaves, soffit, and downspout showing existing rainwater management and roof edge

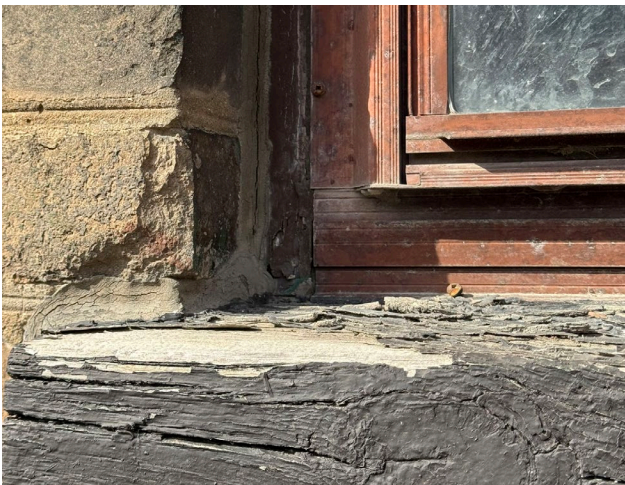
Fig. 5.13. Window sill and jamb showing weathering, and localized deterioration

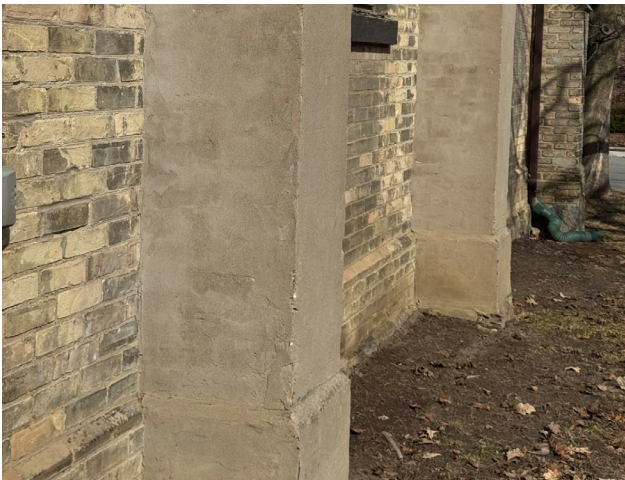
Fig. 5.14. East elevation, buttresses with parged finish

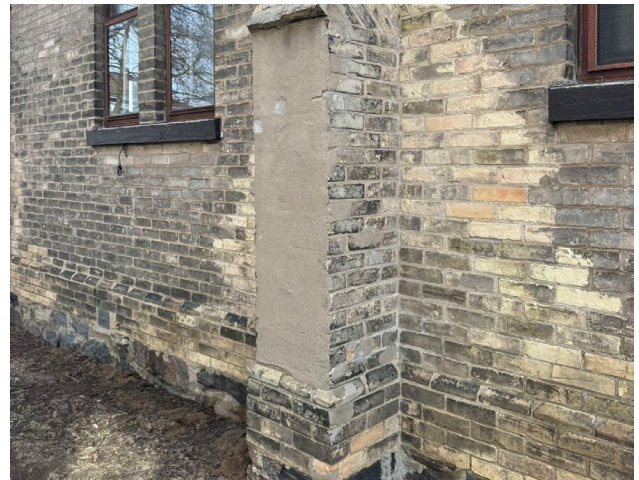
Fig. 5.17. West elevation, buttress with parging and localized deterioration at lower portion

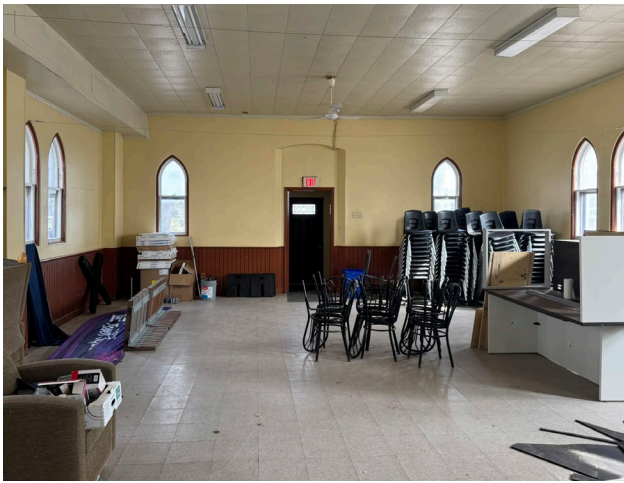
Fig. 5.18. Main hall side trim, and wainscoting

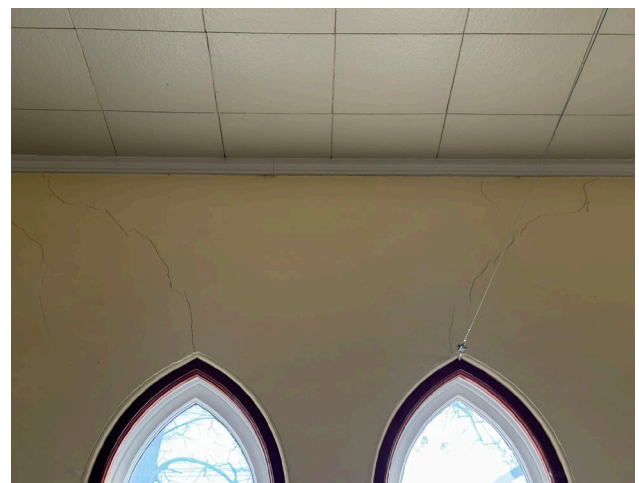
Fig. 5.22. Cracking at the pointed window arch visible at majority of the openings
