# Aurora Community Reflection Space

**FOTENN**  
Planning + Design

Chisholm, Fleming & Associates  
CONSULTING ENGINEERS

## Existing Conditions

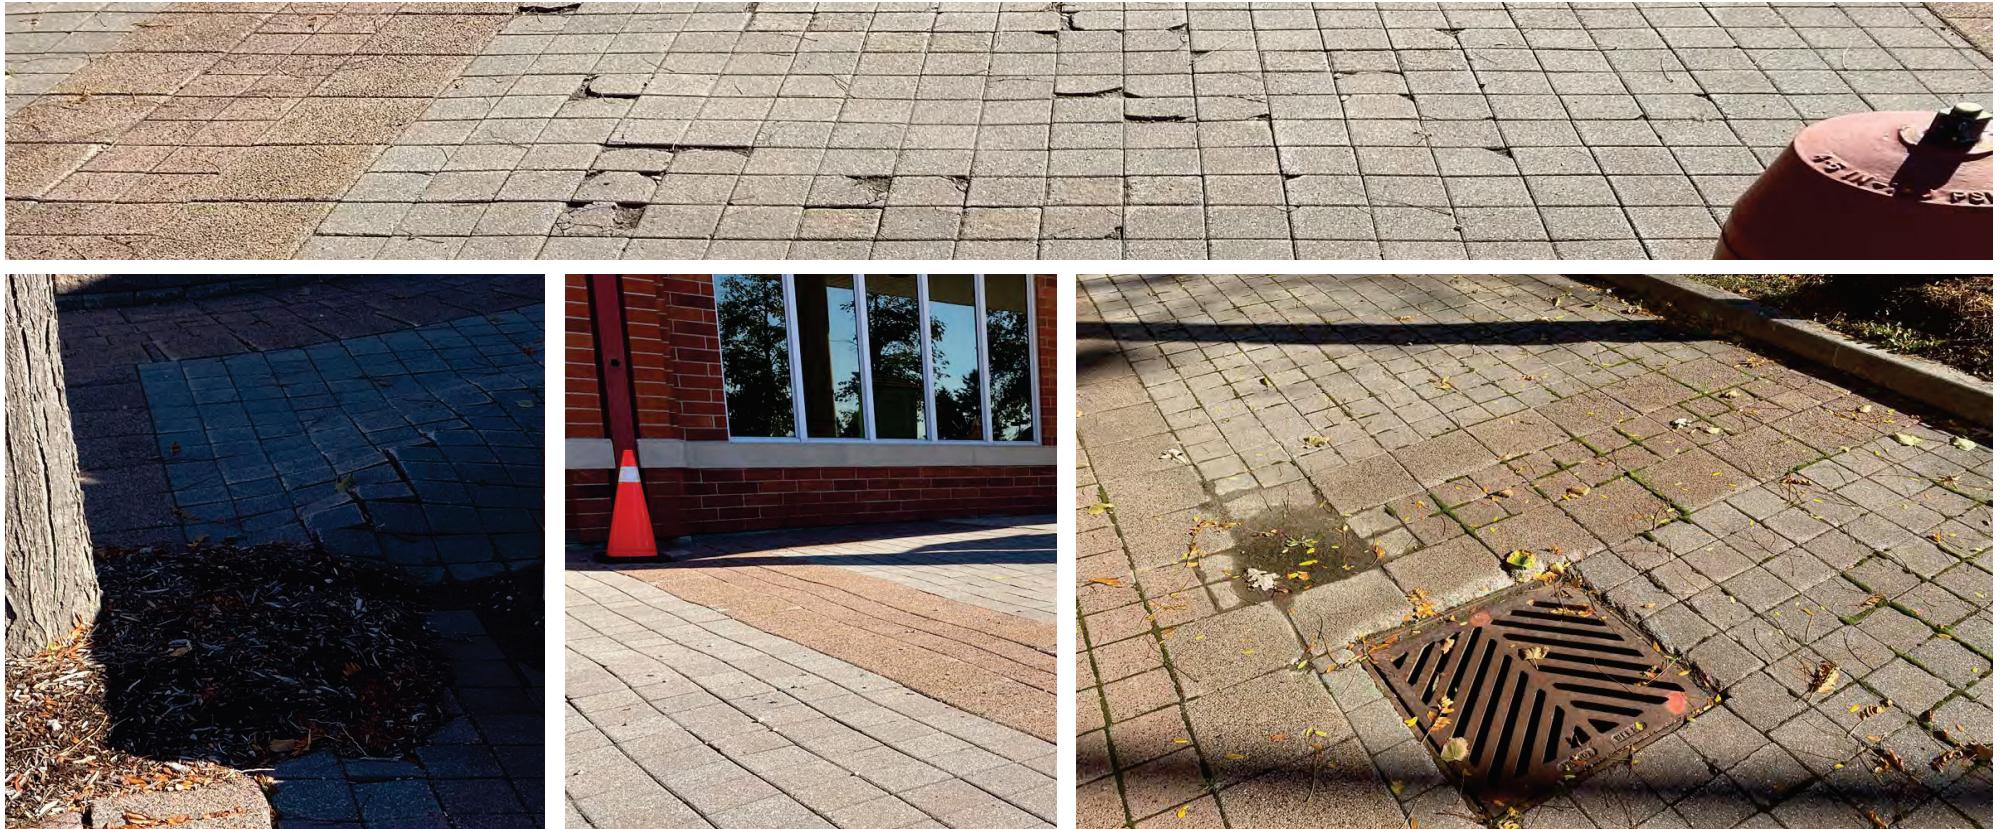
### Surfaces and Water

Existing Pavement in need of replacement. Buckling, sinking, and breakage pose hazards to wheel chairs, walkers, canes, and strollers. Collectively the general condition belays poor drainage and material end of life.

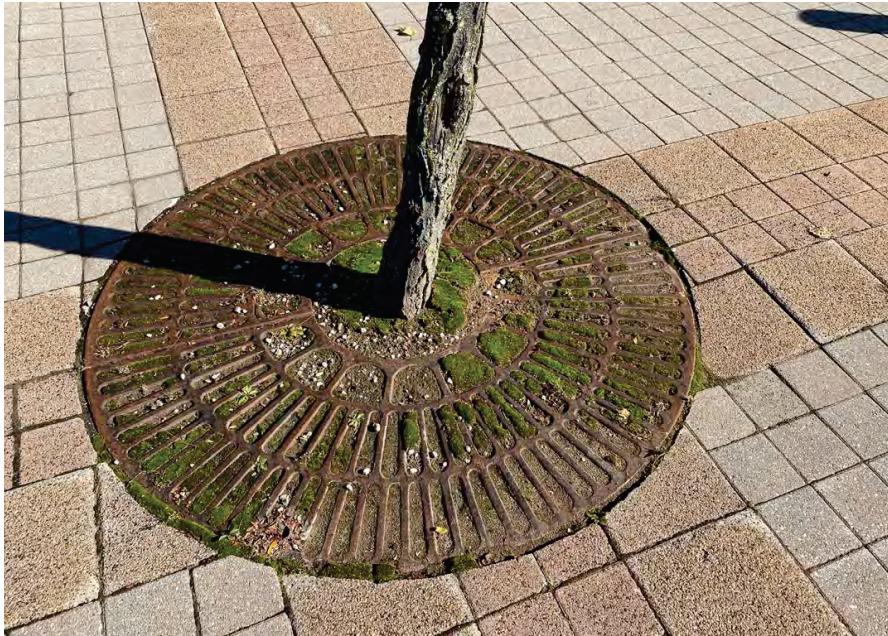
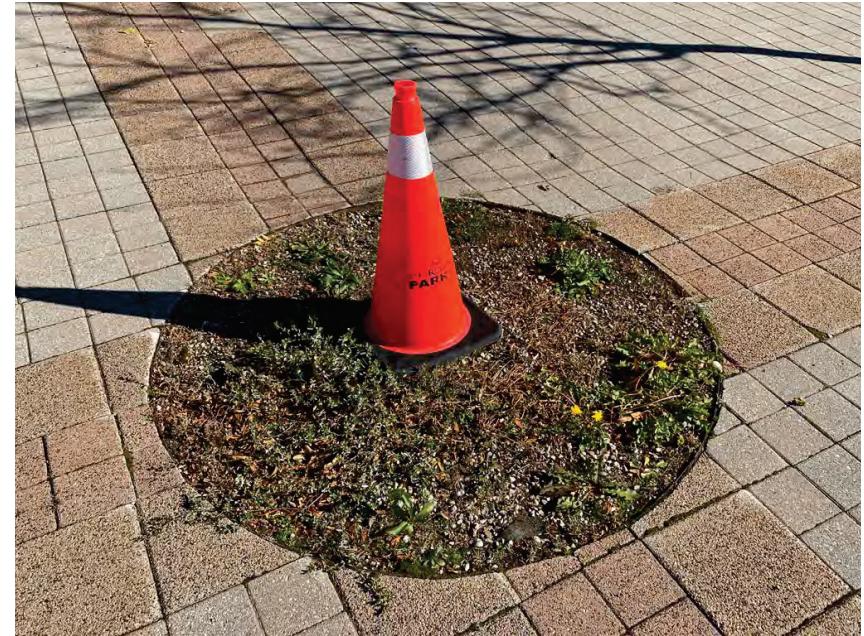
#### Cultural Practices and Durability

Existing trees are in poor condition if not dead. Trees show signs of restricted soil volumes and poor soil conditions. De-icing salt is likely contributing to mortality.

Note: This was not the only orange cone on site in the pedestrian area.

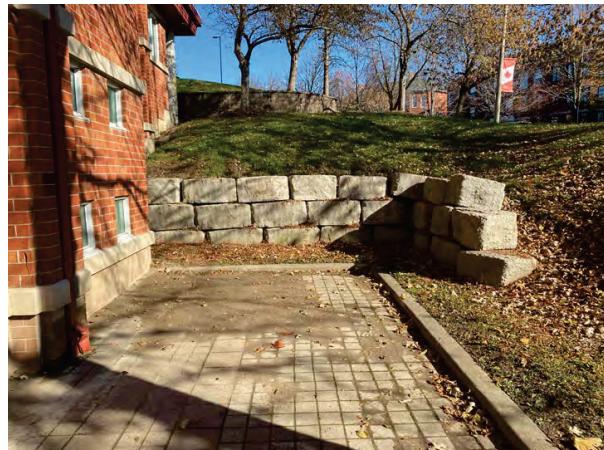
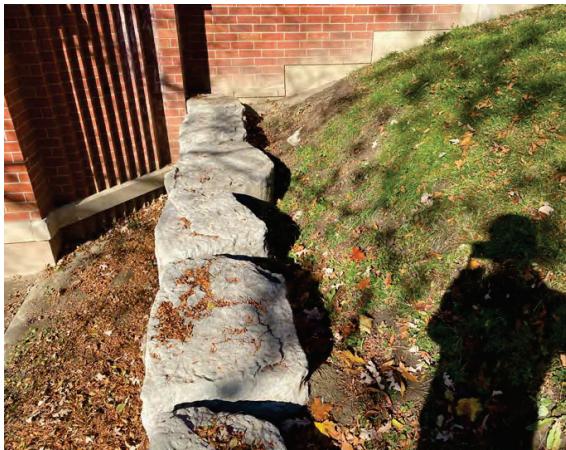
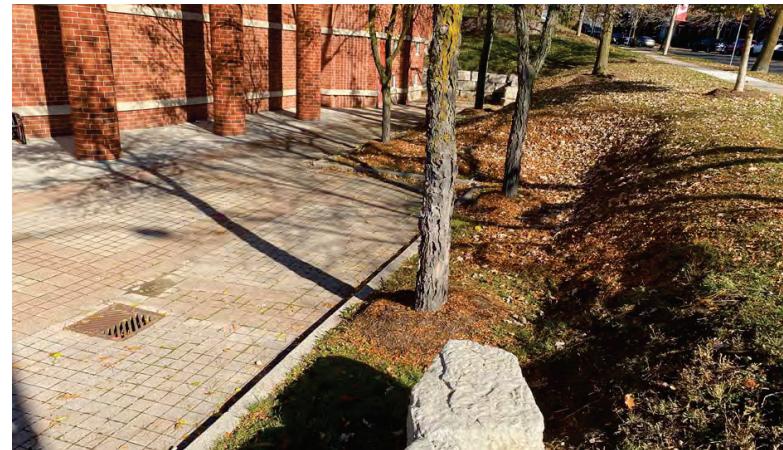
#### Erosion and Unstable Slopes

Currently soil type combined with grading strategy has created a highly erodible condition, with bare soils and shifting infrastructure. These steep slopes also pose as a general barrier to the surrounding community.

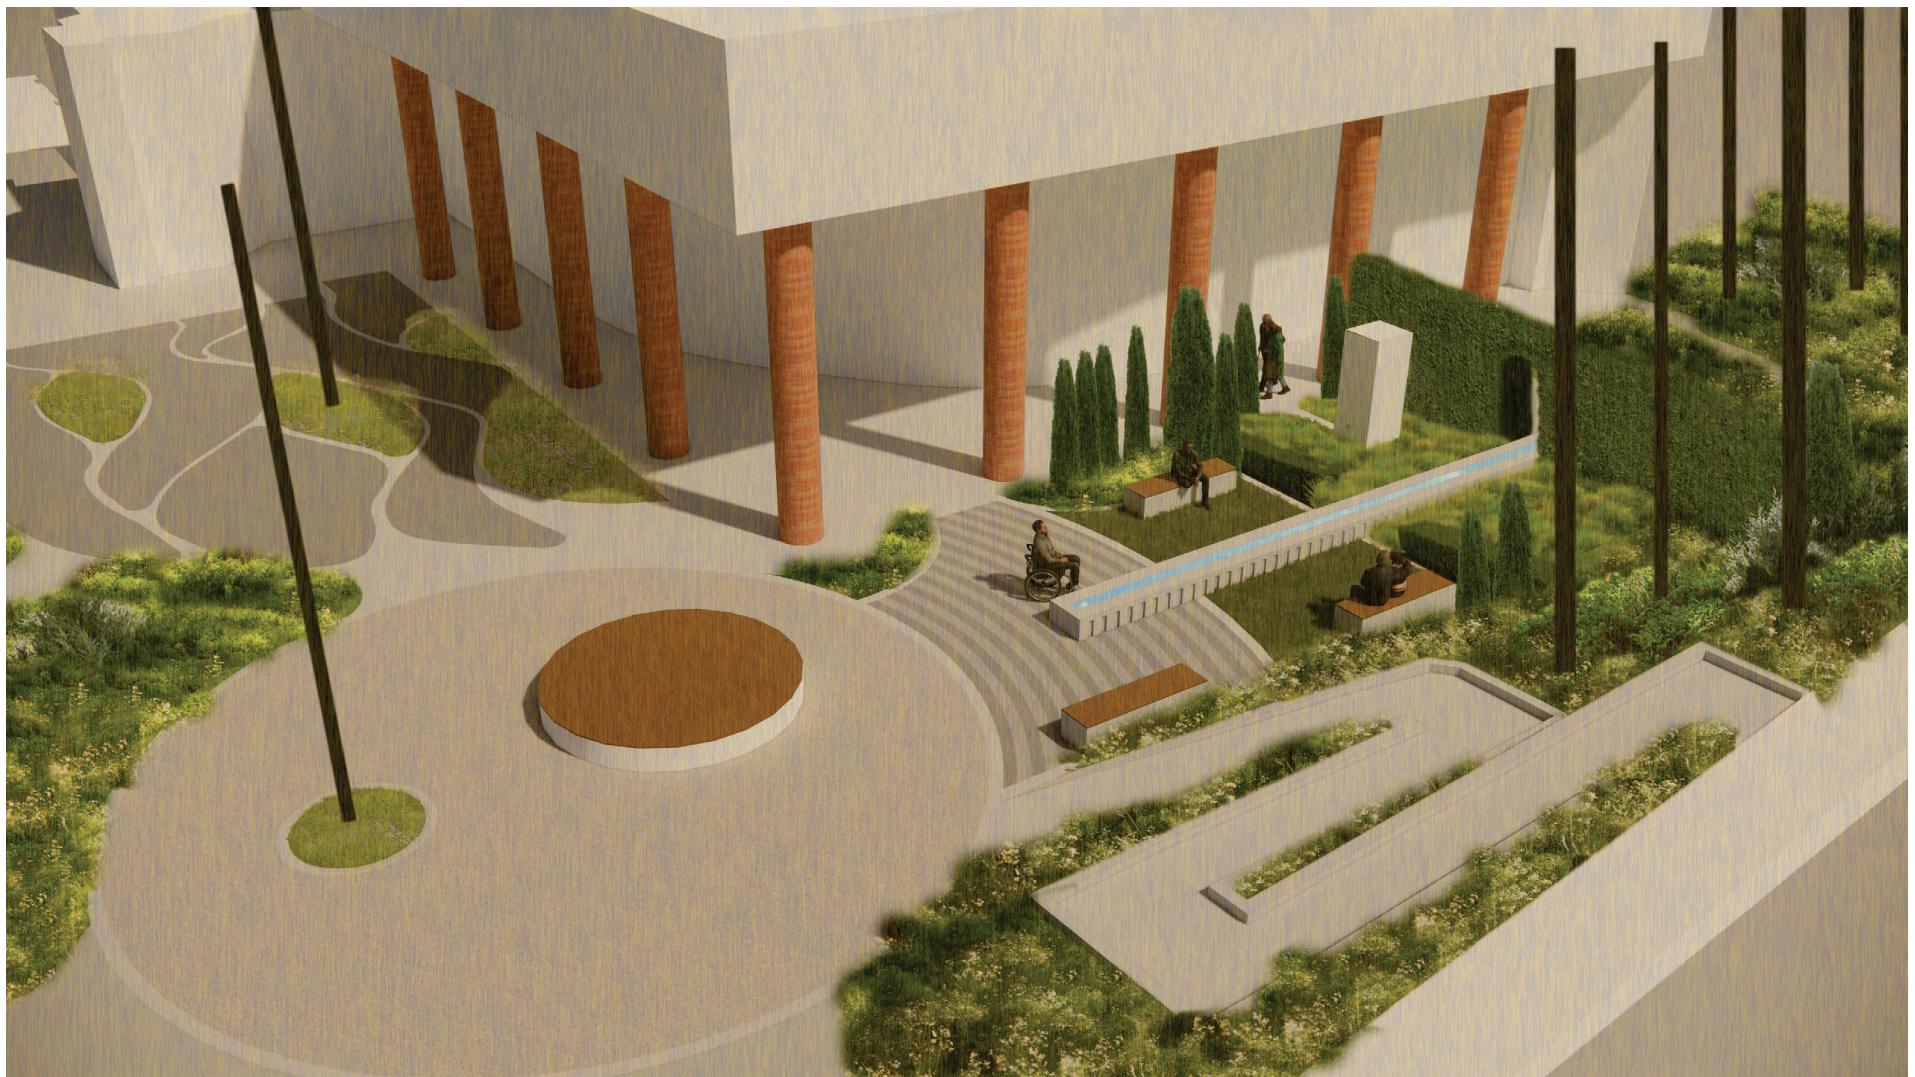
Note: Trees represented as columns as to not visually block general design intent.

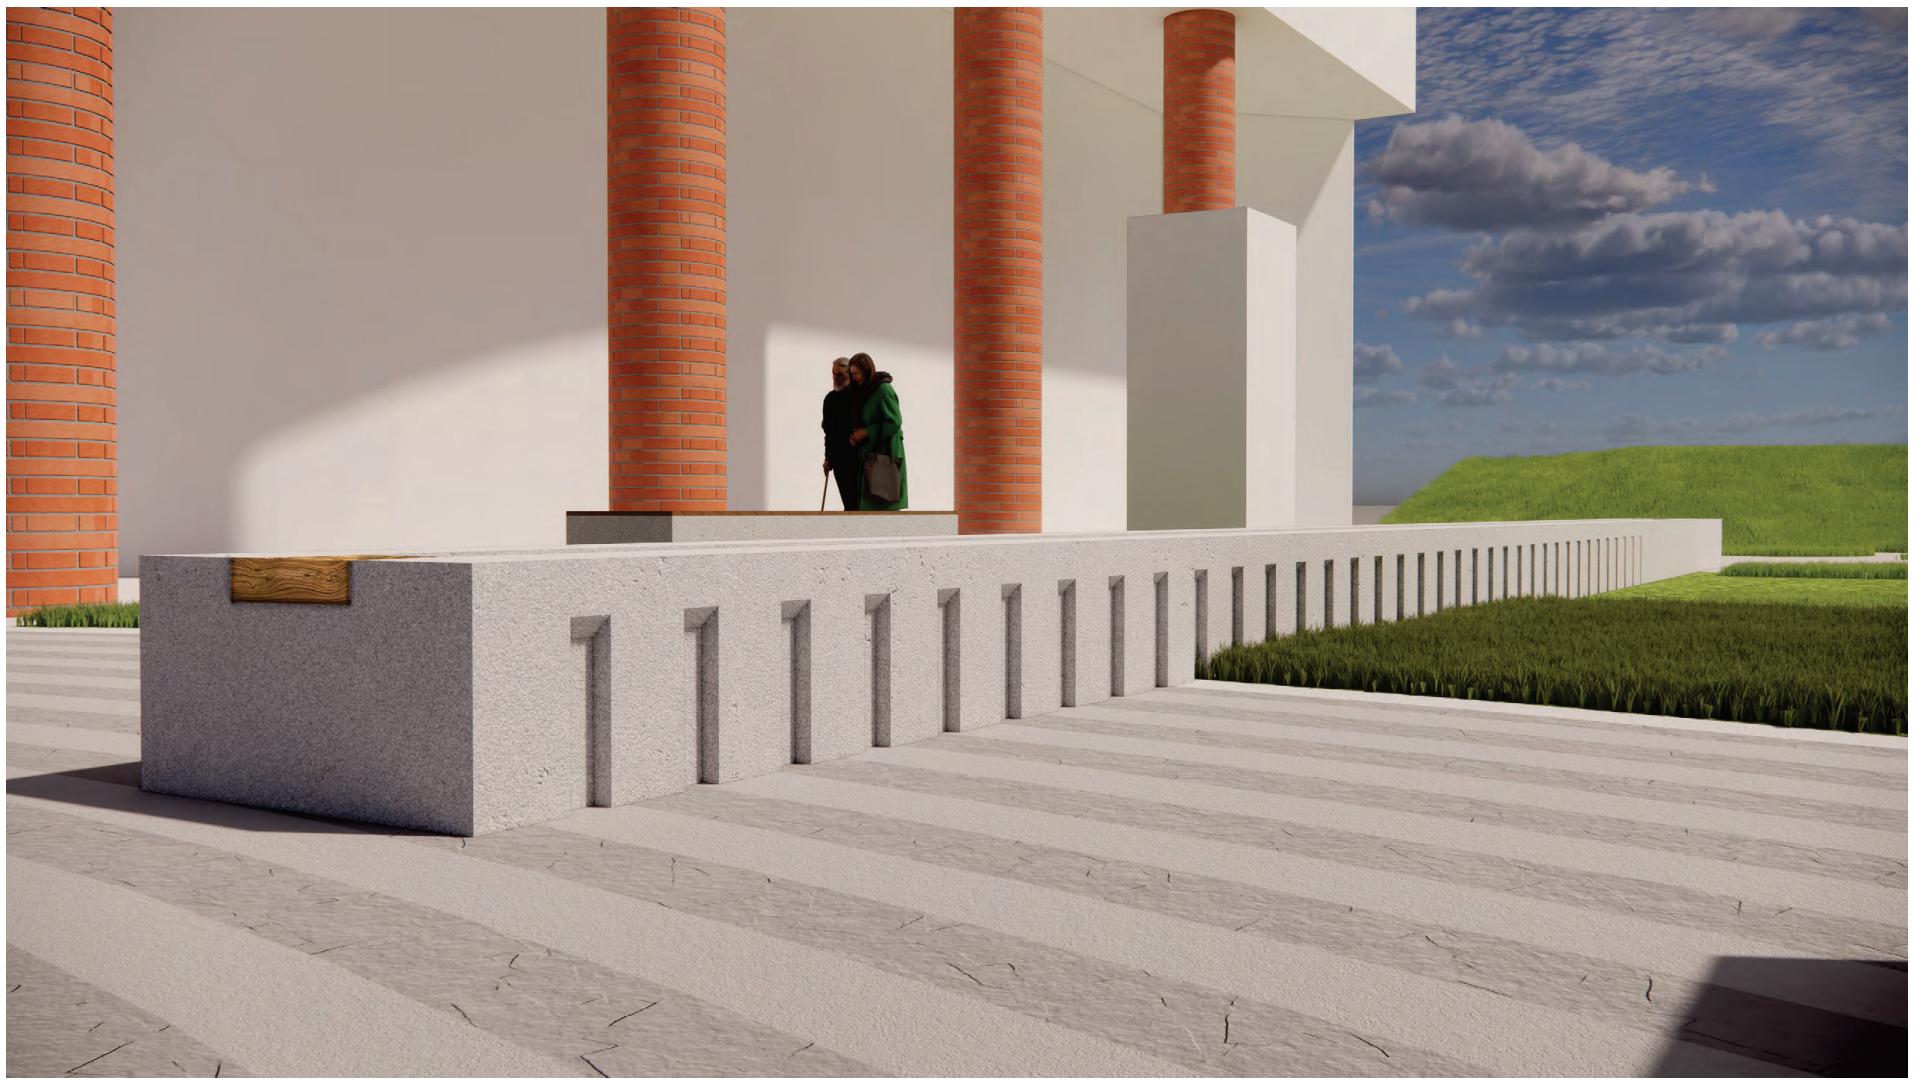
Image of "Sky Ribbon" Plynth depicting simple formwork impression that fades further from the Gathering Place.  
Note: Vegetation removed to show relationship to adjacent spaces.

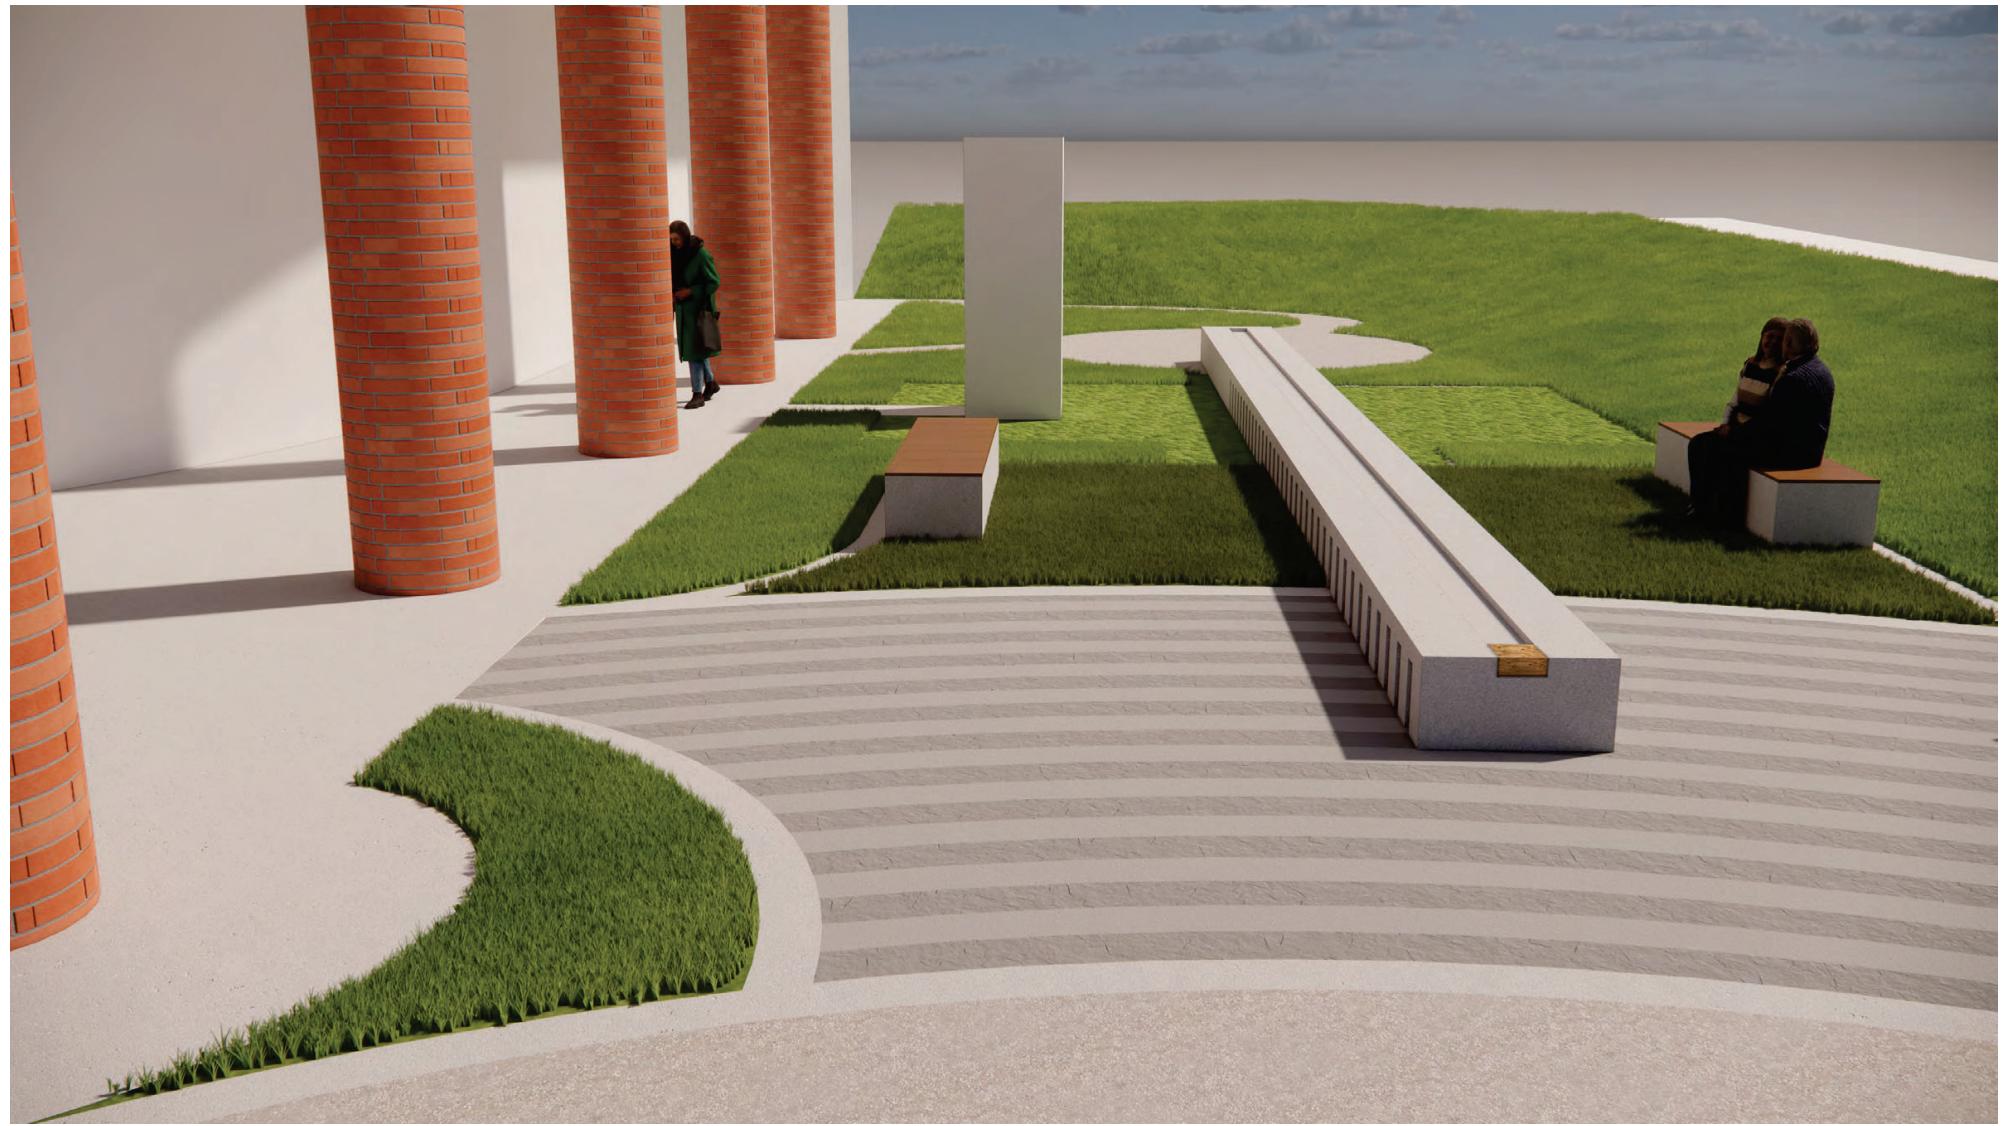
Contemplation Space with vegetation removed to show hardscape elements and spatial relationship of distinct areas.
