#### Attachment 3

Methodology for the evaluation of cultural heritage resources as part of the Review of the Aurora Register Project (i.e. evaluation of listed properties)

# Aurora Register Project – RFP

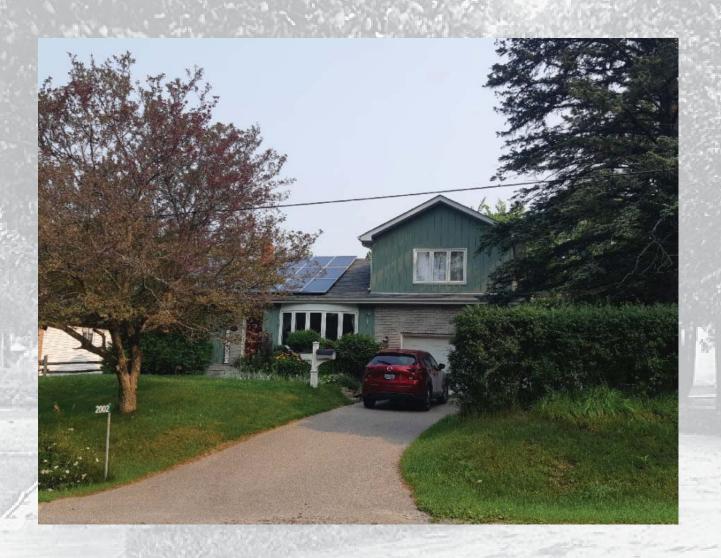
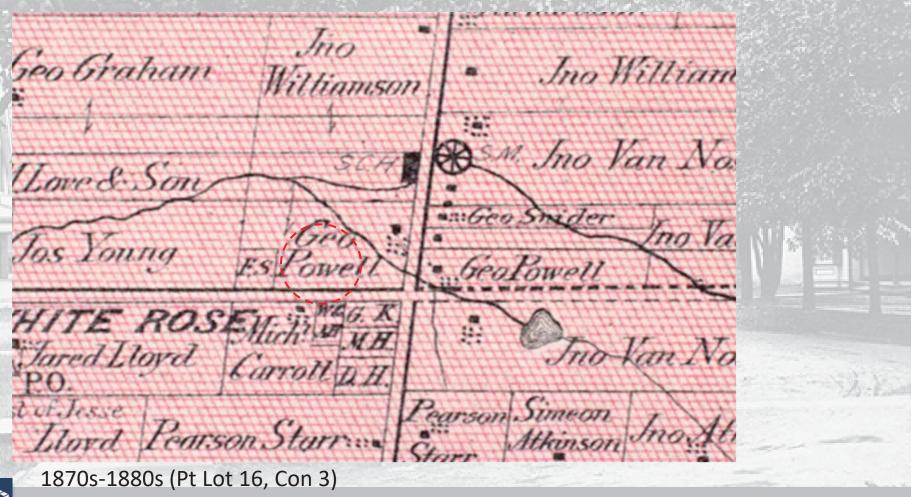
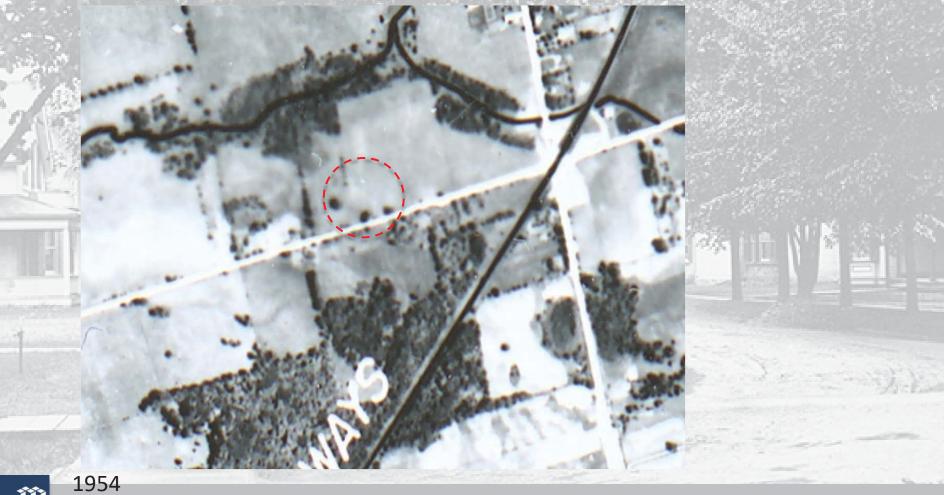
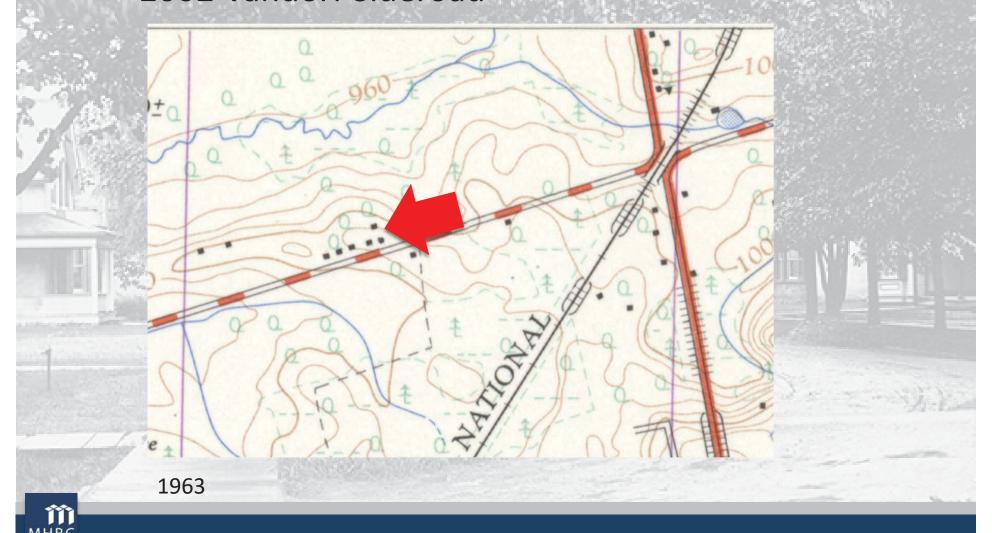
### 2002 Vandorf Sideroad

#### 2002 Vandorf Sideroad (None/Minimal – Remove from the Register) Value: O-Reg 9/06 Sub-Criteria: (Minimal, Moderate, Description: Major) None Has value because it is considered: ■ Minimal ☐ Rare, Altered (unknown style) ■ Moderate ■ Unique Constructed bet. 1954 - 1963 ■ Major Design/ ■ Representative Physical ☐ Early (Pre-Confederation) **Wood Frame** Has value because it demonstrates a: ■ Poor Condition 1.5 storeys ☐ High degree of craftsmanship/artistic merit Loss of Integrity ☐ High degree of technical/scientific achievement ☐ At Risk No information which provides evidence of a significant event, *Direct* associations with a significant: ■ None theme, person, family, activity, etc. Theme ■ Minimal associated with the existing Event Historical/ Person lot/welling. ■ Moderate Associative May have been constructed by Activity ■ Major Organization/Institution members of the Baber family in 1956 (original Baber home at 1978 Vandorf Sideroad) Is *important* in its ability to: Does not define, maintain, or ☐ Define the character of the area support character of the area. ■ None ☐ Maintain the character of an area No important physical, **■**Minimal ☐ Support the character of an area Demonstrates that it is *important* in its: functional, visual, links. ■ Moderate Contextual Physical, functional, visual or historical link to its ■ Major Located adjacent to the original surroundings Baber family home ■ Landmark status Not a landmark.

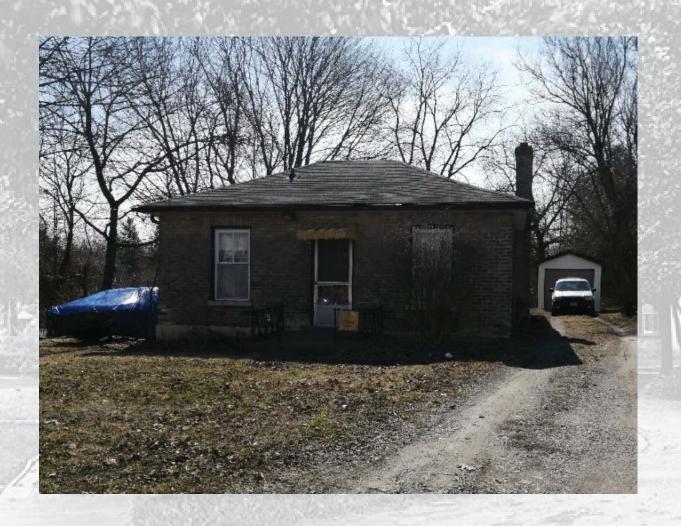
## 59 Tyler Street

- Not included in FIPs
- LACAC research
  - Summaries of tax rools, census, title searches
- Regency characteristics
- 1870s
- Property directly associated with Walter Henry Machell
- Existing house likely not the birth-place of Walter Machell (previously thought to be constructed in the 1850s)

#### 59 Tyler Street (Moderate value – Remain on the Register) Value: O-Reg 9/06 Sub-Criteria: (Minimal, Moderate, Description: Major) ■ None Has value because it is considered: 1870s ■ Minimal ☐ Rare, Regency characteristics ■ Moderate □ Unique Hip roof – single storey ■ Major Design/ Representative Physical ☐ Early (Pre-Confederation) Likely constructed of bricks Has value because it demonstrates a: ■ Poor Condition from the Machell brickyard ☐ High degree of craftsmanship/artistic merit ☐ Loss of Integrity ☐ High degree of technical/scientific achievement ☐ At Risk Direct associations with a significant: Property associated with the ■ None Theme Machell family; ■ Minimal ■ \_Event Historical/ Existing building likely the Person ■ Moderate **Associative** Activity Major residence of Walter Henry Organization/Institution Machell Is *important* in its ability to: ☐ Define the character of the area ■ None ☐ Maintain the character of an area Historically linked to local ■ Minimal Support the character of an area industry (brickyard) ■ Moderate Demonstrates that it is *important* in its: Contextual Physical, functional, visual or historical link to its ■ Major Not a landmark. surroundings ■ Landmark status

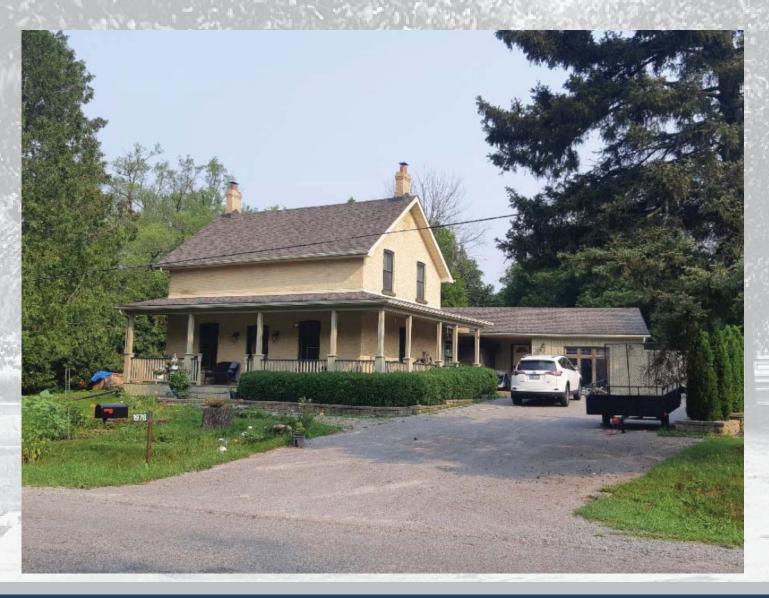
## 1978 Vandorf Sideroad (The Baber House)

1978 Vandorf Sideroad (The Baber House)					
O-Reg 9/06	Sub-Criteria:	Description:	Value: (Minimal, Moderate, Major)		
Design/ Physical	Has value because it is considered:  □ Rare, □ Unique □ Representative □ Early (Pre-Confederation)  Has value because it demonstrates a: □ High degree of craftsmanship/artistic merit □ High degree of technical/scientific achievement	<ul> <li>Brick Classical Revival</li> <li>1880s</li> <li>Common in Ontario</li> <li>Integrity retained</li> <li>Original verandah removed</li> </ul>	<ul> <li>□ None</li> <li>□ Minimal</li> <li>■ Moderate</li> <li>□ Major</li> <li>□ Poor Condition</li> <li>□ Loss of Integrity</li> <li>□ At Risk</li> </ul>		
Historical/ Associative	Direct associations with a significant:  ☐ Theme ☐ Event ☐ Person ☐ Activity ☐ Organization/Institution	<ul> <li>Built for Fred Ransom (farmer, made maple syrup)</li> <li>Baber family home</li> </ul>	□ None □ Minimal □ Moderate □ Major

Contextual  MHBC	Is important in its ability to:  ☐ Define the character of the area ☐ Maintain the character of an area ☐ Support the character of an area ☐ Demonstrates that it is important in its: ☐ Physical, functional, visual or historical link to its surroundings ☐ Landmark status	<ul> <li>Context has changed, no longer a farm complex.</li> <li>Became 1 acre lot by 1939</li> <li>Not important physical, functional, visual, links.</li> <li>Baber family later constructed a house next door in 1956</li> <li>Not a landmark.</li> </ul>	□ None □ Minimal □ Moderate □ Major

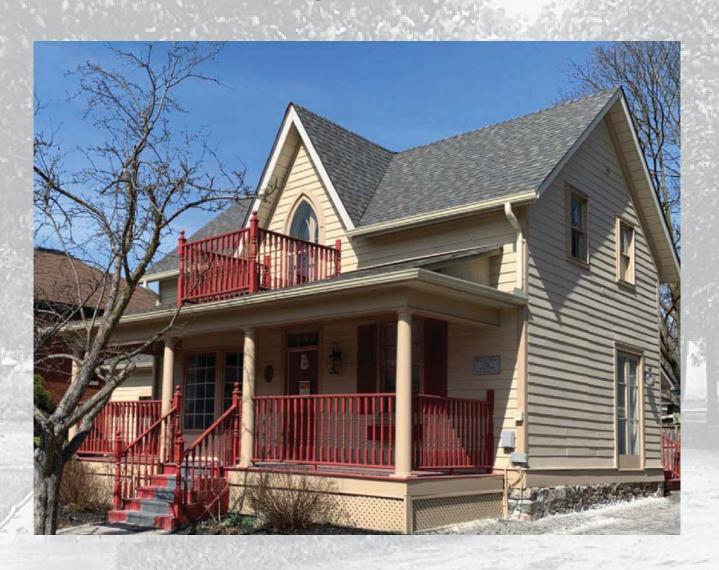
### 50 Wellington Street East

- "Andrews-Morrison House"
- C. 1855
- Gothic Revival cottage
- Plan 107, Pt lot 19
- Assoc. with Edward Andrews (tailor) and George Morrison (carriage maker)

#### 50 Wellington Street East (Consider Part IV Designation) Value: O-Reg 9/06 Sub-Criteria: Description: (Minimal, Moderate, Major) ■ None Has value because it is considered: Gothic Revival Cottage; ■ Minimal ☐ Rare, ■ Moderate **□ ⊌**nique c. 1855 Design/ Representative ■ Major Physical ■ Early (Pre-Confederation) Has value because it demonstrates a: ■ Poor Condition ☐ High degree of craftsmanship/artistic merit □ Loss of Integrity ☐ High degree of technical/scientific achievement At Risk Direct associations with a significant: ■ None **Andrews-Morrison House** Theme ■ Minimal Event Edward Andrews (tailor) Historical/ Person ■ Moderate Associative George Morrison (carriage Activity ■ Major maker) Organization/Institution Is important in its ability to: ☐ Define the character of the area ■ None ☐ Maintain the character of an area ■ Minimal Support the character of an area Part of the Wellington St. E. Moderate Demonstrates that it is *important* in its: Contextual streetscape ☐ Physical, functional, visual or historical link to its ■ Major surroundings ■ Landmark status

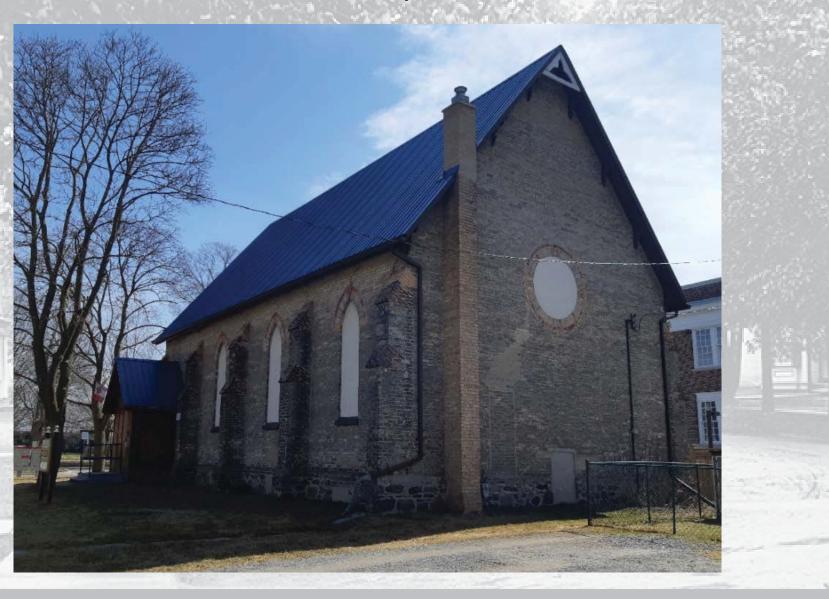
## 57 Mosley Street

### 57 Mosley Street (Methodist Episcopal Church/Rising Sun Masonic Lodge)

O-Reg 9/06	Sub-Criteria:	Description:	Value: (Minimal, Moderate, Major)
Design/ Physical	Has value because it is considered:  □ Pare, □ Unique □ Representative □ Early (Pre-Confederation)  Has value because it demonstrates a: □ High degree of craftsmanship/artistic merit □ High degree of technical/scientific achievement	<ul> <li>Gothic Revival Church (1877)</li> <li>Unique elements as a result of use as a Masons Lodge (since 1885)</li> <li>Built by Cane &amp; Sons</li> <li>Alterations which have taken on value as part of its use as a Masonic Lodge</li> <li>Some unsympathetic alterations</li> </ul>	<ul> <li>□ None</li> <li>□ Minimal</li> <li>□ Moderate</li> <li>□ Major</li> <li>□ Poor Condition</li> <li>□ Loss of Integrity</li> <li>□ At Risk</li> </ul>
Historical/ Associative	Direct associations with a significant:  ☐ Theme ☐ Event ☐ Person ☐ Activity ☐ Organization/Institution	<ul> <li>Associated with two institutions which have had a significant impact on the local community</li> </ul>	□ None □ Minimal □ Moderate □ Major

<b>MHBC</b> xtual	Is important in its ability to:  Define the character of the area Alaintain the character of an area Support the character of an area Demonstrates that it is important in its: Physical, functional, visual or historical link to its	<ul> <li>Supports the Southeat Old Aurora neighbourhood;</li> <li>Local landmark</li> </ul>	<ul><li>□ None</li><li>□ Minimal</li><li>□ Moderate</li><li>□ Major</li></ul>
