Town of Aurora

Closed Session Council Report No. PDS20-046

Subject: Potential Property Acquisition – 250213 Holdings Ltd (15157, 15165, 15171 Yonge Street)

Property Condition Assessment Report Of an Improved Commercial Property

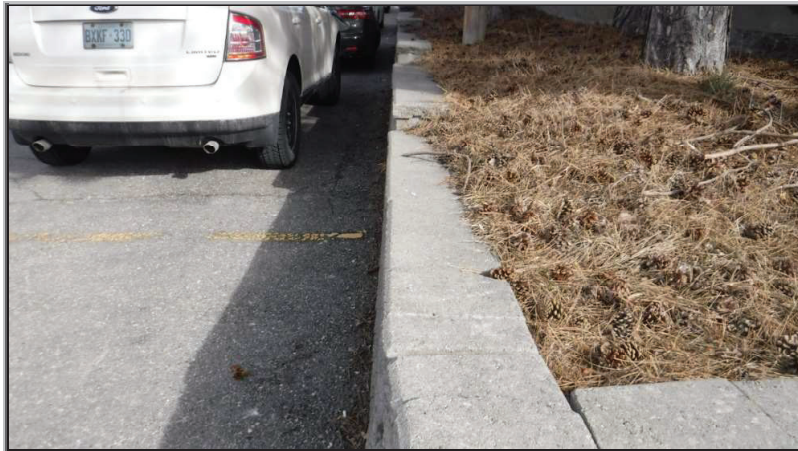
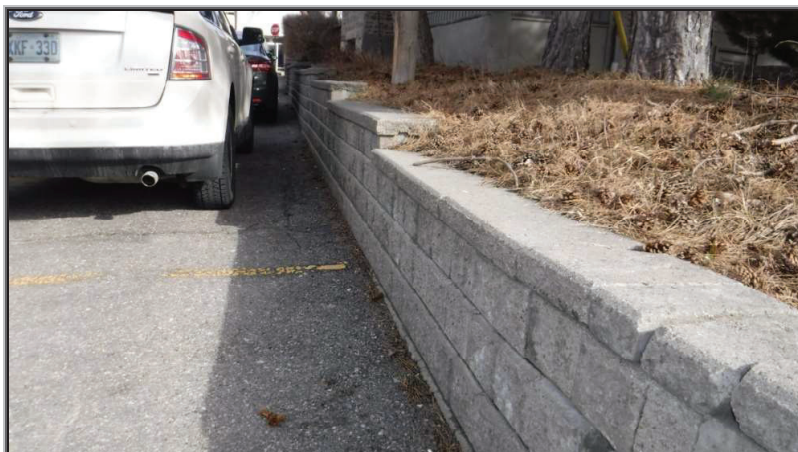
SITE PHOTOGRAPHS

The site shows signs of wear over time as it appears to be in original condition. There are no cost assessments considered within the next 3 years. Periodic maintenance is always recommended for any building system or site.

No significant capital expenditures pertaining to the ingress, egress, paving, curbing, parking and landscaping are anticipated over the next three (3) years, apart from ongoing routine maintenance and repairs. Cracks, and landscaping should always be monitored and mitigated as needed
