CONSERVATION PLAN

Preliminary

KNOWLES / READMAN HOUSE 15356 YONGE STREET TOWN OF AURORA, ONTARIO

March 2022

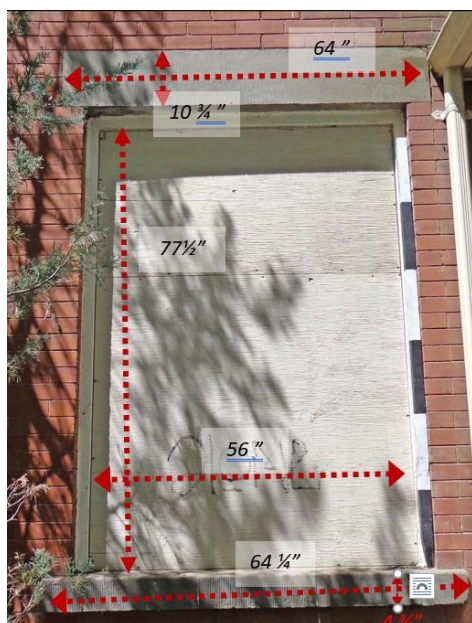
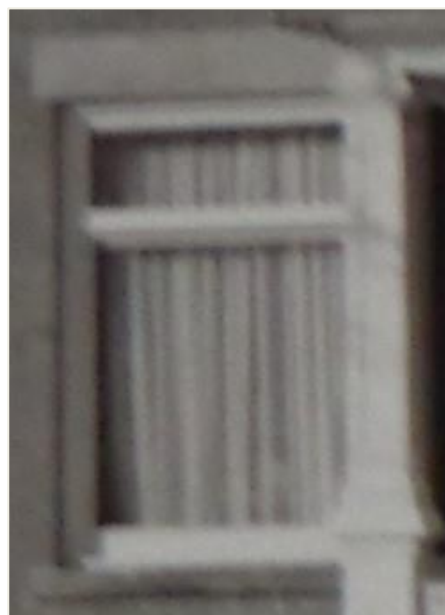
Figure 4.3
Window – Ground Floor East Elevation. 2016 (left), 1982 (right)

The typical window opening is rectangular with a flat head. The openings have flat concrete lintels and lug sills, the facing edges of which have been fashioned to imitate sawn stone (Figure 4.3). Most window openings have been boarded. The front windows have had two sashes – a narrow upper sash above a much larger single glazed lower sash. A smaller window opening on the south elevation still contains its one over one sash.

3. Restoration / reconstruction of windows on the south, east and north elevations as specified in **Appendix D** will involve:
 - a. Repairing all extant window frames and sashes.
 - b. Where window frames and sashes are not repairable; constructing duplicates to match the original.
 - c. Where window frames or sashes are missing, constructing ones which match others elsewhere on the House.
 - d. Repairing / reconstructing the upper floor window on the east elevation to match the one that appears in the 1982 photograph (Figure 5.16).

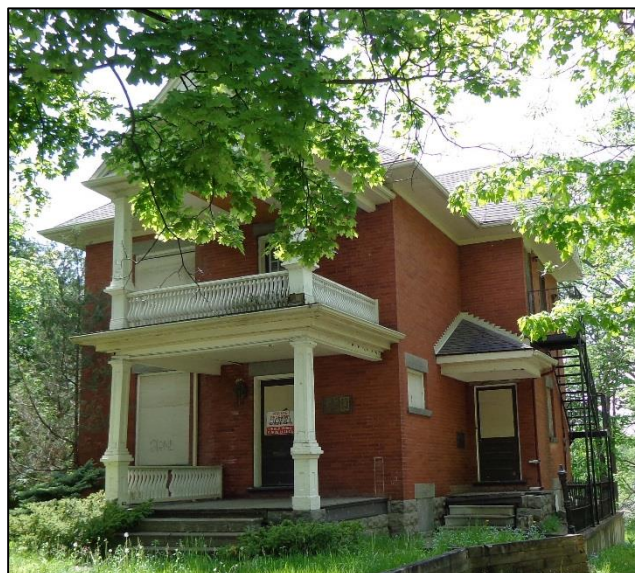
Figure 4.4
East and North Elevations
2016.

East Elevation – This is the principal or front elevation of the House. It is a two bay façade, with a north door and south window on both the ground and upper floors (Figure 4.4).

The prominent feature of this elevation is the two storey porch capped by a gable roof. The porch is supported by tapered, square, paneled posts resting on square, paneled concrete piers. On the upper floor the posts are supported by wood piers. Originally there was a triple set of posts and piers on the outer corners of both levels of the porch (Figure 4.6). The balustrade has carved balusters. On the upper floor, the balustrade encloses the porch, while on the lower floor, it is limited to the north and south sides. The rock-faced concrete block porch foundation is identical to the House foundation.

2. The front porch will be restored using salvaged material from the existing front porch and new material designed using salvaged material as templates. The restored front porch will contain the triple corner posts in both the upper and ground levels and the full balustrade as shown in the c1920 photograph in Figure 4.5. Detailed architectural plans for the restored front porch are contained **Appendix D** of this Plan.

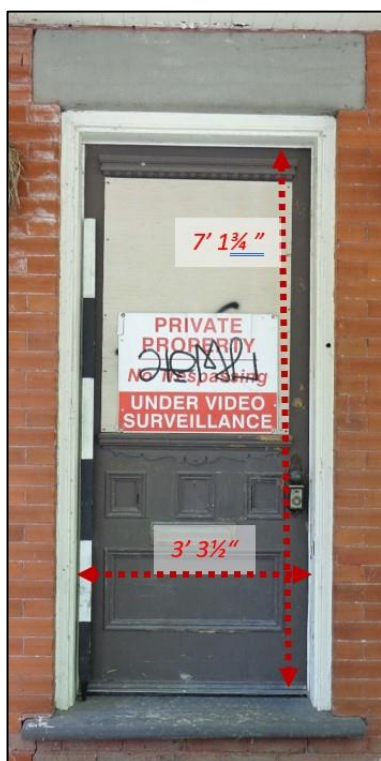
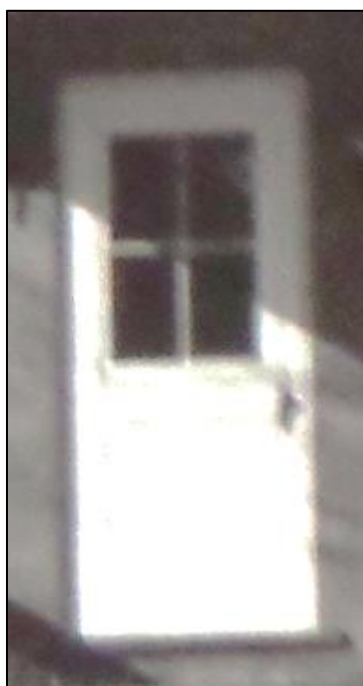
Figure 4.5
Front Door – Ground
Floor East Elevation.
2016 (left), 1982 (right)

The door openings have concrete lintels, similar to those over the windows, wood thresholds and plain wood surrounds with moulded edges (Figure 4.5). The ground floor door is solid wood with three sections - an upper, four paned glazed section; a middle consisting of a line of three small square panels; and a lower with one large rectangular panel. The upper floor door opening contains a modern door. Although original there were no storm doors on the ground and upper floors, there was a wooden storm door in 1982 on both; since removed.

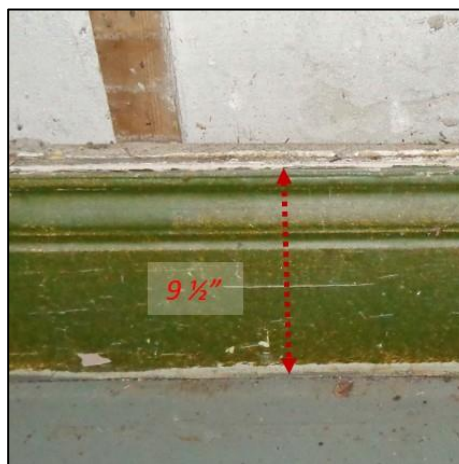
Figure 4.8
Baseboards – Rooms 1 & 2.
2016

The staircase window casing remains intact, but has different from casings elsewhere on the floor. Some of the front door casing remains; the base blocks of which are identical to those remaining in Room 2 suggesting the casing is original. Room 2, the parlour, retains baseboards identical to those in the hall (Figure 4.8). The exposed bricks on the south wall of Room 2 indicate removal of an earlier window. Between Rooms 2 and 3, two paneled pocket doors remain within wall partitions; the upper two panels were once glazed. Room 3, the dining room, contains baseboards identical to Rooms 1 and 2. The plain window casings remaining in this Room are the same as the front door, supporting the originality of both. Room 3 contains

1. Some baseboards, two window casings and one door casing remain on the ground floor of the Building as shown in this Plan in Figure 4.8 and in the Heritage Impact Assessment, **Appendix G** – Ground Floor Photographs 2 to 16.

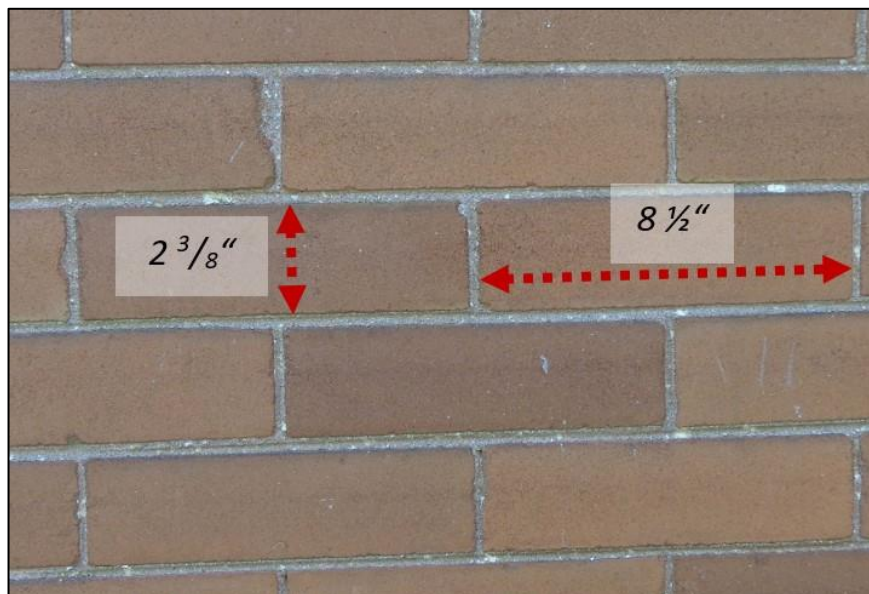
Figure 5.8
Original Masonry
work, east elevation

Figure 5.8 shows the existing masonry wall construction, including the profile and relative thickness of the mortar joints and the dimensions of the bricks.

2. Repointing will be addressed by:
 - a. Matching, to the extent possible, the original brick work mortar mix in terms of strength, granularity and colour based on a chemical and visual analysis of original mortar. Areas of pure white mortar joints are **not** acceptable.

- b. applying mortar to defective joints raked out by hand, not by machines.
 - c. duplicating the profile and width of original mortar joints.
3. Where replacement bricks are required, they will match, to the extent possible, the original bricks in terms of dimensions and colour. Such bricks will be laid in a bond that duplicates the original.

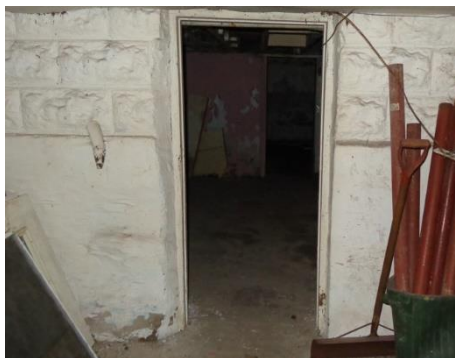
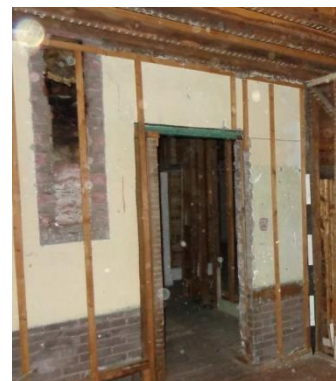
Figure 5.11
Painted and plastered
surfaces to be exposed
following removal of
the Rear Wing

3. Where the existing Rear Wing will be removed, part of the remaining wall of the House was painted (the concrete block foundation in Room 16) or plastered (Room 5) as shown in Figure 5.11.
4. The plaster may be removed from the brick wall and the paint from the concrete blocks using non-abrasive techniques.
5. Where paint and other materials is to be removed as specified 4 above, small test patches using the proposed technique are to be prepared. The project architect shall review the results of the test patches and determine whether the removal technique is approved for use on all of the painted surfaces. Following removal, repairs to the walls will be made in accordance with section 5.2.2 of this Plan
6. No waterproof coating is to be applied to the exterior brickwork or concrete block foundation.

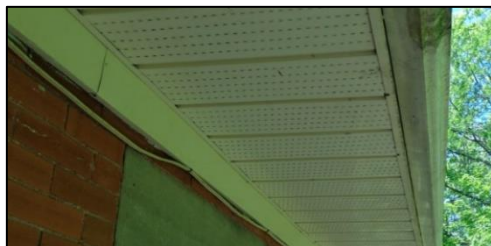
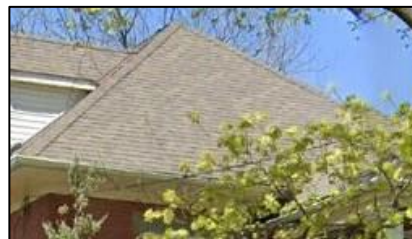
Figure 5.12 Existing soffits, frieze, fascia and eaves troughing (left), shingles (right).

1. Existing cladding as shown in Figure 5.12 is:
 - a. Roof – brown asphalt shingles;
 - b. Soffits – vented aluminum panels
 - c. Frieze – wood
 - d. Fascia – wood and modern synthetic material (aluminum or vinyl)
 - e. Eaves troughing – paint clad aluminum

2. Originally the roof would have been clad in cedar shingles and the frieze, soffits and fascia would have been painted wood.
3. *Shingles* - The existing shingle roof cladding is to be replaced with 50 year grey (the colour of weather cedar shingles) asphalt shingles more closely approximately the texture of cedar shingles as shown in Figure 5.13. Following removal of the existing shingles, existing roof boards are to be inspected and any damaged or rotting boards replaced prior to installing the new cladding.

4. *Soffits, Fascia, Frieze and Eaves Troughing* – The existing soffits, fascia, frieze and eaves troughing may be retained, except in the roof gables discussed in section 5.2.6 below, but must be repaired where damage has occurred, such as the soffit on the south elevation, either in the past or during restoration / renovation work. Downspouts must provide for drainage away from the Building.

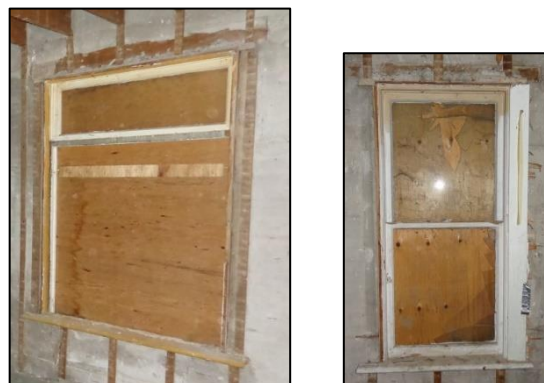
Figure No. 5.17
Interior views of windows –
ground floor east elevation
(left), ground floor south
elevation (right).

1. All windows have been boarded from the outside; many were visible from the interior. Photographs of the earlier appearance of the front windows are shown in Figure 5.16. The upper front window has been enlarged and altered from a one over one sash configuration to a larger, single sash. The ground floor window appears unchanged although, as shown in Figure 5.17, the lower sash is missing.

2. The intent of this Plan is to restore the original appearance of all windows on the south, east and north elevations, except for the east elevation upper floor window which has previously been enlarged.
