APPLICANT: Three Small Rooms Restaurant, Bar & Grill, Fine Dining Inc.

LOCATION: 15032 Yonge Street

FILE: HPA-2019-17

ATTACHMENT 1

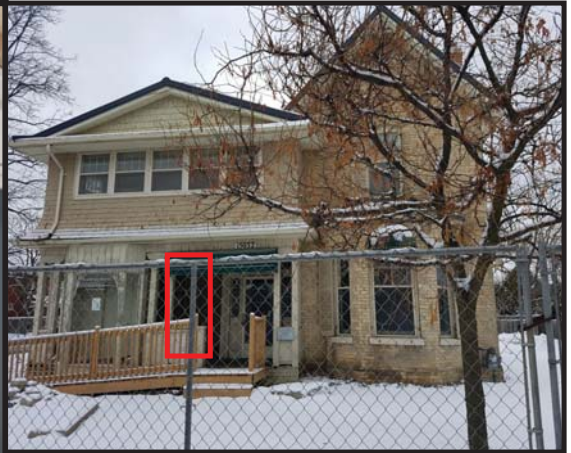
### Shutters # 1

**Location:** Side window behind the glass display on the east elevation facing Yonge Street.

**Condition:** Both shutters are generally in good condition with minimal damages on the stile and mid rail.

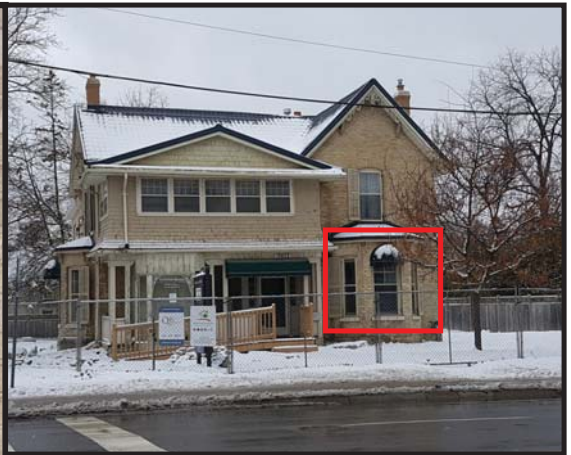
## **Shutters # 2**

**Location:** Bay window on the east elevation facing Yonge Street.

**Condition:** The left shutter is in good condition with minor peeled paint on several slats.

The right shutter is in good condition with minor damages mainly on the bottom rail.

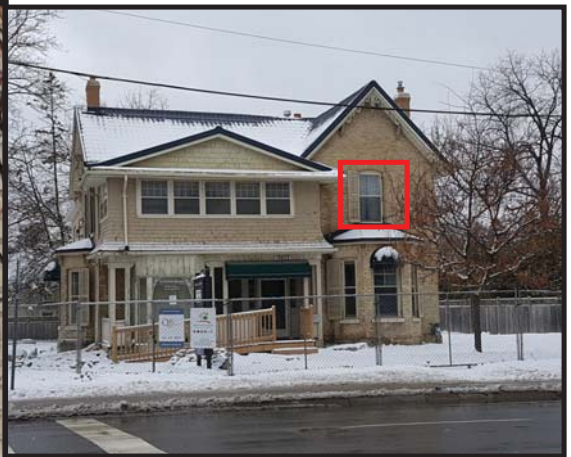
### **Shutters # 3**

**Location:** Window above the bay window on the east elevation facing Yonge Street

**Condition:** The left shutter has severe damages on the stiles and a number of slates.

The right shutter has fallen off the building due to broken hinges. It has moderate damages on most of the slates.

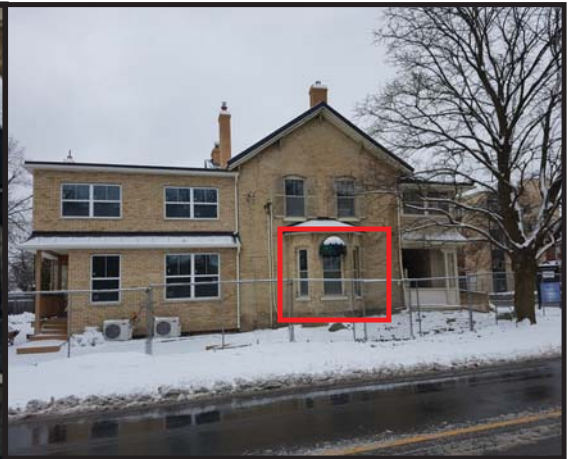
### **Shutters # 4**

**Location:** Bay window on the south elevation facing Kennedy Street.

**Condition:** The applicant indicates the left shutter was removed in August 2019 due to severe deterioration.

The right shutter has moderate damages on the left stile, push rod and many of the lower slates.

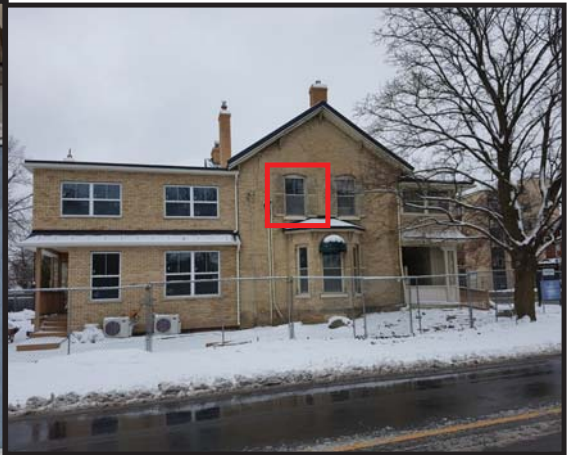
## **Shutters # 5**

**Location:** Top left window above the bay window on the south elevation facing Kennedy Street.

**Condition:** Both shutters are in poor condition with severe rotting wood and broken parts.

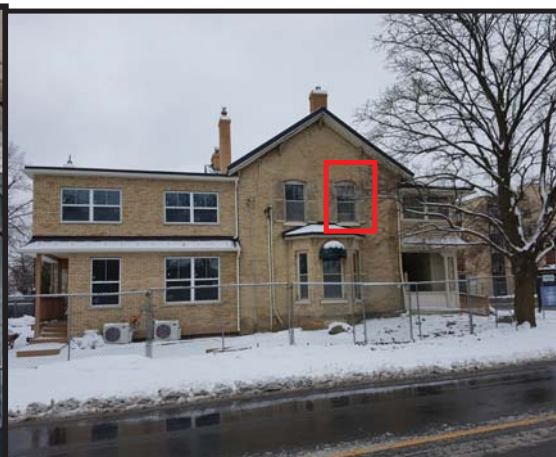
## **Shutters # 6**

**Location:** Top right window above the bay window on the south elevation facing Kennedy Street.

**Condition:** Both shutters have moderate to severe damages on the rail and stile.
