# Aurora Cenotaph

The following is a short report to outline recommendations and options for the Cenotaph located at

**Aurora War Memorial Peace Park  
Younge St Aurora Ontario**

A complete on-site inspection was performed on Dec 10 , 2:00 p.m the following is an update to the original submitted report. New slides are highlighted in Orange block

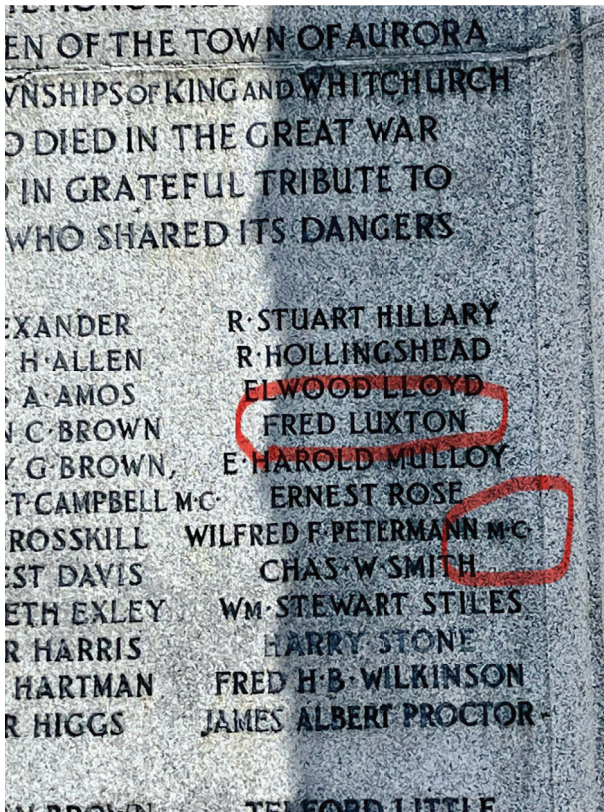
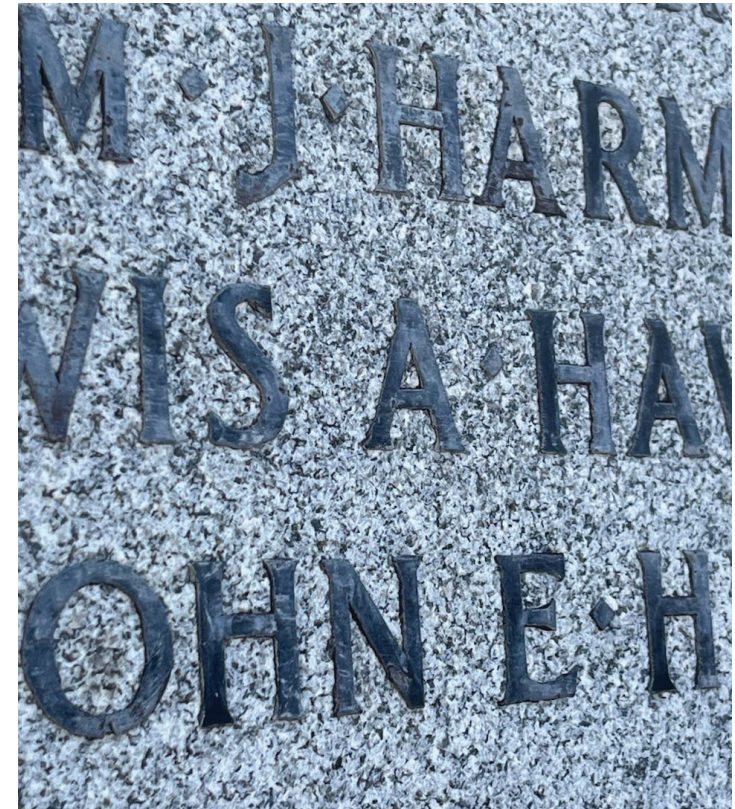
## LEAD LETTERING

Each letter height is 1 ½ inch high & 1 inch wide

The spelling of FRED LUXTON too FRED LUXON ( remove the T)

Remove the M.C after the Name Wilfred P. Petermann

We will also perform a complete inspection of all lettering and touch up or repaint letters as required

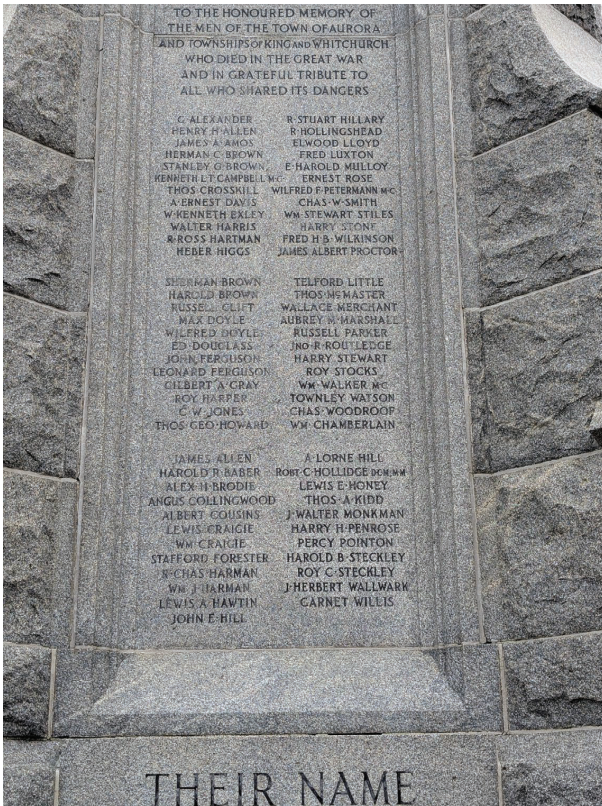
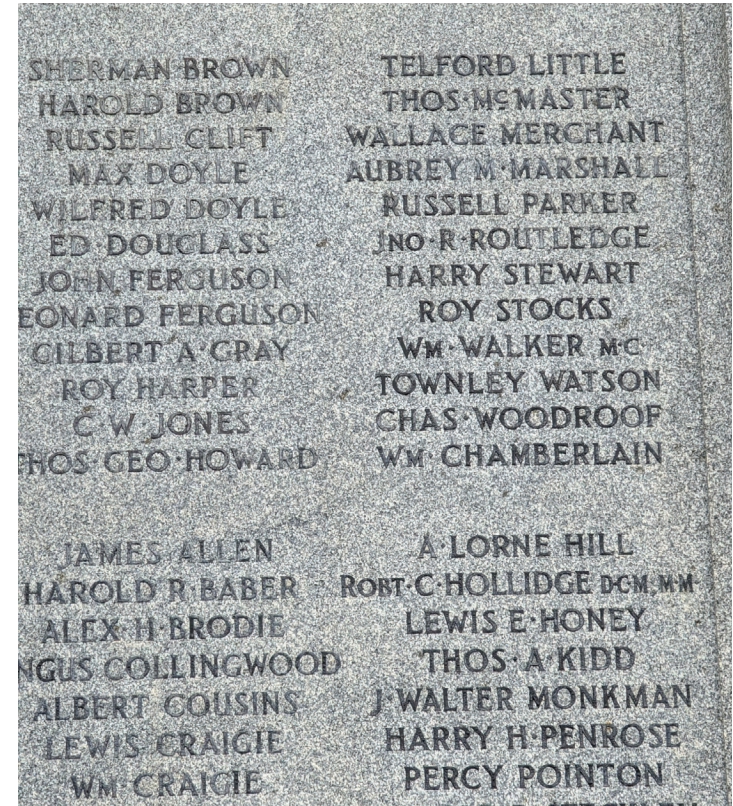
## LEAD LETTERING

**AFTER CLOSE INSPECTION  
Of the Lead lettering**

**Will confirm that all lead  
lettering will be painted , re  
hand painting , Currently the  
lettering is inconsistent , some  
darker than others**

**As well There is a small amount  
of Engraving that requires  
freshen up , not all engraving is  
painted, and we will not paint  
what was originally painted**

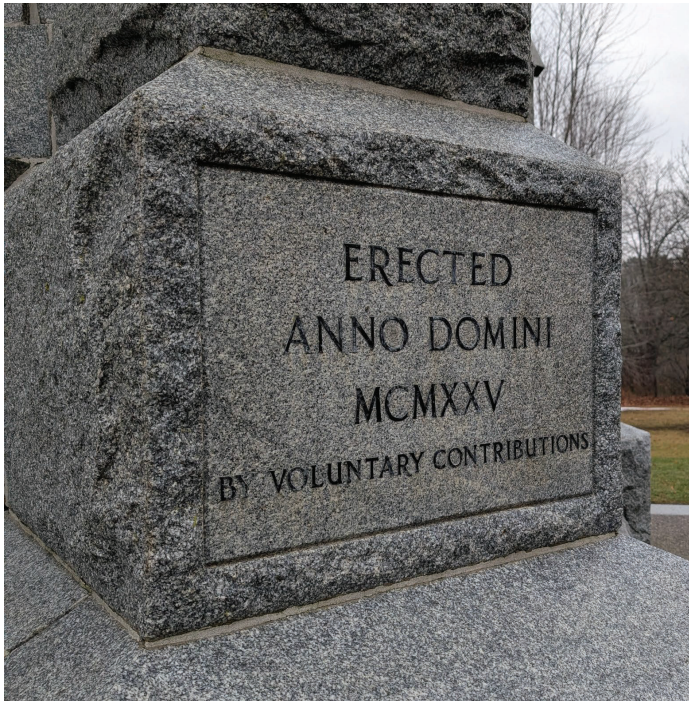
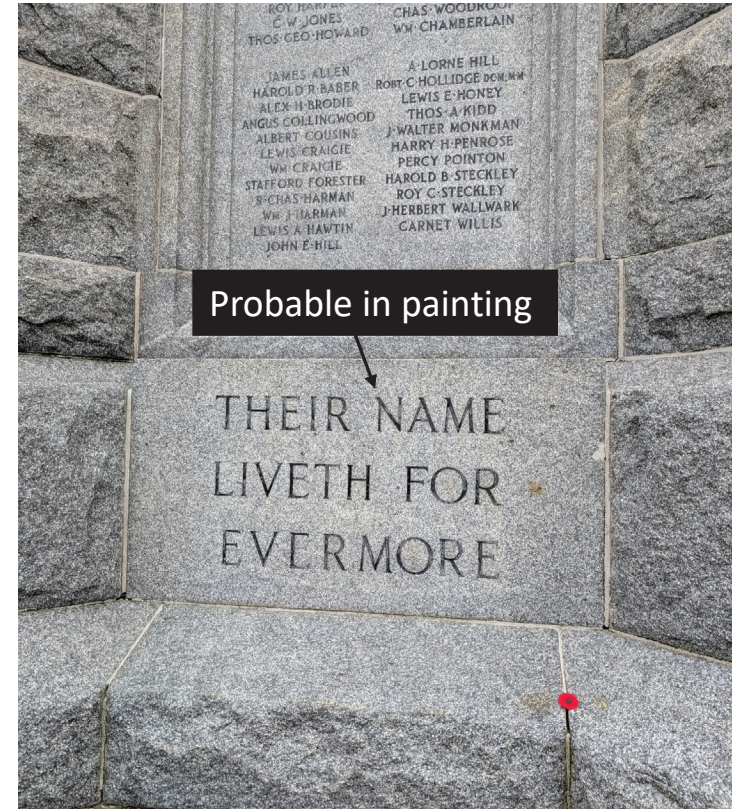
## LEAD LETTERING

**AFTER CLOSE INSPECTION  
Of the Lead lettering**

**Will confirm that all lead lettering will be painted , re hand painting , Currently the lettering is inconsistent , some darker than others**

**As well There is a small amount of Engraving that requires freshen up , not all engraving is painted, and we will not paint what was originally painted**

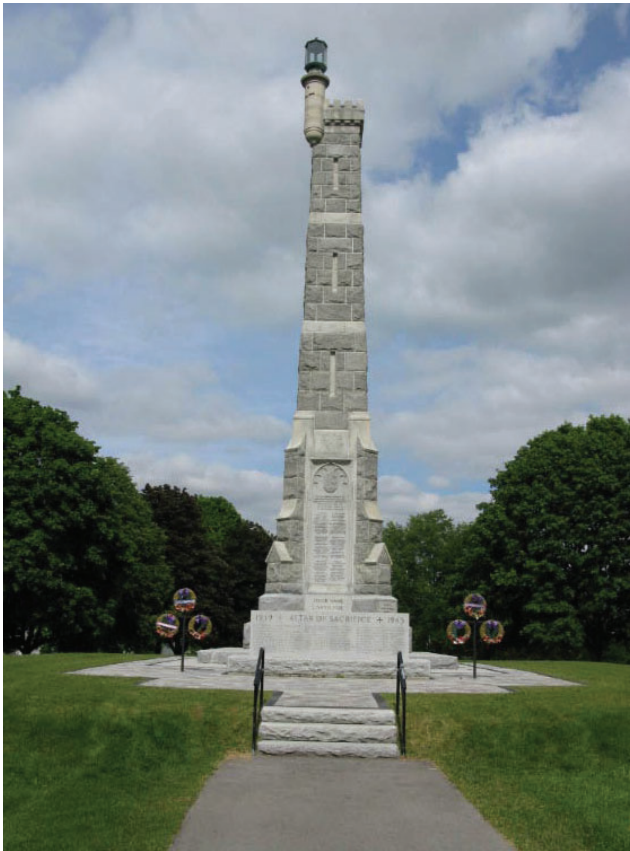
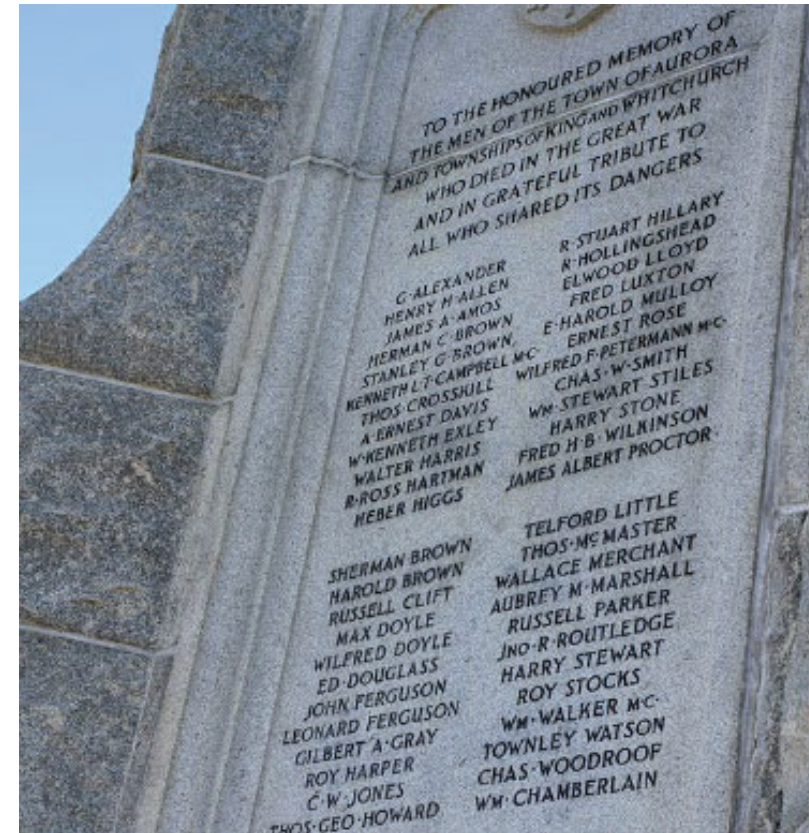
## CLEANING

Structures of this nature are subjected to soiling of various types

We propose an entire site & structure application / cleaning of a BIOCIDE cleaner, power washing on granite elements and surrounding cement pads & natural stone elements.

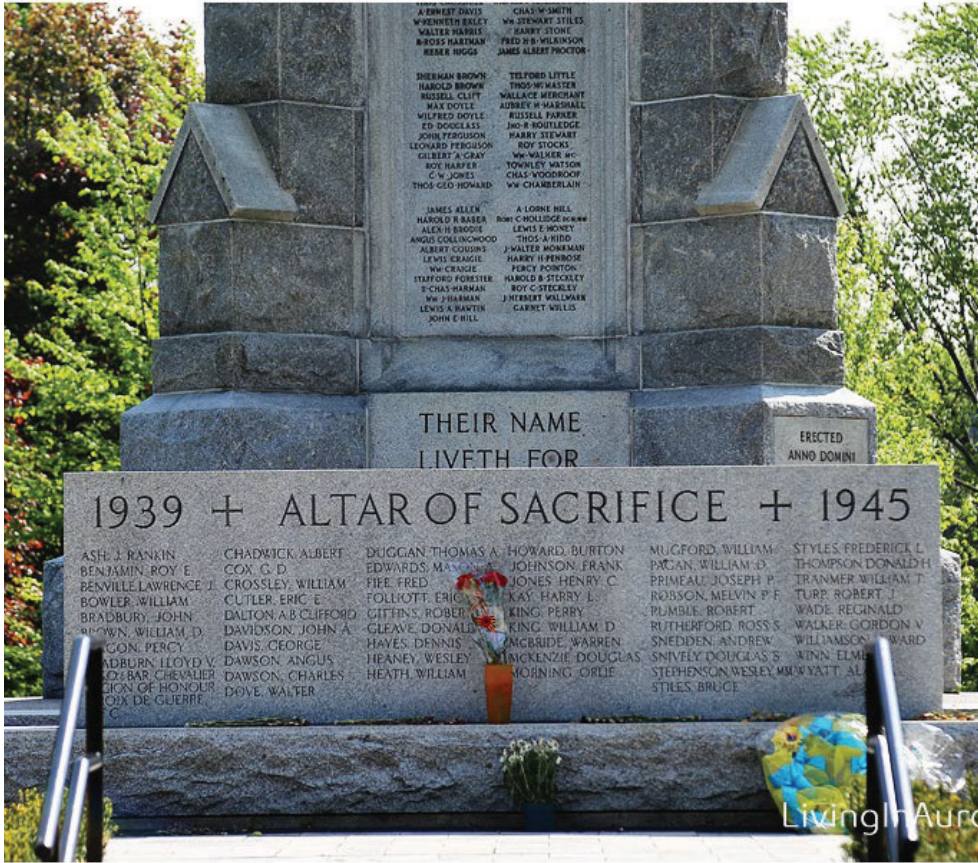
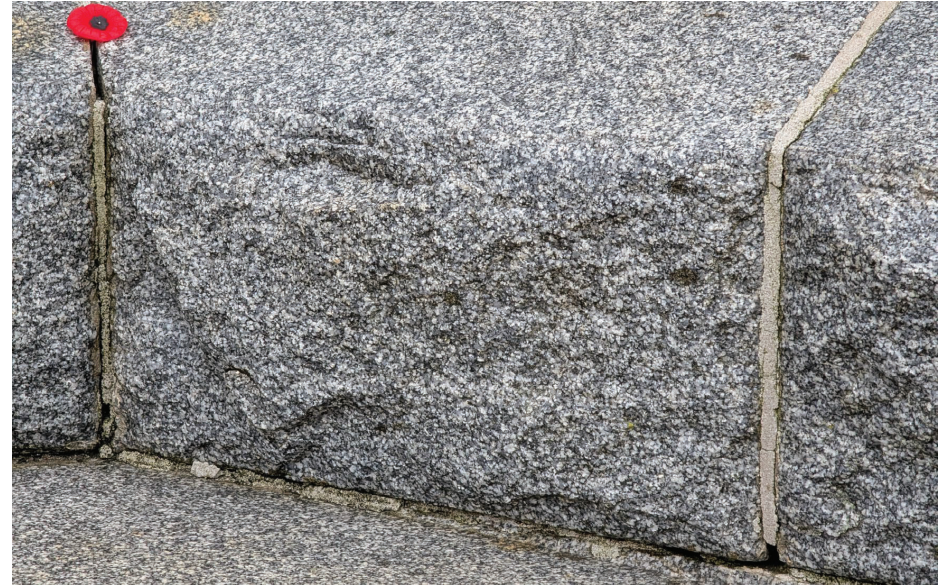
## MASONRY JOINTING

I performed a visual inspection of the joints while on site, there is a considerable amount of jointing ( low level , within my sightline ) it's difficult to determine the state of joints higher than my viewpoint, but we will inspect while cleaning, and report back significant issues immediately .
