# Aurora Cenotaph

The following is a short report to outline recommendations and options for the Cenotaph located at

**Aurora War Memorial Peace Park  
Younge St Aurora Ontario**

A complete on-site inspection was performed on Dec 10 , 2:00 p.m the following is an update to the original submitted report. New slides are highlighted in Orange block

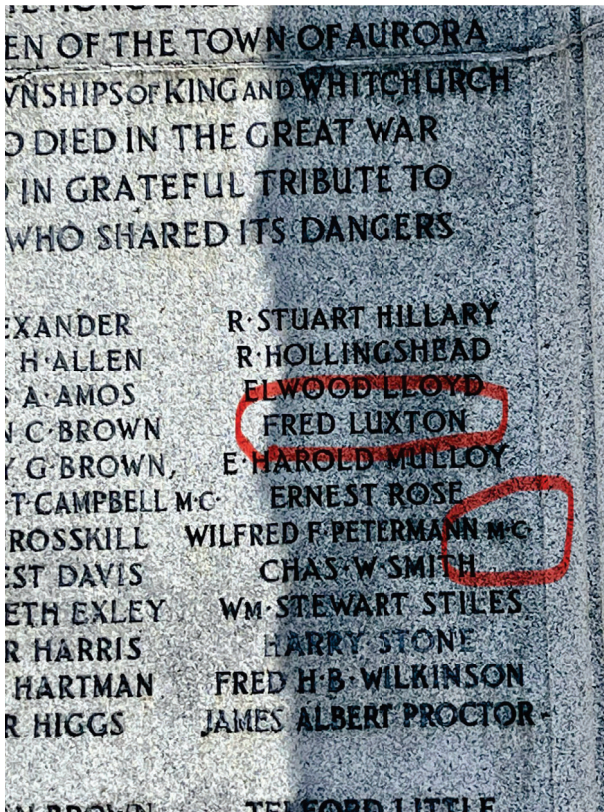
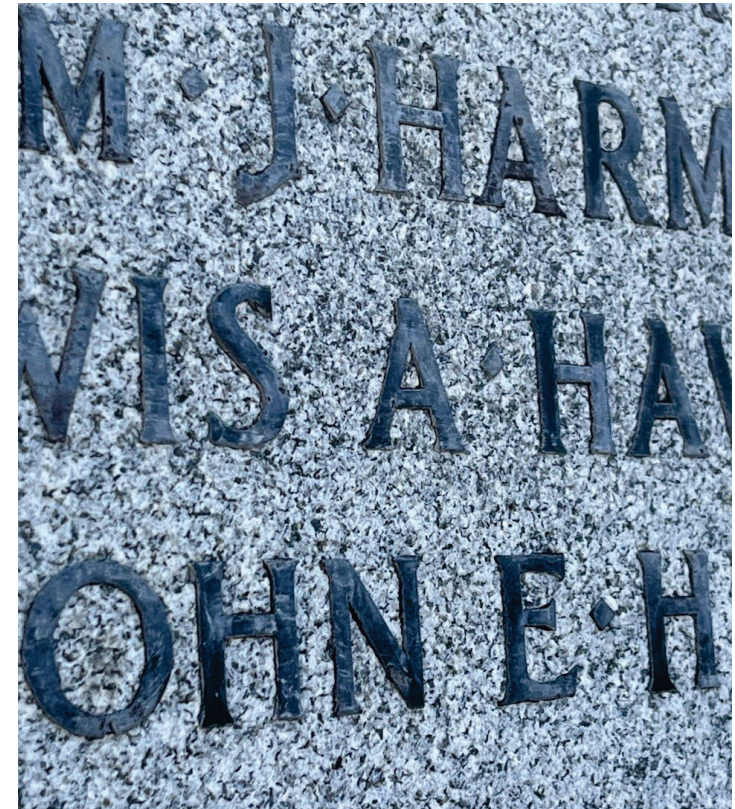
## LEAD LETTERING

Each letter height is 1 ½ inch high & 1 inch wide

The spelling of FRED LUXTON too FRED LUXON ( remove the T)

Remove the M.C after the Name  
Wilfred P. Petermann

We will also perform a complete inspection of all lettering and touch up or repaint letters as required

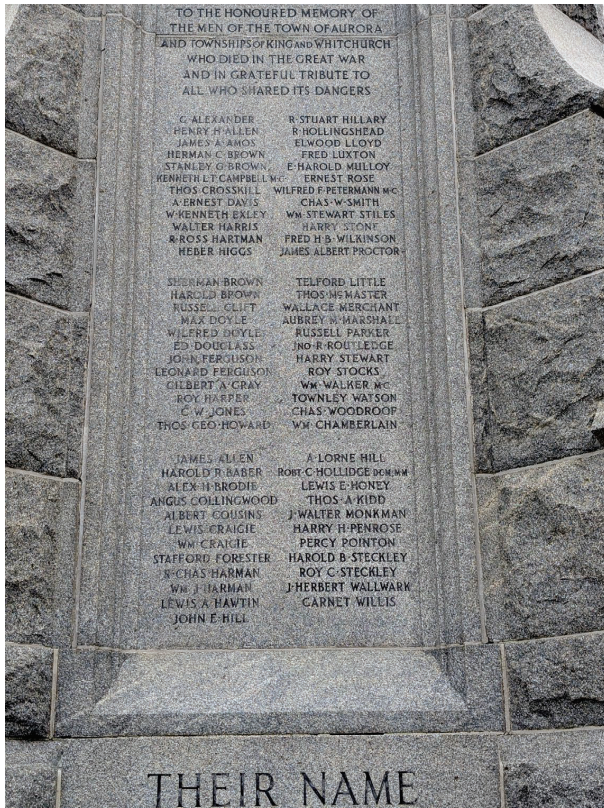
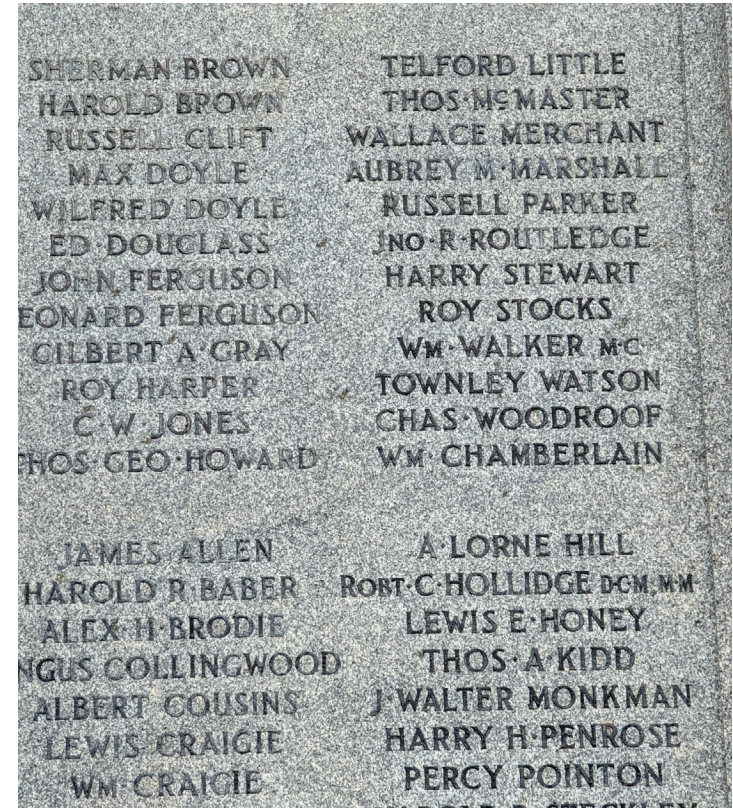
## LEAD LETTERING

**AFTER CLOSE INSPECTION  
Of the Lead lettering**

**Will confirm that all lead  
lettering will be painted , re  
hand painting , Currently the  
lettering is inconsistent , some  
darker than others**

**As well There is a small amount  
of Engraving that requires  
freshen up , not all engraving is  
painted, and we will not paint  
what was originally painted**

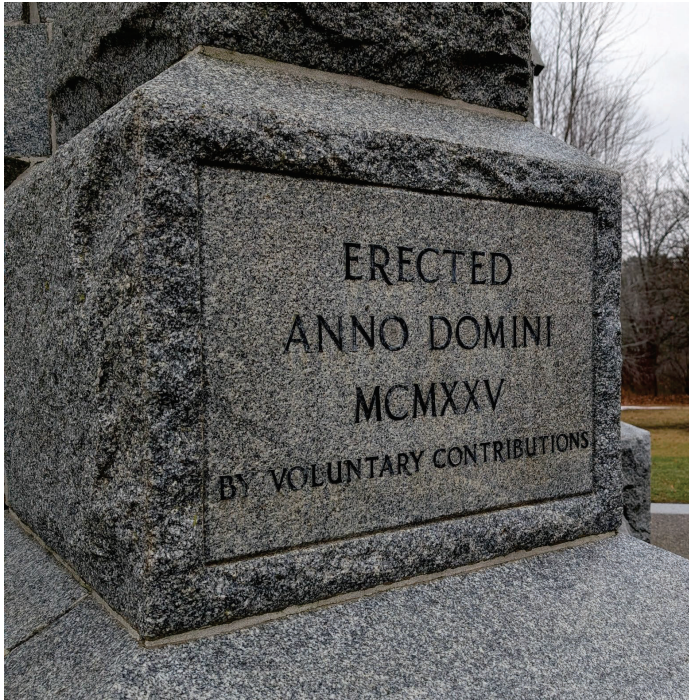
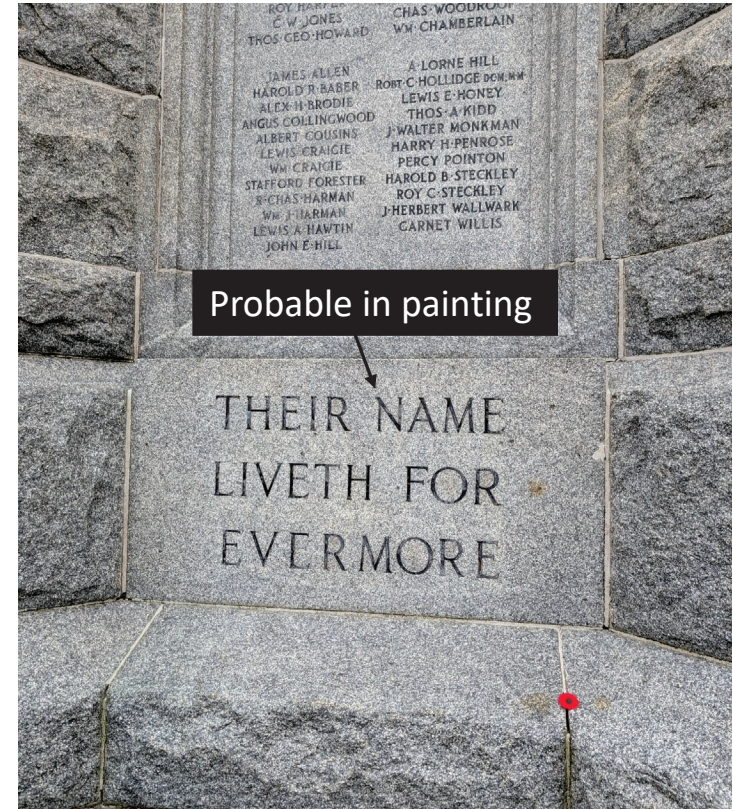
## LEAD LETTERING

**AFTER CLOSE INSPECTION  
Of the Lead lettering**

**Will confirm that all lead lettering will be painted , re hand painting , Currently the lettering is inconsistent , some darker than others**

**As well There is a small amount of Engraving that requires freshen up , not all engraving is painted, and we will not paint what was originally painted**

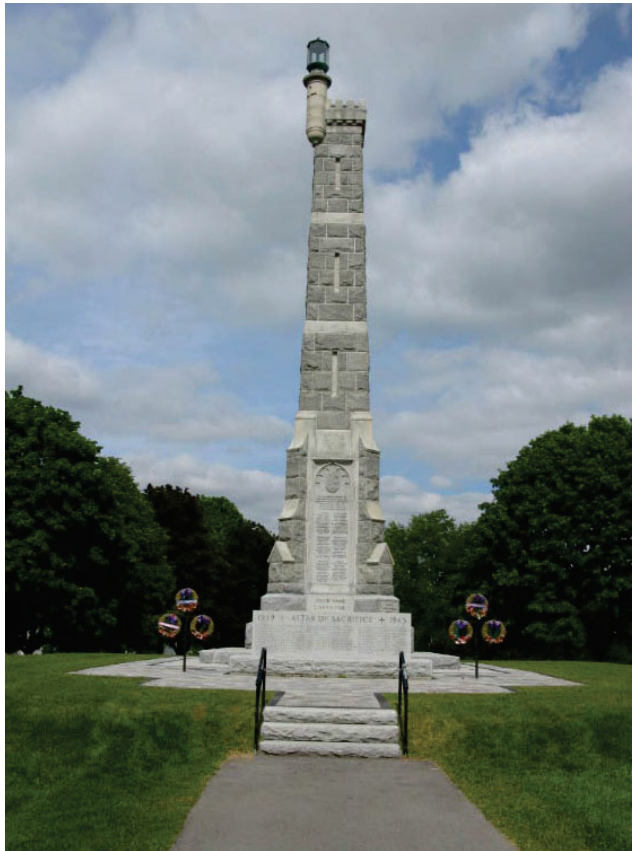
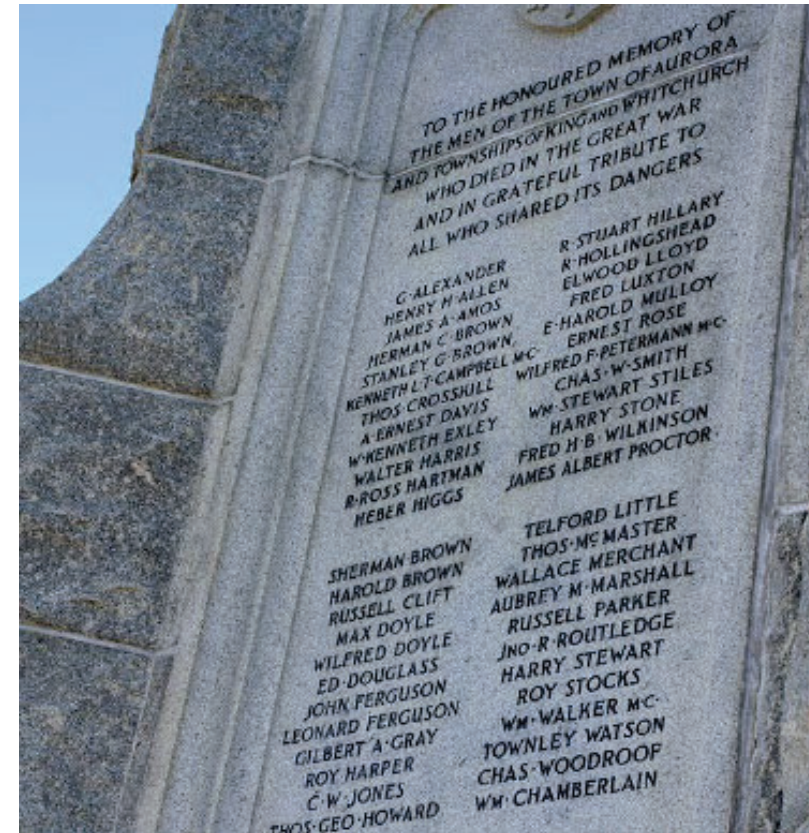
## CLEANING

Structures of this nature are subjected to soiling of various types

We propose an entire site & structure application / cleaning of a BIOCIDES cleaner, power washing on granite elements and surrounding cement pads & natural stone elements.

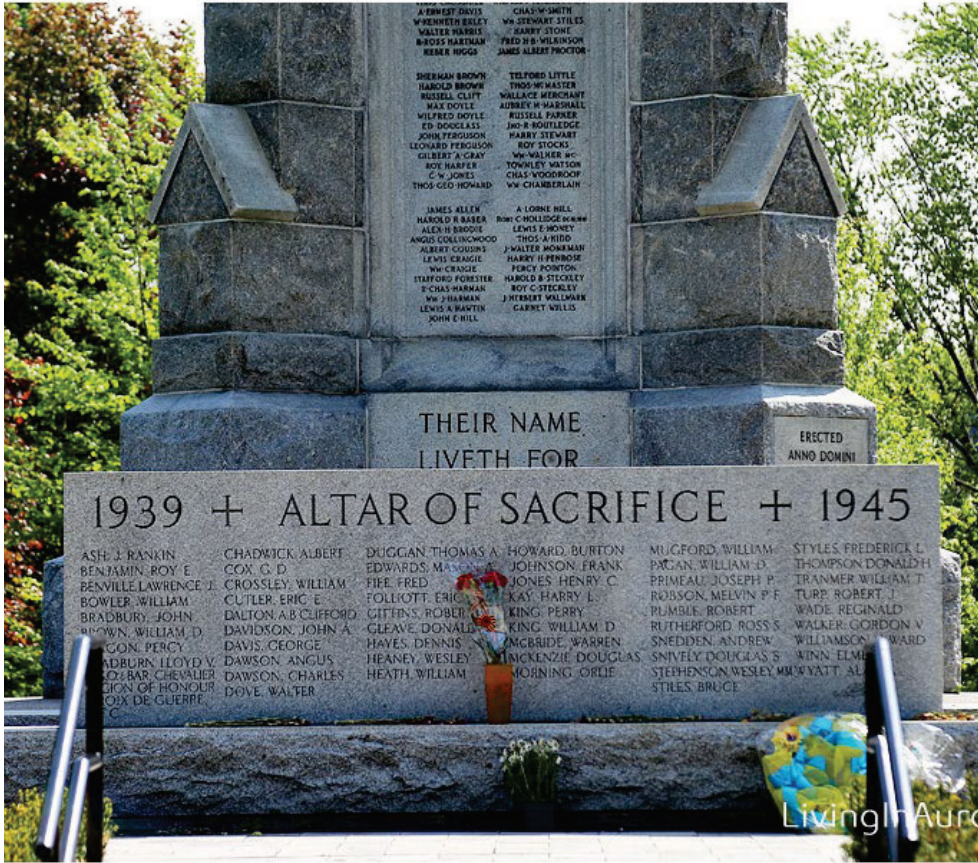
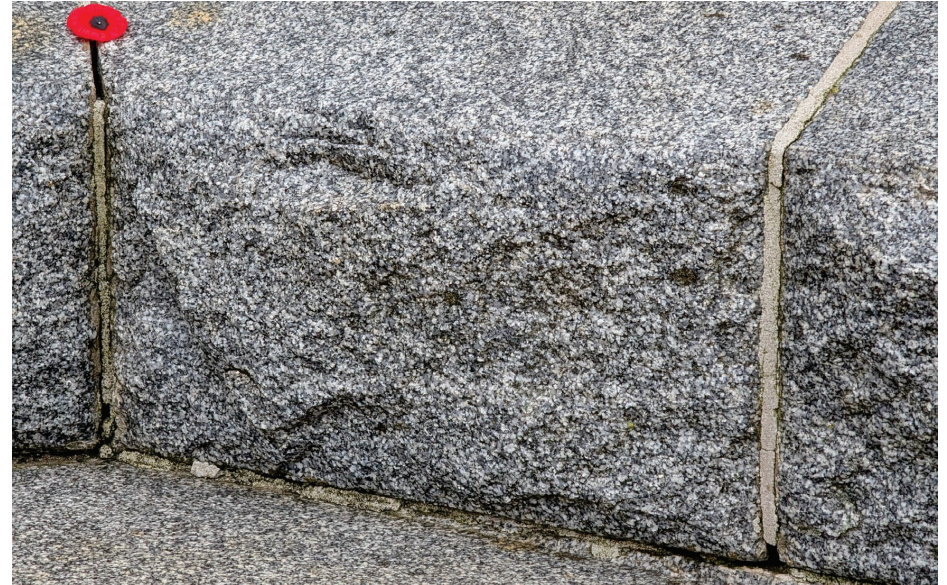
## MASONRY JOINTING

I performed a visual inspection of the joints while on site, there is a considerable amount of jointing ( low level , within my sightline ) it's difficult to determine the state of joints higher than my viewpoint, but we will inspect while cleaning, and report back significant issues immediately .
